**USDA NRCS Bismarck State Office**

**Dam Assessment Report**

## **English Coulee Dam**

**Grand Forks County, North Dakota**

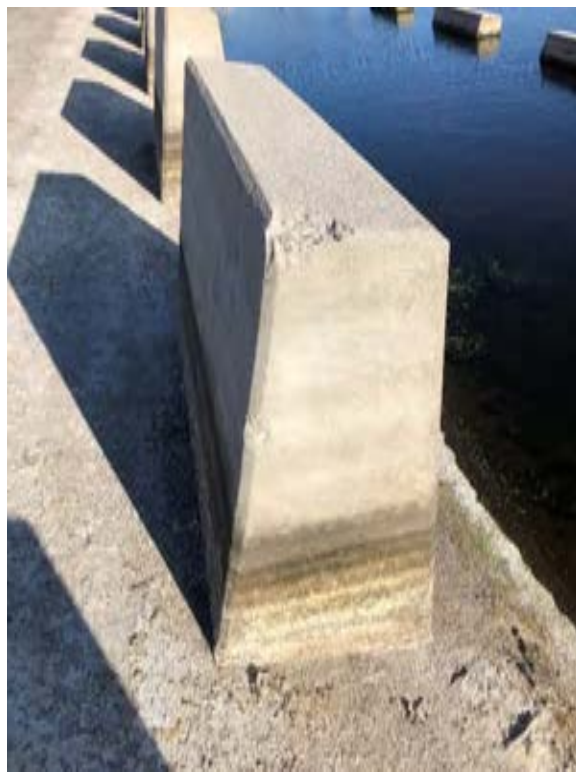
*Photo 7 Superficial damage to baffle likely due to shooting*

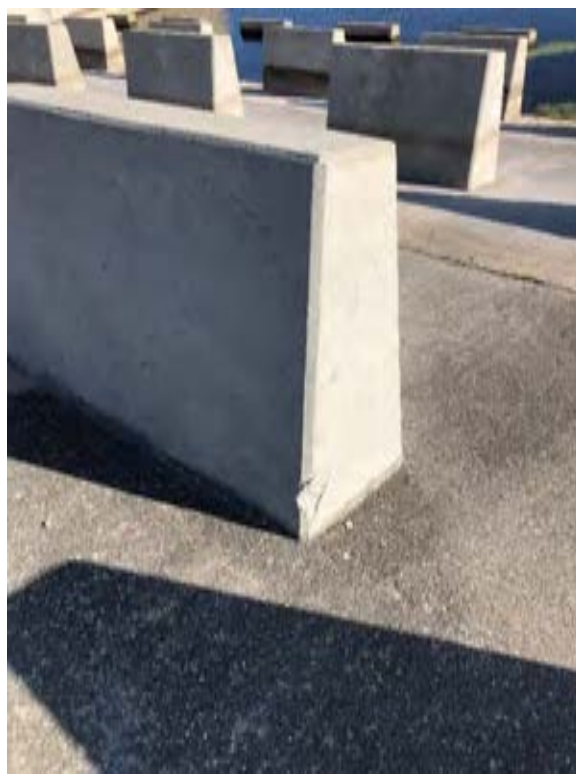
*Photo 8 Superficial damage to baffle likely due to shooting*

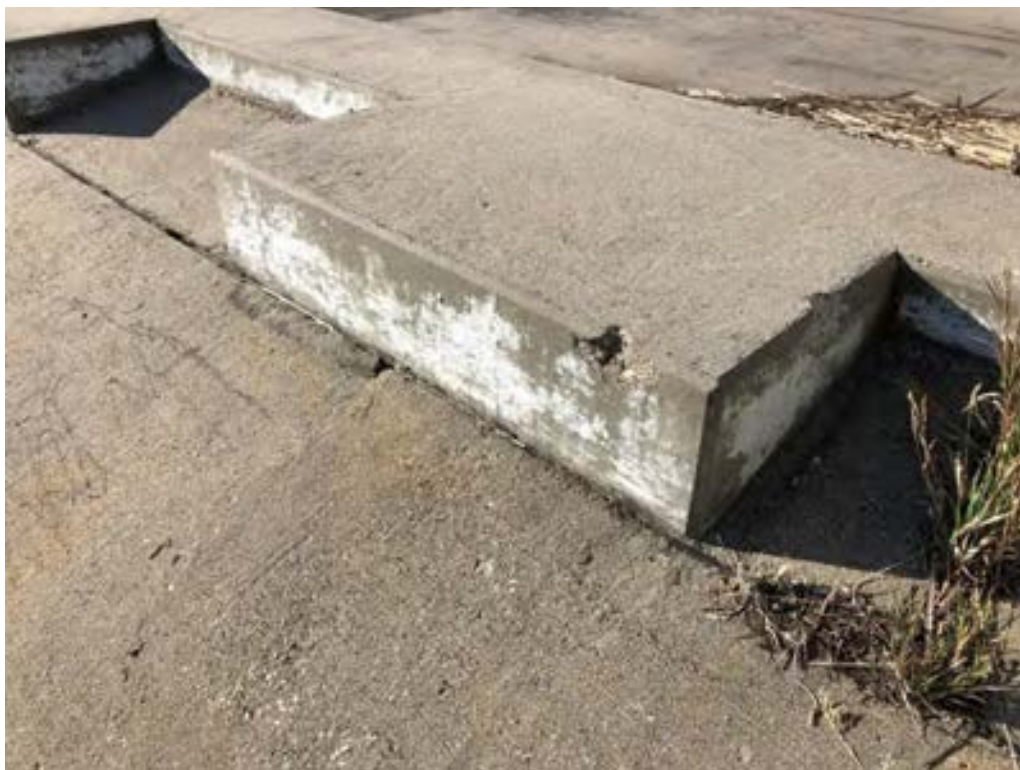
*Photo 9 Damaged edge of auxiliary spillway crest weir*

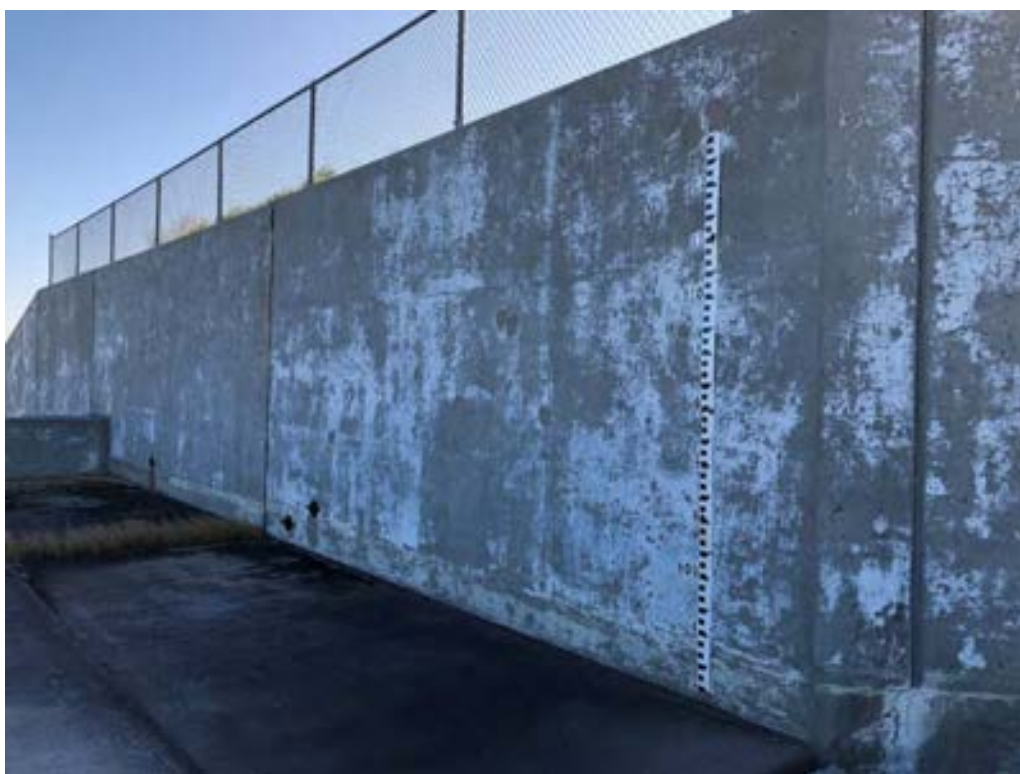
*Photo 10 Staff gauge on right wall of AS; board members noted gauge is difficult to read from opposite side during high water events*

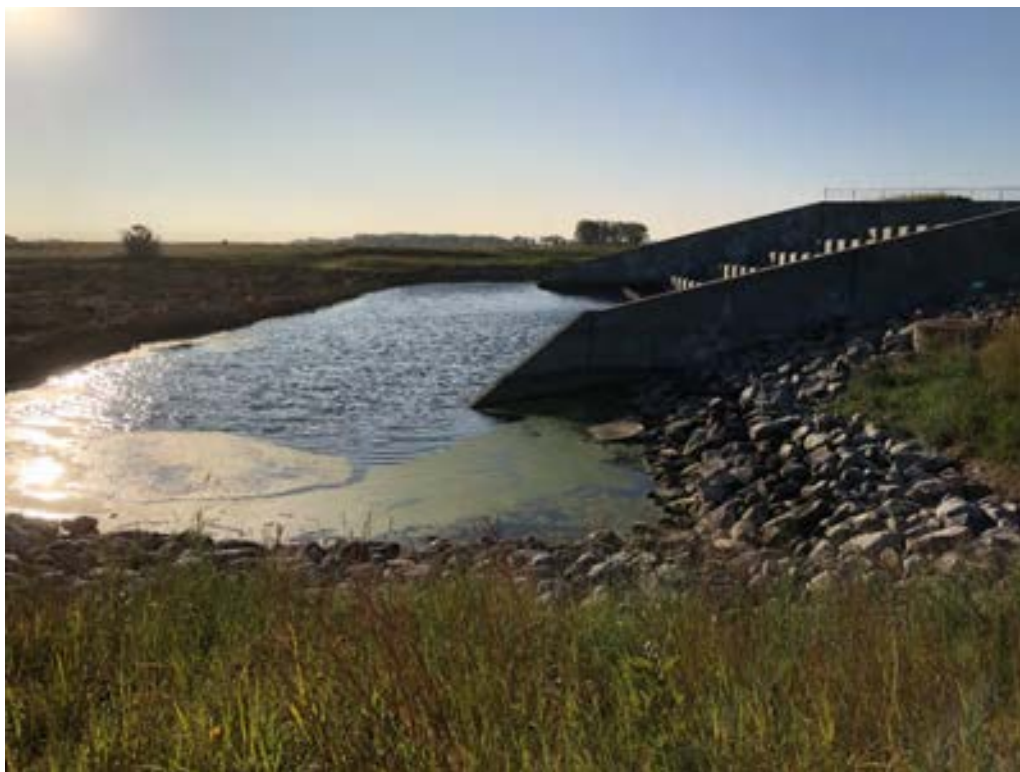
*Photo 11 Auxiliary spillway stilling basin; bottom of spillway and drain access manhole submerged*

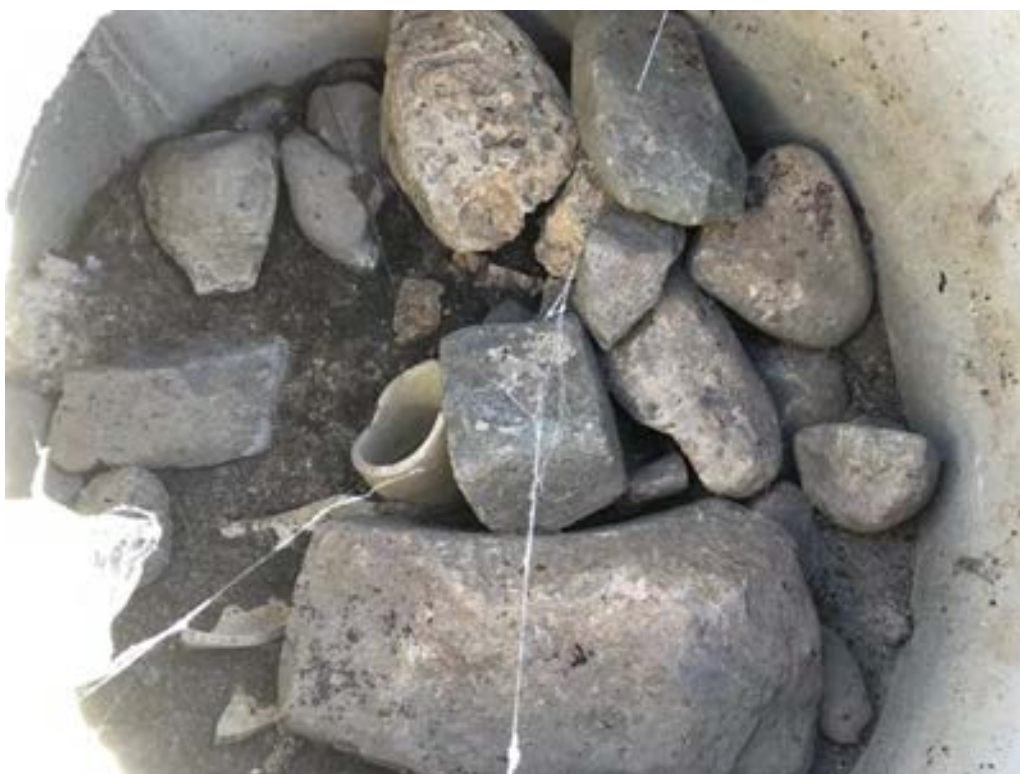
*Photo 14 Drain cleanout broken due to vandalism by dropping rocks into manhole*

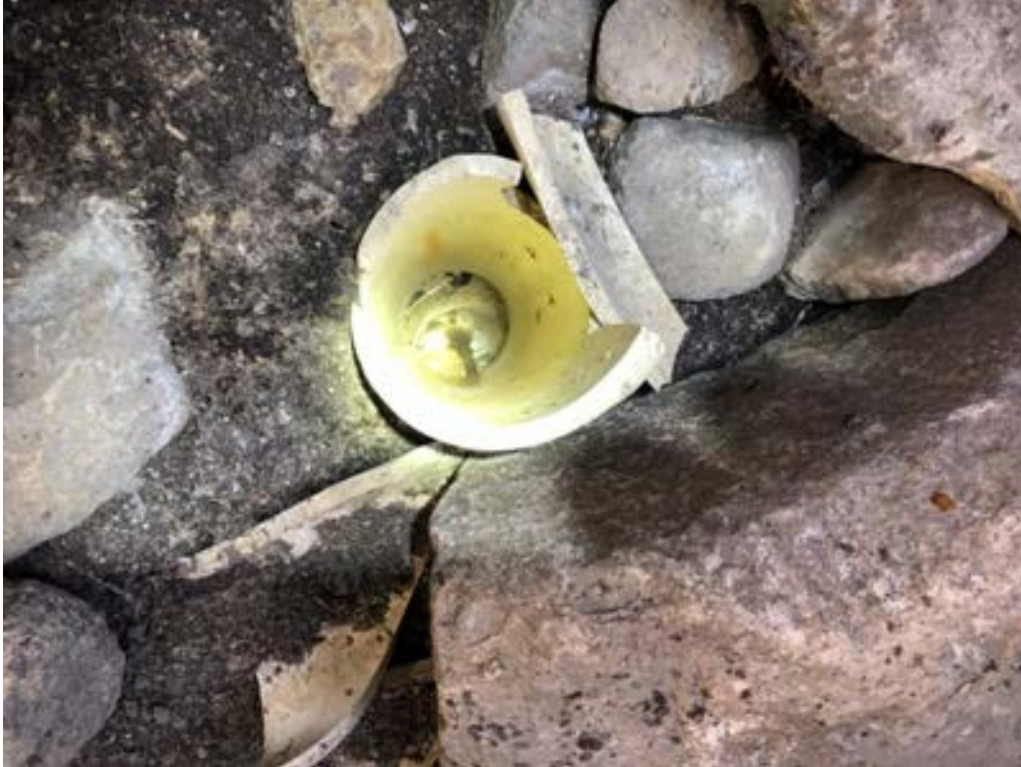
*Photo 15 Broken drain cleanout dislodged from foundation drain pipe*

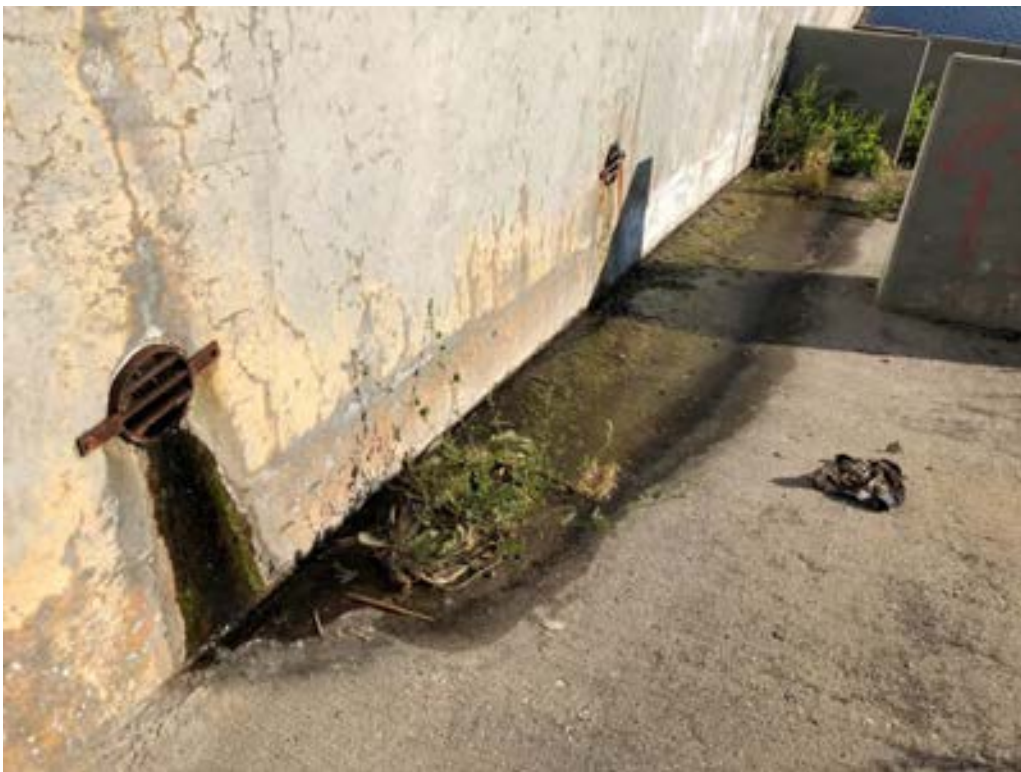
*Photo 16 Auxiliary spillway foundation drains functioning; heavy vegetative growth*

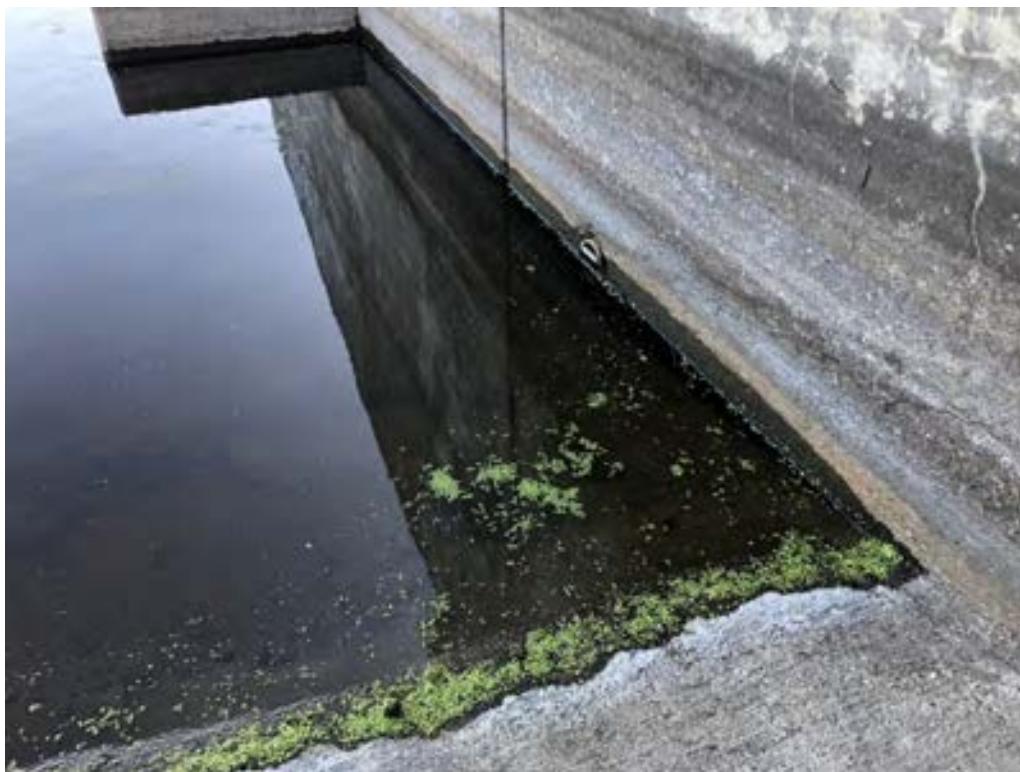
*Photo 17 Lower auxiliary spillway foundation drains submerged due to improper drainage of stilling basin*

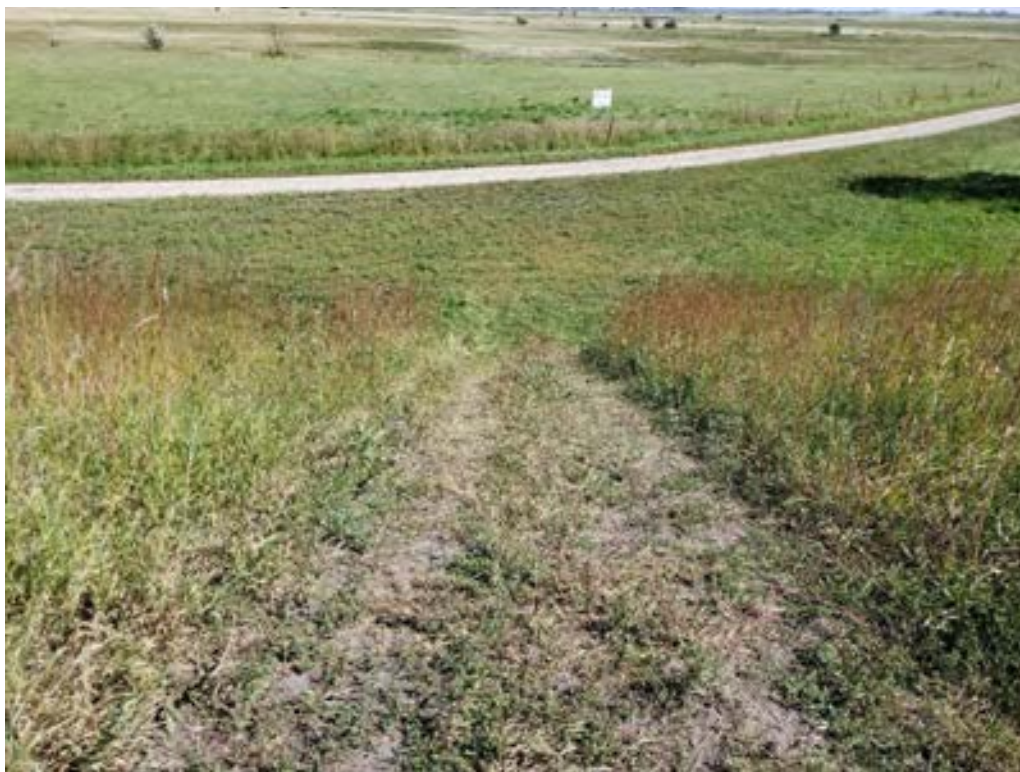
*Photo 31 Worn vehicle tracks on downstream face of embankment*

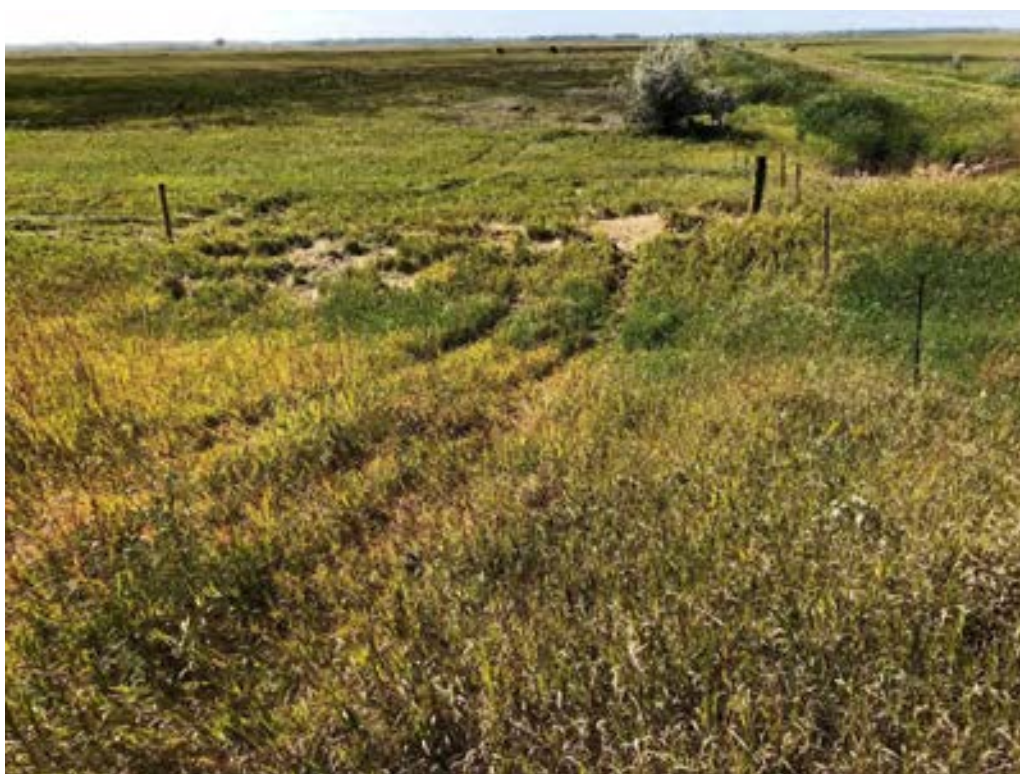
*Photo 32 Vehicle tracks on upstream face of embankment*
