# Upper Turtle River Watershed Dam #9, Larimore Dam

*Appendix D-1: Existing Conditions  
Assessment Report (DRAFT)*

**Grand Forks County Water Resource  
District  
USDA - NRCS**

February 19, 2026

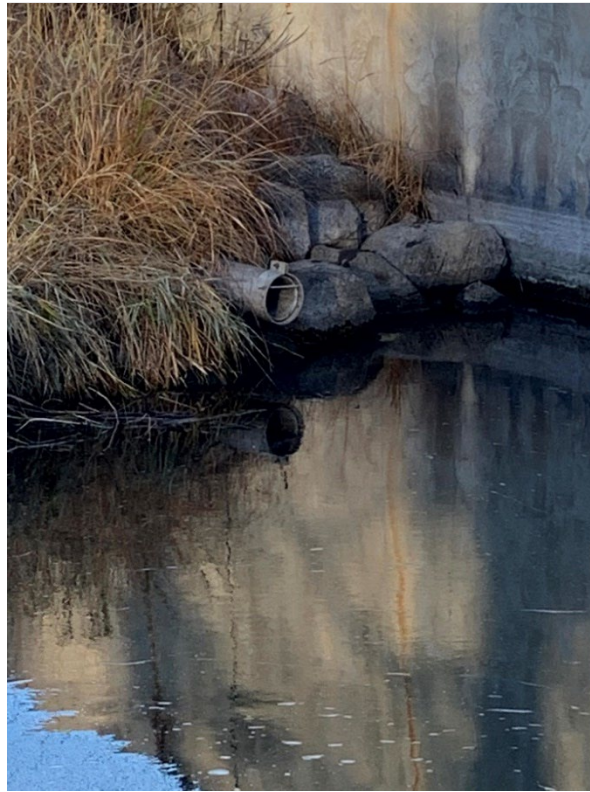
| Foundation Drains | <ul style="list-style-type: none"> <li>• Right foundation drain animal guard is missing.</li> </ul> |

**Photo 8: Right foundation drain outlet, missing animal guard.**

A new animal guard on the outlet of the right foundation drain should be added. The principal spillway conduit appears to be adequate to last through the expected dam rehabilitation design life of 50 years. All structural elements should continue to be monitored on a regular basis. Observations from the inspection associated with the principal spillway concrete inlet structure, conduit, and outlet are provided in Table 3.

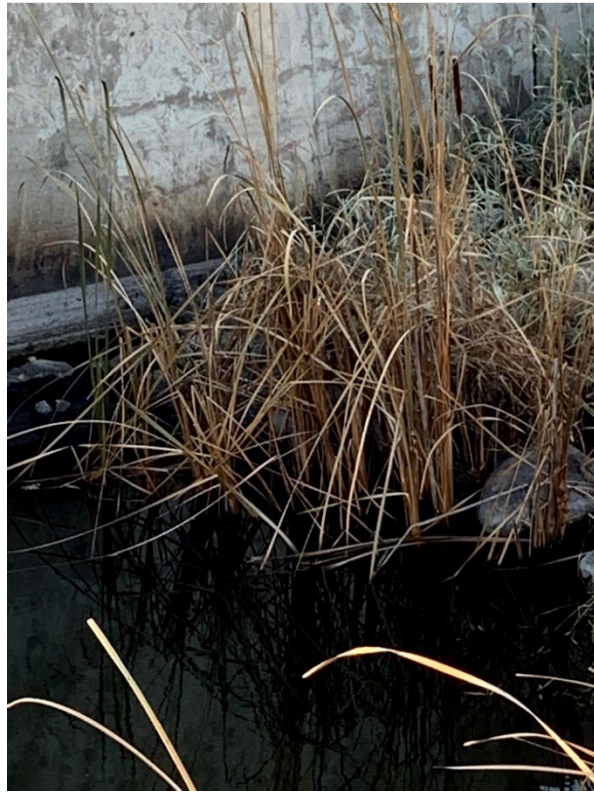
**Photo 9: Left foundation drain outlet with animal guard.**

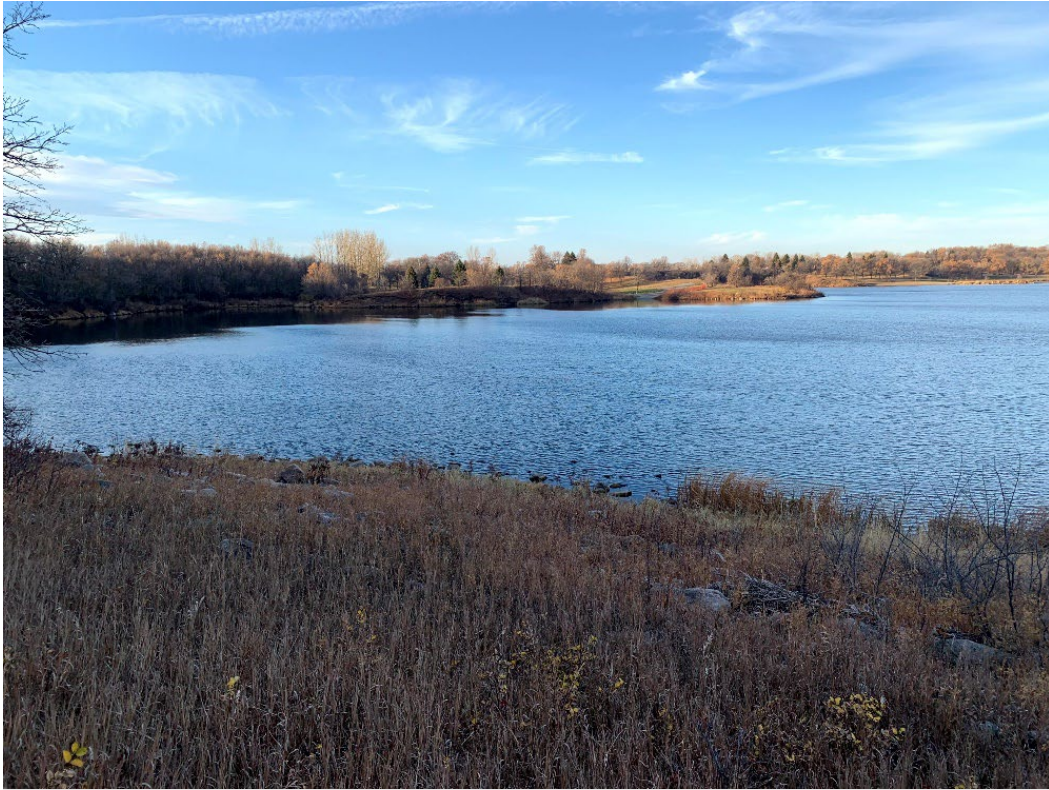
to record findings and the 2022 Larimore Dam inspection checklist is presented in **Attachment 2**. The condition of the dam embankment during the 2022 inspection was overall fair. The upstream slope had a small tree near the left abutment and trees in the right abutment. The riprap along the upstream slope had minor woody vegetation growing within. The crest had some minor rutting from wheel tracks. The downstream slope had minor woody vegetation along it and trees in both abutments. The downstream berm had severe rutting from wheel tracks. It also had wetland vegetation on it but the ground was dry at the time of inspection. The auxiliary spillway had a large area with severe rutting from ATV activity. There were large areas on the left side slope of the auxiliary spillway that have collapsed and eroded. The auxiliary spillway also had patches of woody vegetation growing throughout and gopher holes present. The District intends to complete vegetation removal on the dam and fill/stabilize/grass seed ruts and cut slope on the ASW in the summer of 2024.

**Photo 12: Woody vegetation on upstream slope.**

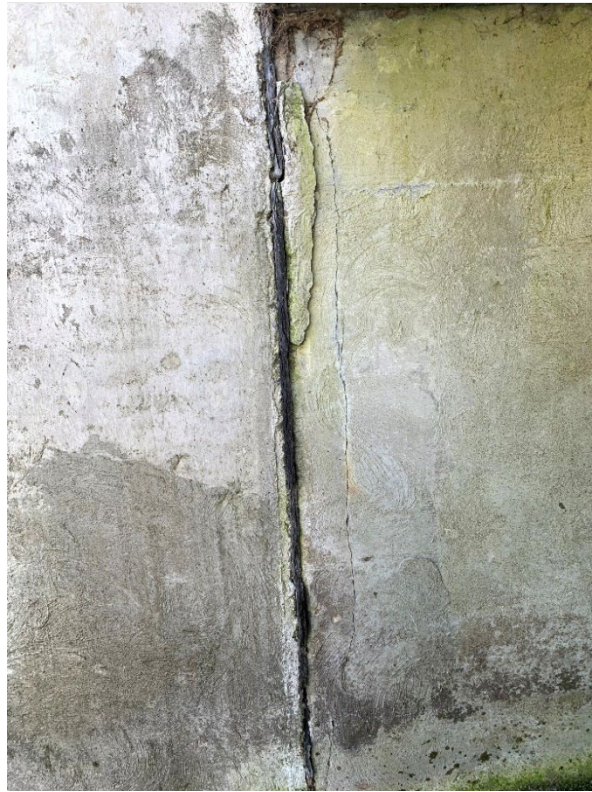
**Photo 28: Cracking, Joint #1.**

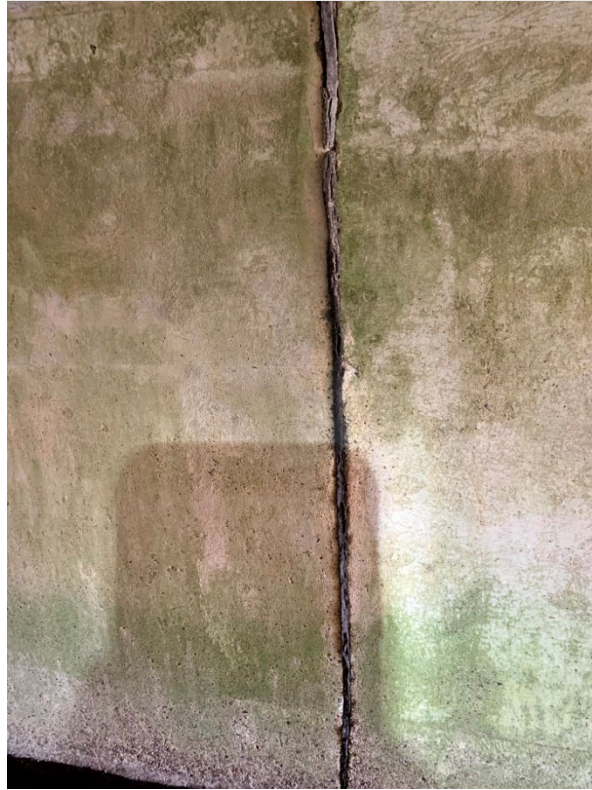
**Photo 29: Joint filler, Joint #2.**

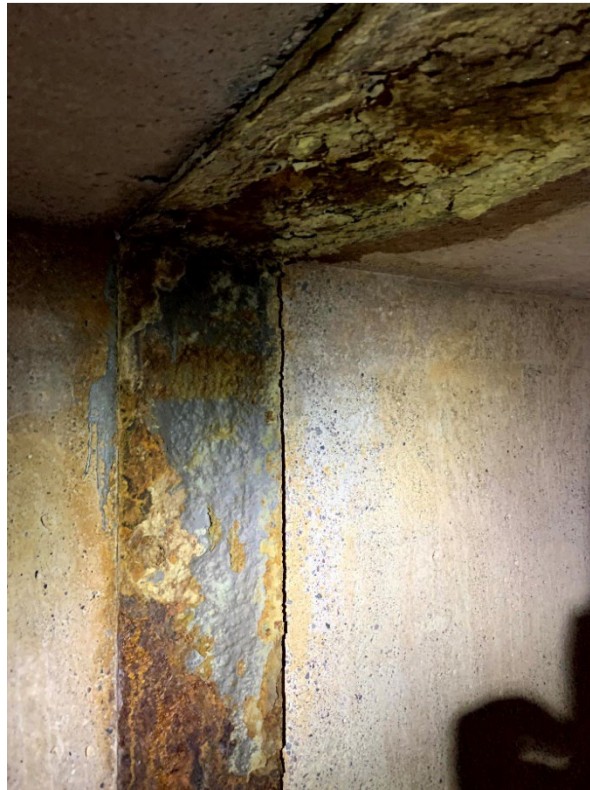
**Photo 31: Steel plate corrosion, Joint #4.**

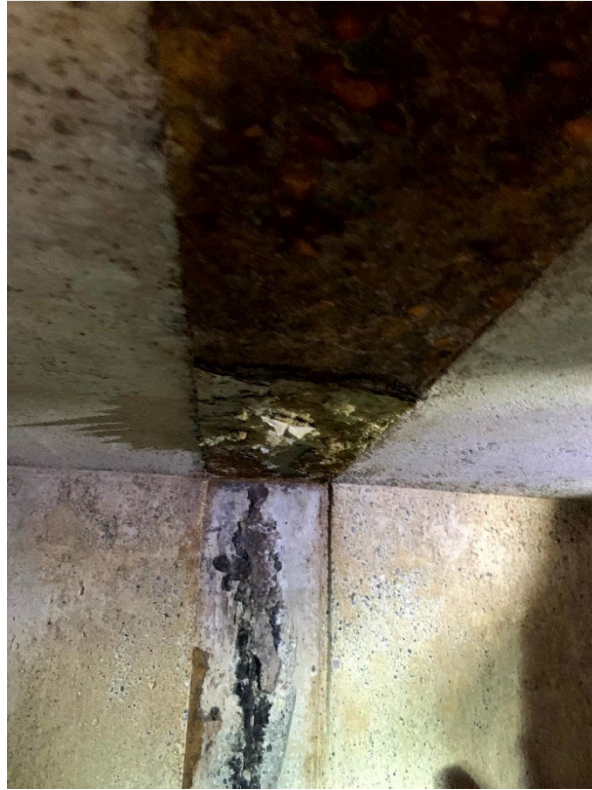
**Photo 32: Missing steel plate, Joint #5.**

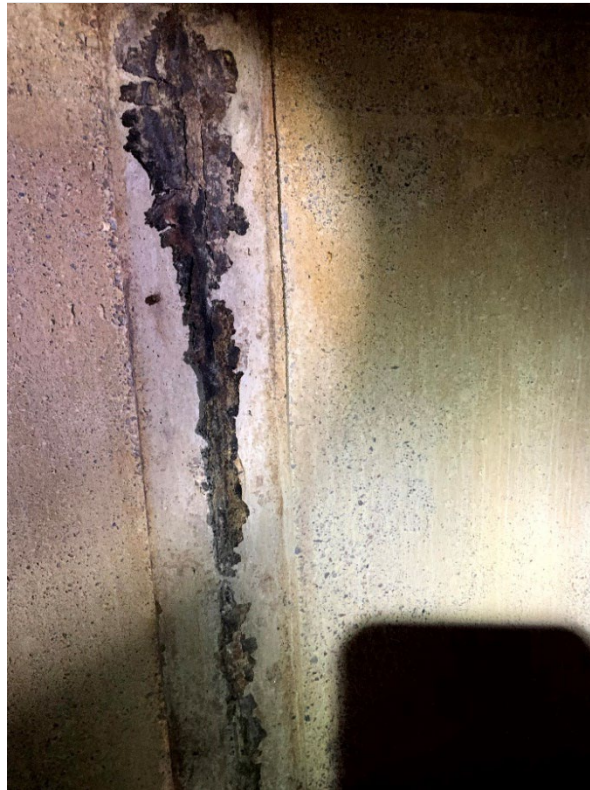
**Photo 33: Missing steel plate, Joint #6.**

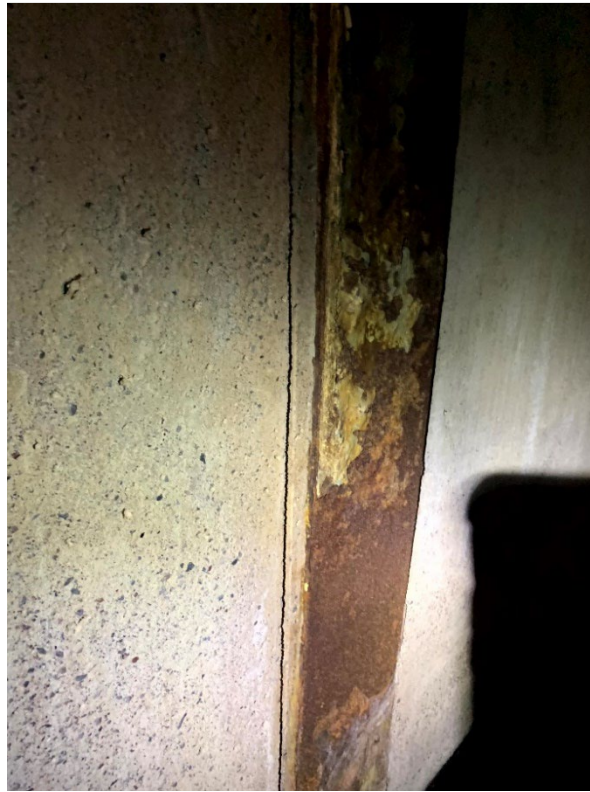
| Deficiency Location | Description |
|---|---|
| Principal Spillway Conduit: As-Built Joint #7 | <ul style="list-style-type: none"> <li>Steel plate on left side is missing</li> </ul> |

**Photo 34: Separated steel plate, Joint #7.**

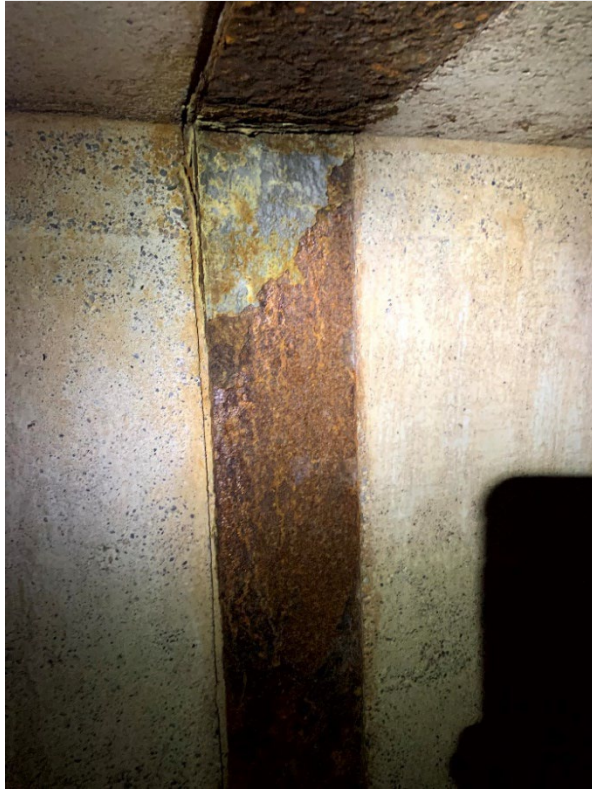
| Deficiency Location | Description |
|---|---|
| Principal Spillway Conduit: As-Built Joint #9 | <ul style="list-style-type: none"> <li>Steel plate on left side is missing.</li> </ul> |

**Photo 36: Steel plate corrosion, Joint #9.**

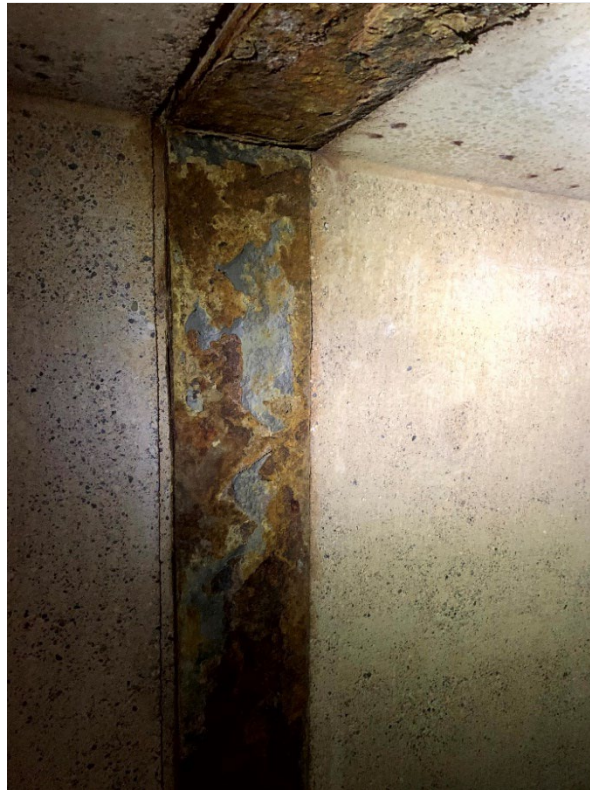
**Photo 37: Steel plate corrosion, Joint #10.**

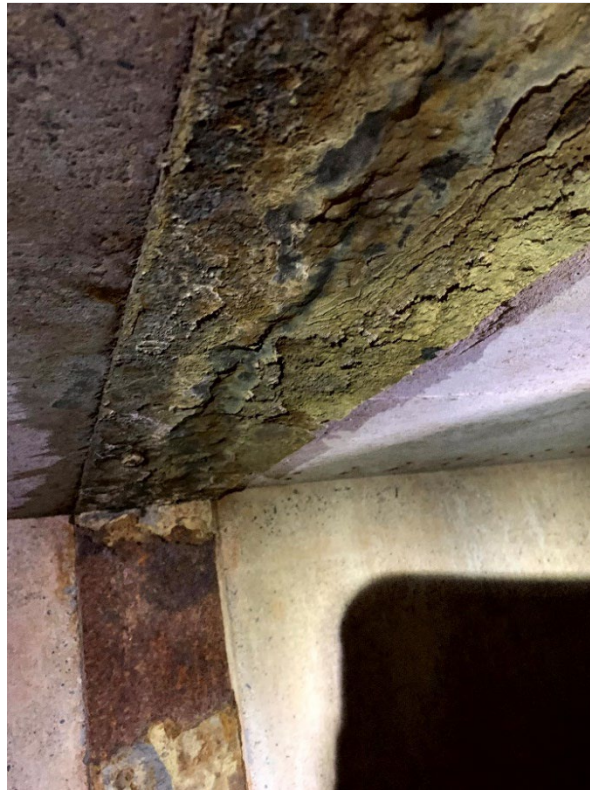
**Photo 38: Steel plate corrosion, Joint #11.**

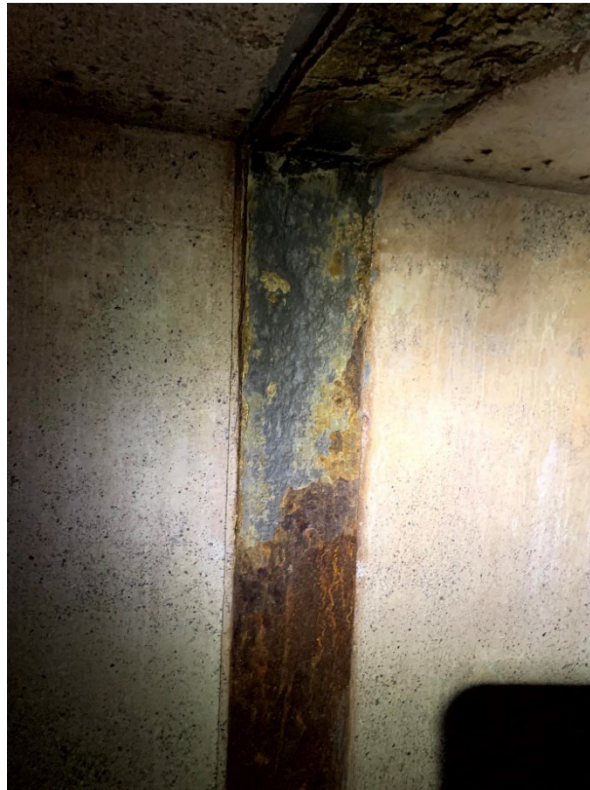
**Photo 39: Steel plate corrosion, Joint #12.**

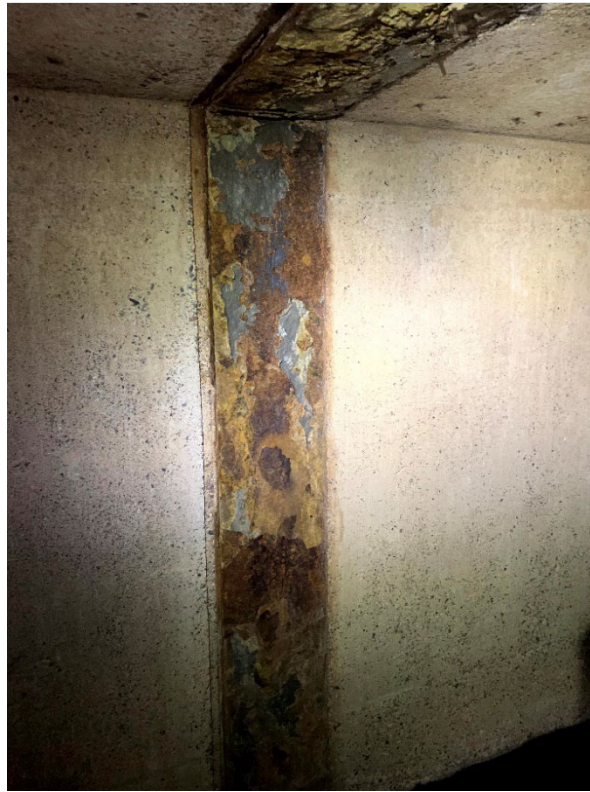
**Photo 40: Steel plate corrosion, Joint #13.**

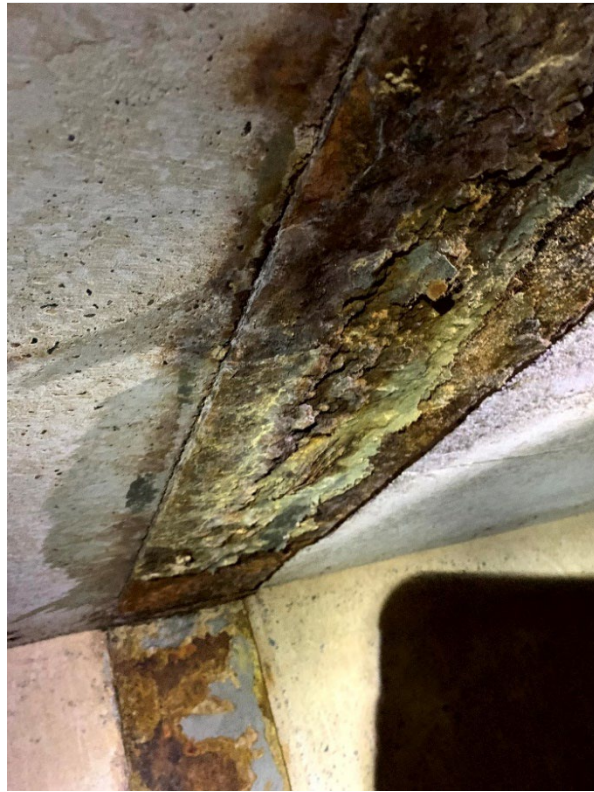
**Photo 41: Steel plate corrosion and wet on top, Joint #14.**

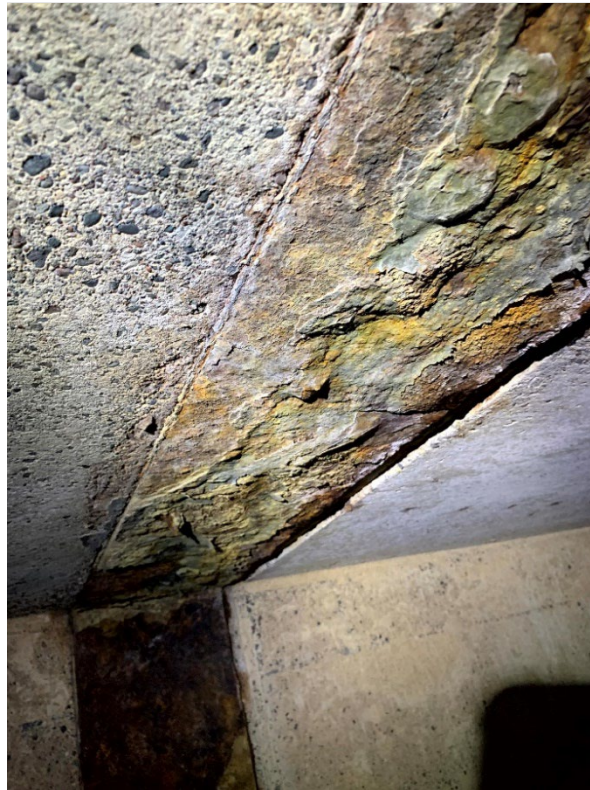
**Photo 42: Steel plate corrosion, Joint #15.**

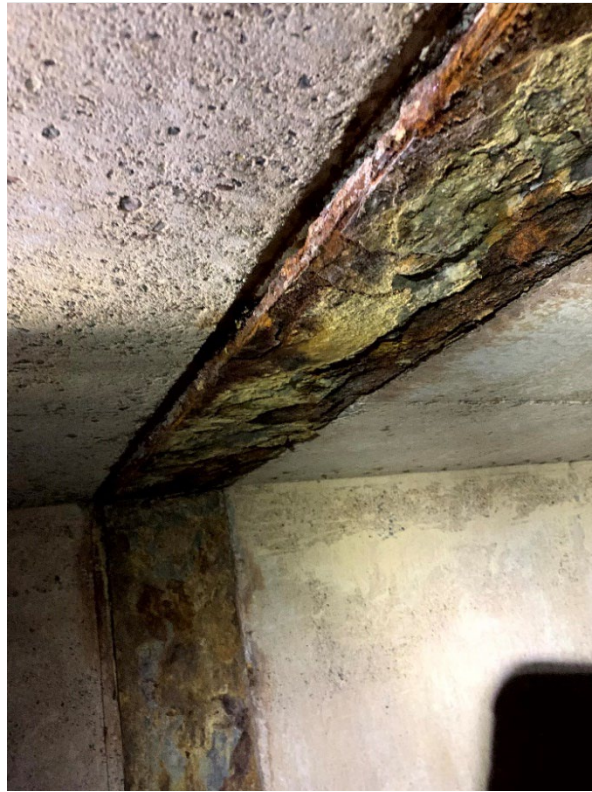
**Photo 43: Steel plate corrosion, Joint #16.**

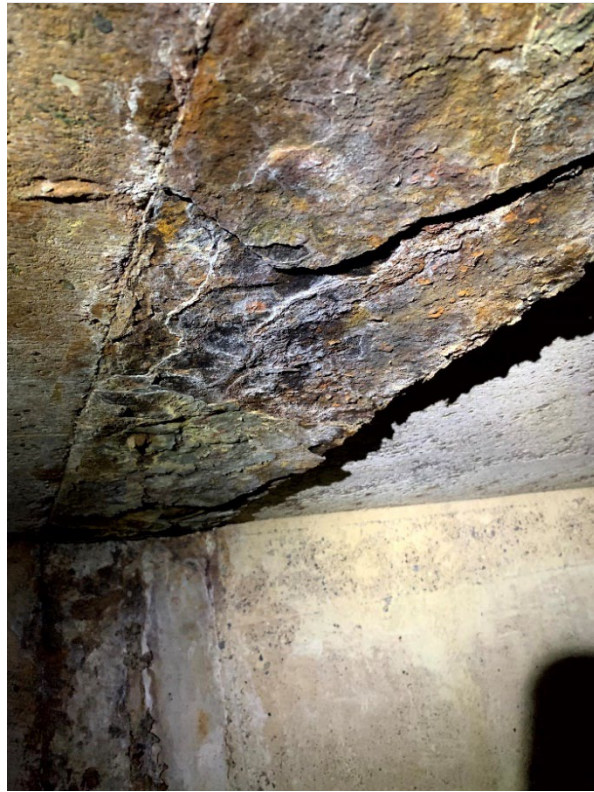
**Photo 44: Steel plate corrosion and missing plate, Joint #17.**

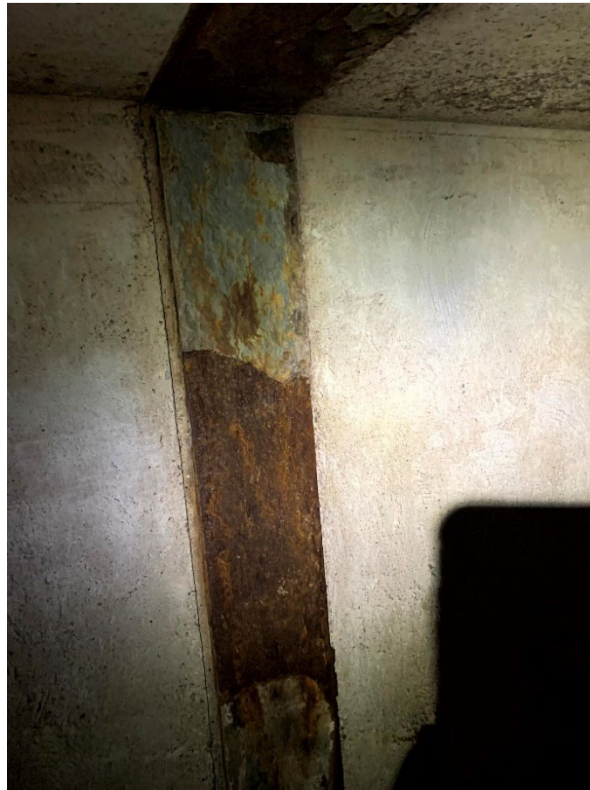
**Photo 45: Steel plate corrosion, Joint #18.**

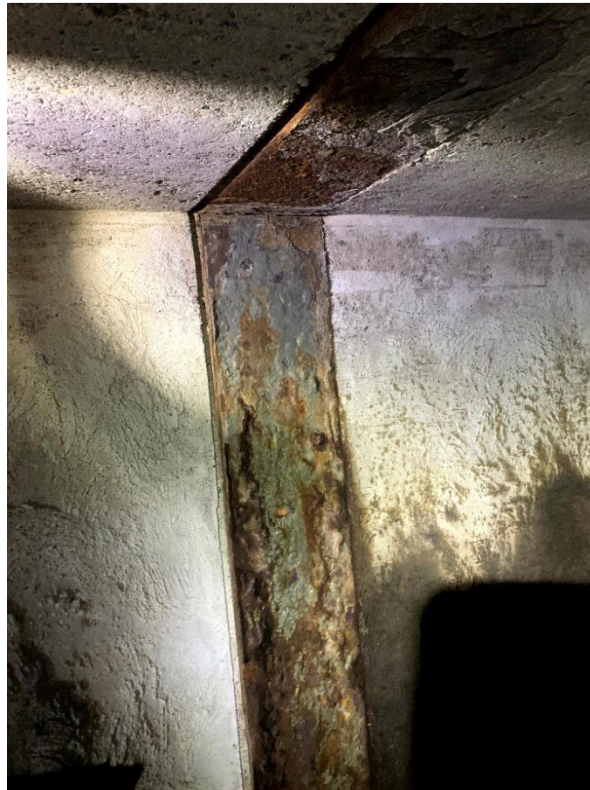
| Principal Spillway<br>Conduit: As-Built<br>Joint #19 | <ul style="list-style-type: none"> <li>• Steel plate on left side is missing.</li> </ul> |

**Photo 46: Steel plate corrosion, Joint #19.**

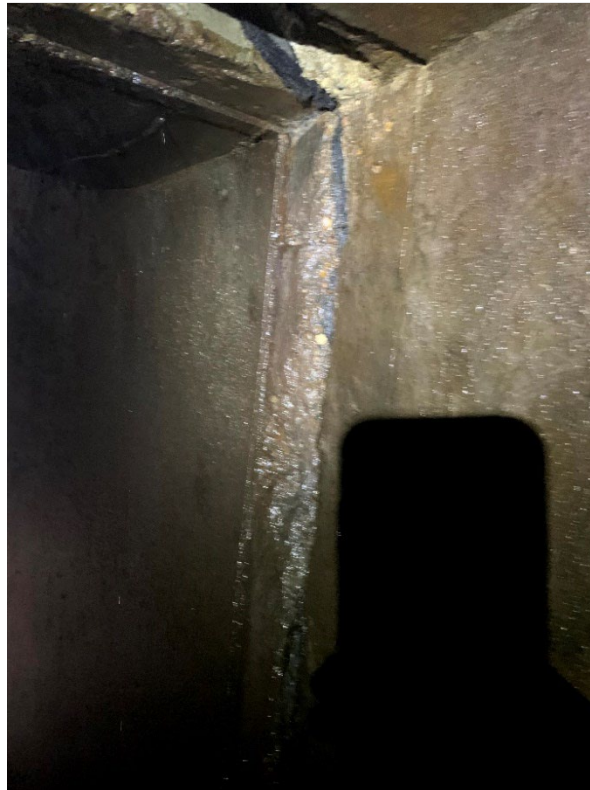
**Photo 47: Missing steel plate, Joint #20.**

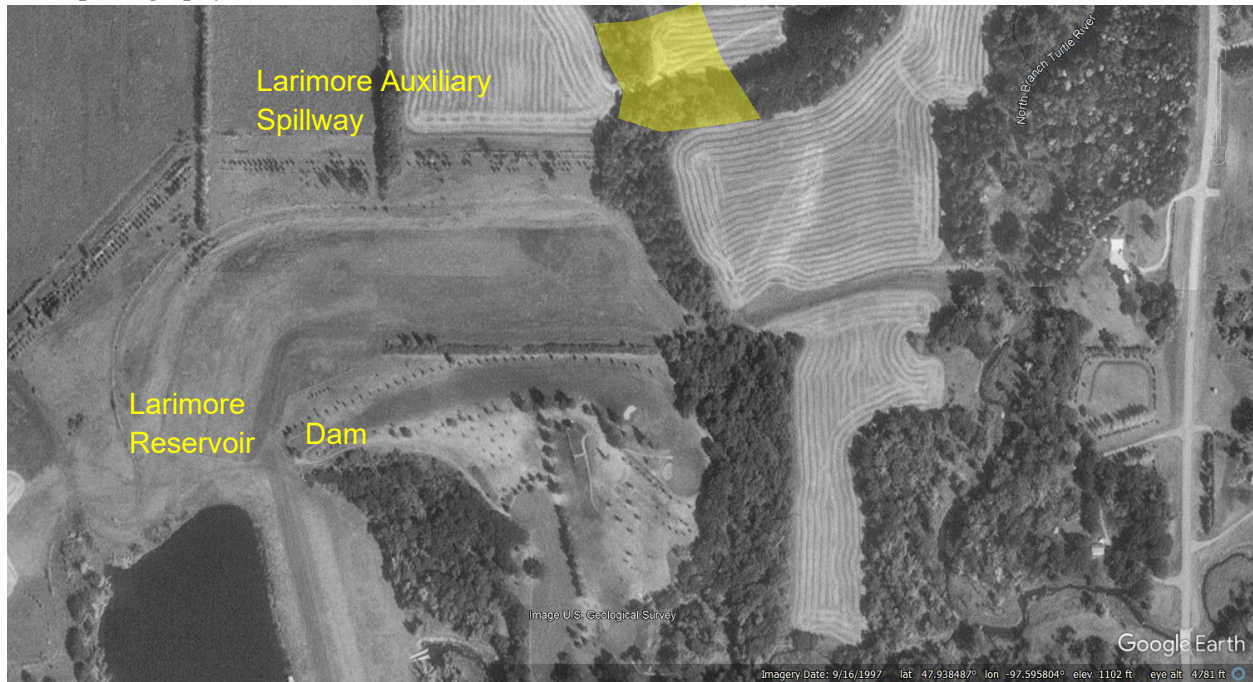
September 16, 1997, shows the auxiliary had trees on a hill slope. The June 2000 flood eroded at the location of trees. In 2001, an Emergency Watershed Protection (EWP) project was completed to remove the trees within the auxiliary spillway and re-grade erosion that occurred during the flood event. Figure 2 shows aerial photography from Google Earth after the EWP regrading was completed. The date of the aerial photography is June 27, 2003.

Figure 1. Google earth aerial photography dated September 16, 1997. The Pale yellow polygon represents the location of auxiliary spillway erosion and the EWP tree removal and grading repair.

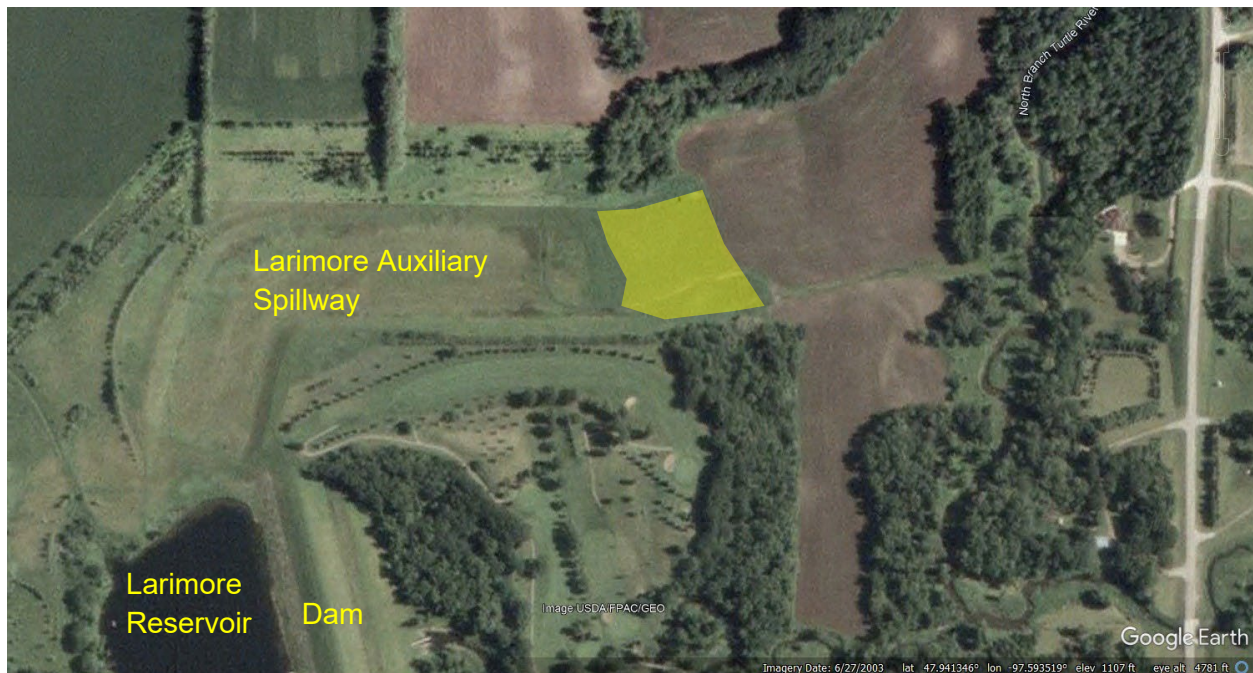
Figure 2. Google earth aerial photography dated June 27, 2003. The Pale yellow polygon represents the location of auxiliary spillway erosion and the EWP tree removal and grading repair.
