# Soil and Plant Science Division

## High Tunnel and Ground Subsidence

### Wasilla, Alaska, Major Land Resource Area (MLRA) Soil Survey Office (SSO)

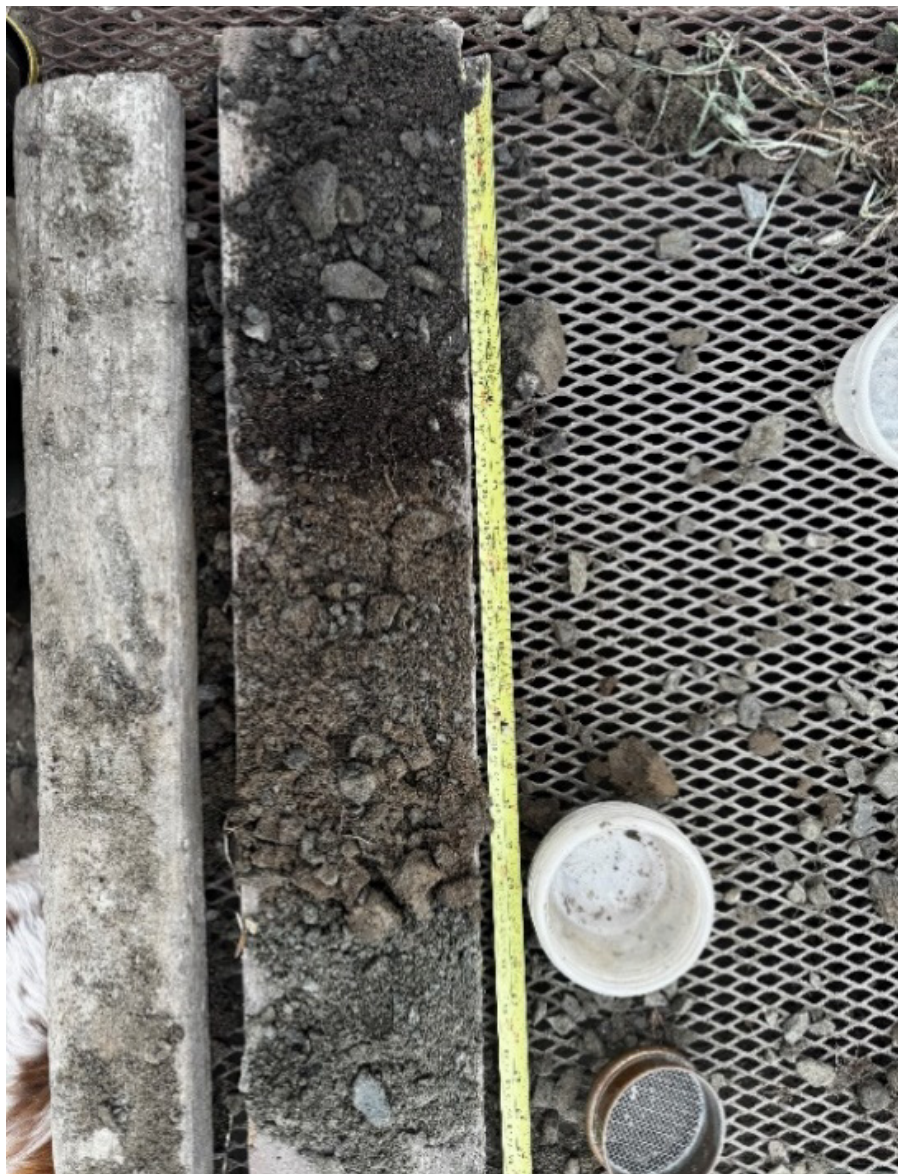
The producer was initially concerned about the lack of organic matter and the presence of rock fragments, which make excavation difficult. Upon investigation, it became clear that much of the issue was related to a compacted surface layer likely left over from residential construction more than 50 years ago (fig. 1). Beneath this disturbed material, the native soil profile was better developed, showing characteristics consistent with glacial till and loess-derived silts and sands typical of the area. Once the compacted layer was broken up, the underlying soil was significantly easier to work with and showed potential for productive use with the addition of fertilizer in the form of organic matter. The team described the soil profile as follows:

- ^C horizon: 0 to 20 cm; dark grayish brown sandy loam; about 30 percent gravels and occasional cobbles. Compacted fill material likely from construction of the home and other structures.
- A horizon: 20 to 22 cm; dark brown sandy loam; very high in organic matter.
- Bw horizon formed from windblown sands and silt: 22 to 50 cm; brown; sandy loam or fine sandy loam; with some redder mottles.
- 2C horizon: 50 cm and deeper; very gravelly sandy loam with 40 percent rock fragments mostly in the form of channers less than 20-mm wide. Formed from gray gravelly and sandy glacial till.

**Figure 1.—A soil profile from a high tunnel. Notice the original surface buried under construction fill.**

The team found that the compacted fill layer inside the high tunnel was the main issue limiting good soil conditions. Once this layer was broken up, the native soil underneath was much easier to work with and showed good potential for growing plants with added organic matter. They determined that the sinking ground on the property is likely caused by thawing permafrost, which helped the landowner understand what is happening and what signs to watch for in the future.

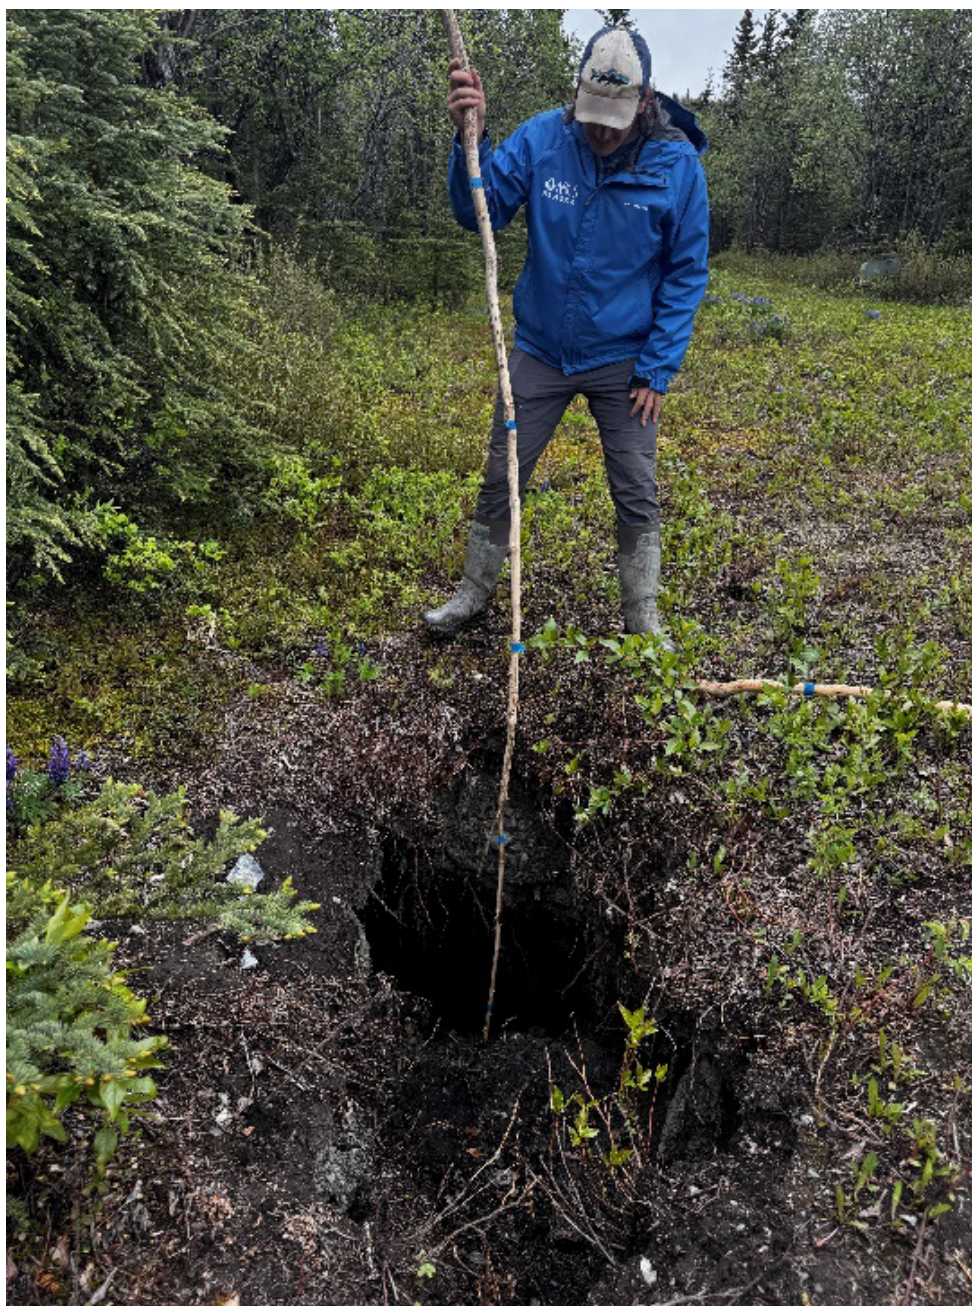
The producer also pointed out an area on the property experiencing significant subsidence, or sinking, resulting in a large surface void now covered with plywood for safety (fig. 2). Based on visible linear features and site context, the likely cause is thawing of permafrost, or ground ice, near the boundary of a black spruce stand recently cleared for home construction. Removal of insulating original plants and organic layers in the soil may have increased heat transfer into the soil, which would increase thaw. Some soils in the area are underlain by sometimes very coarse glacially derived sands and gravels (outwash) that can facilitate rapid water movement and instability when frozen ground degrades. While observations suggest thaw-related subsidence, the precise cause, rate of development, and long-term implications are uncertain.

Figure 2.—Matt Kugel showing the depth and size of the subsidence.
