June 2016

# Dam Rehabilitation Fact Sheet

## Lake Pelham, Mountain Run Watershed

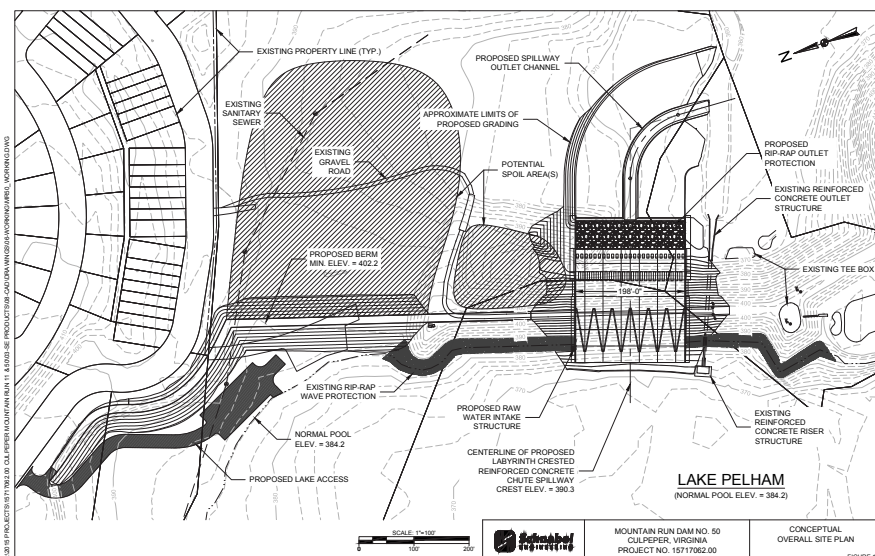
The plan view drawing below outlines the proposed solution to the auxiliary spillway problem.

The plan includes the following rehabilitation activities:

- Installing a 198-foot wide, 6-cycle structural concrete labyrinth weir auxiliary spillway over the embankment
- Installing an earthen berm across the existing auxiliary spillway
- Installing a stilling basin and rip-rap outlet protection below the dam
- Upgrading the water intake structure

Project activity will not affect existing water supply storage, recreational uses or current levels of flood protection downstream.

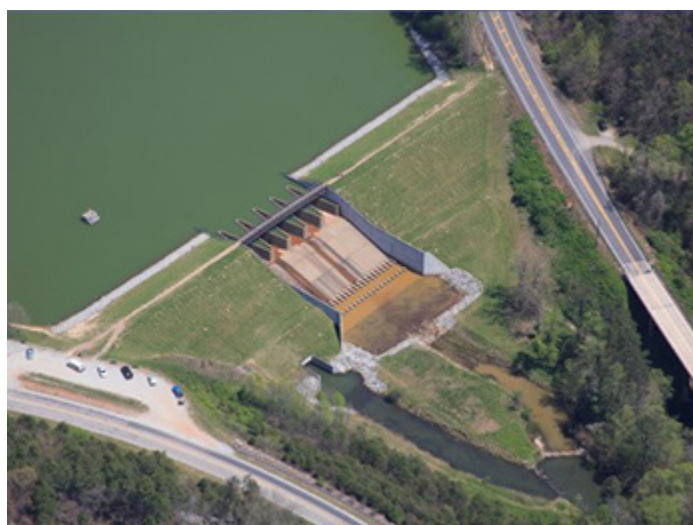
The photo above is an aerial view of a typical labyrinth weir. The graphic below provides a closer look at how this enhancement to a spillway helps to control rising flood waters.
