# Technical Soil Services

## Special Projects Office and Connecticut NRCS

### Ground-Penetrating Radar (GPR) Investigation Supports Farm Bill Conservation Planning

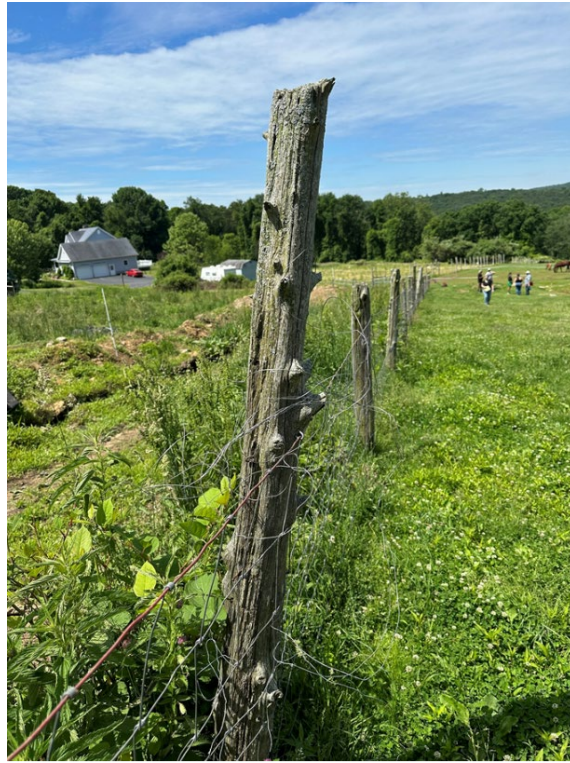
**Figure 1.—A photograph of the open trench behind the fence.**

First, the team used an open trench to verify the depth of the bedrock and set up the GPR equipment (see fig. 1). Next, the team collected GPR transects in the pasture where the farming operations will be expanded (see fig. 2).

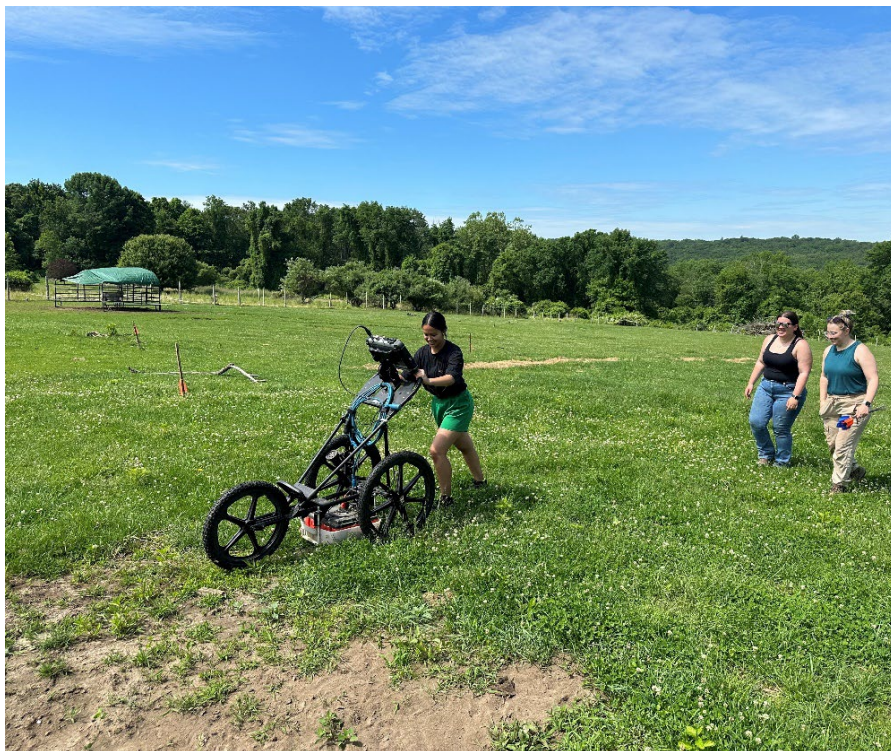
**Figure 2.—NRCS staff collecting a GPR transect in the pasture.**
