## Technical Soil Services

## Tuckahoe Wildlife Management Area Impoundment Restoration Sampling

### Hammonton, New Jersey, Soil Survey Office

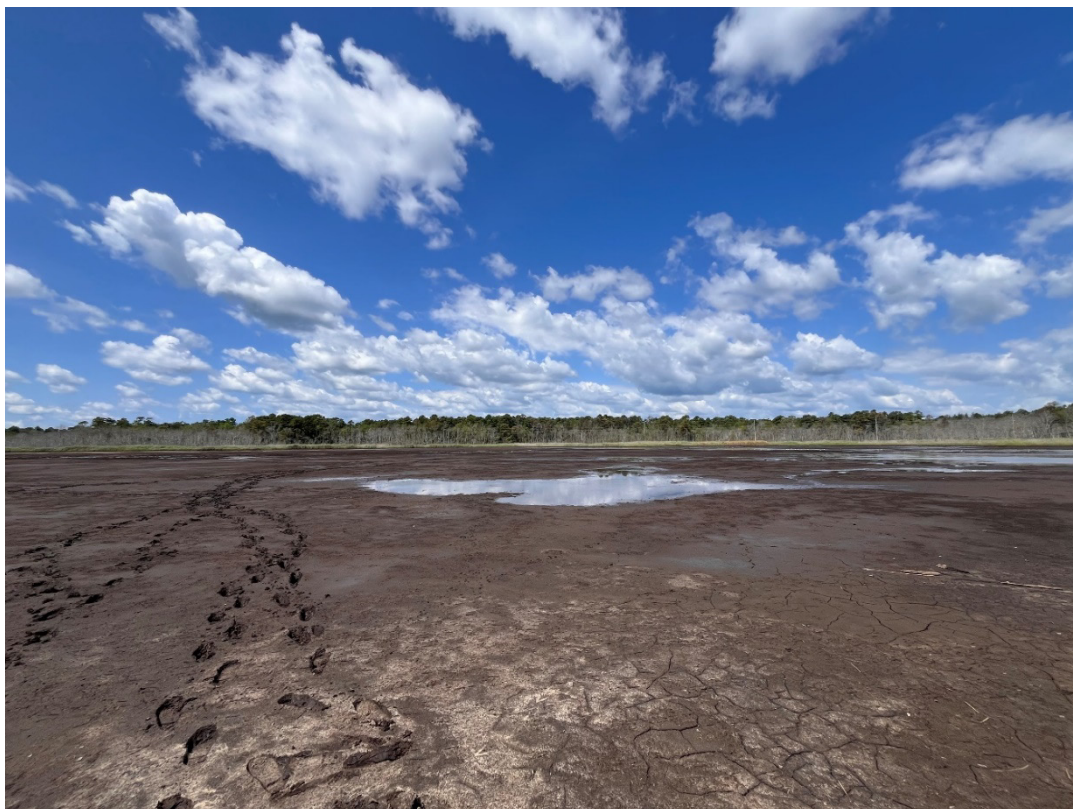
Figure 3.—Section of the impoundments with little to no SAV cover.

The nature of the impoundments required staff to use a kayak to access the points of interest, given the tidal implications, walking difficulty, and fluid soils found in the borrow ditches surrounding the berms (fig. 1). The samples were collected and described by horizon to a depth of 50 cm. There was a wide range of soils found within the impoundments, from submerged, sandy uplands to former organic tidal marsh soils (fig. 2). During preliminary observations, staff saw that areas with thin layers of recent (i.e., deposits since being impounded) silts in the surface overlying firmer, denser material (i.e., either moderately decomposed organics, sands, or a mix of both) seem to have a higher percentage of SAV cover. Staff did not observe high percentages of SAV cover in areas with very fluid silts, former tidal marsh organic surfaces, and sandy surfaces (fig. 3).
