Upper Turtle River Dam No. 9 (Larimore Dam)

Class III Cultural Resource Survey

T152N; R54W; Portions of Sec. 31 & 32

Grand Forks County, North Dakota

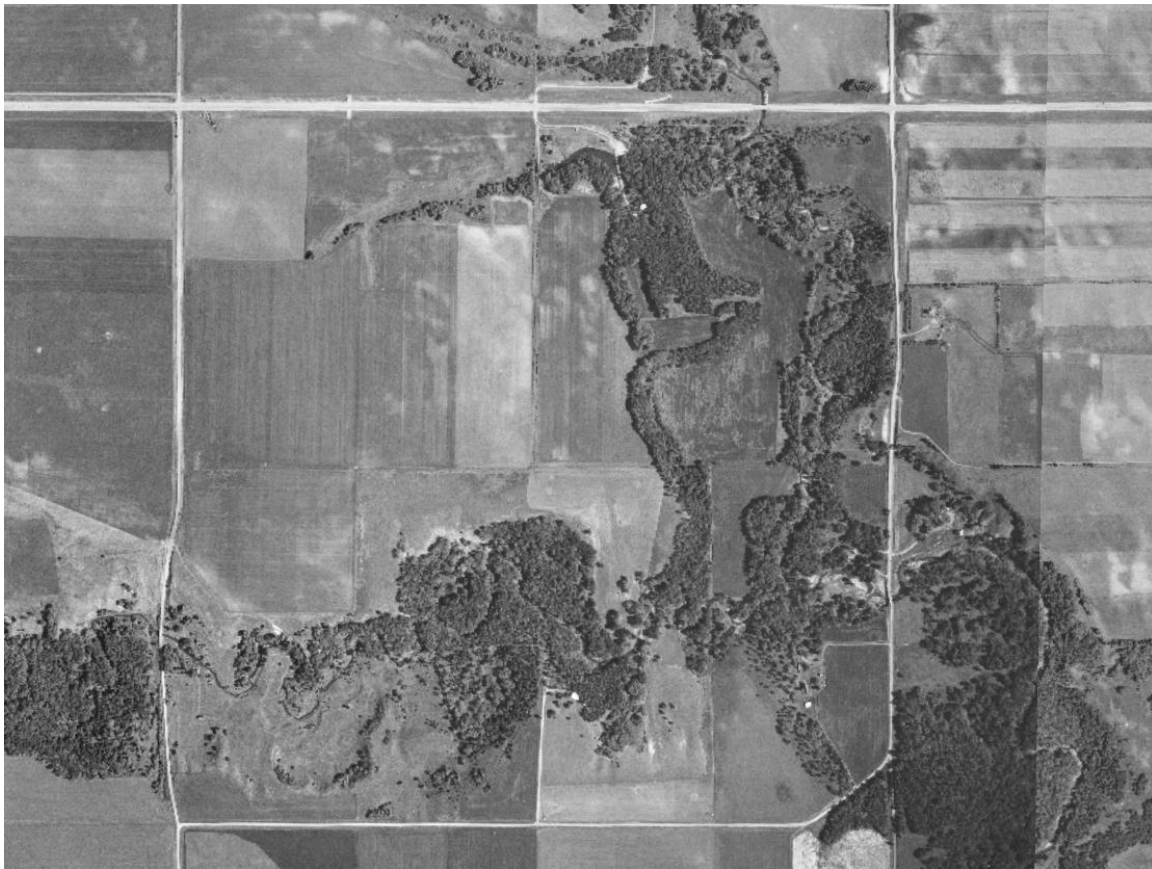
*Figure 7 Section 32-152-54 - 1957 Aerial Photography*  
Source: NDGIS Hub State of ND

Aerial photography from 1957 (Figure 7) provides context on the APE prior to the dam construction and recreational land use changes. Prior to dam construction there was already significant disturbance as it appears that woodland had been cleared for grazing in what is now under the permanent pool and other park facilities. A few small structures may have been present in the permanent pool area. A farmstead appears to be present at the site of the Country Club. The construction of the dam embankment and auxiliary spillway required significant amounts of tree removal and land shaping/filling. The majority of the golf course was developed in what appears to be crop or hayland. In the eastern portion of the APE, there appears to be no change in landuse. The current cropland boundaries that were not converted to the dam and recreational areas, have not changed since 1957.

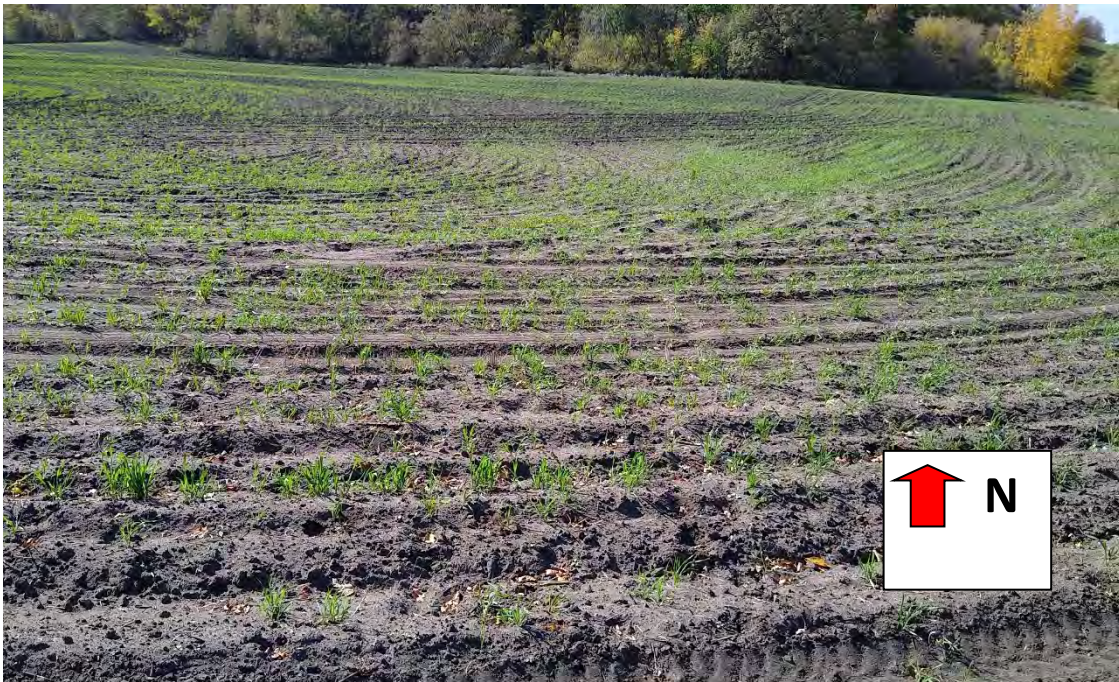
*Figure 12: Visibility of North Field*  
 Lat/Lon 47.941728, -97.586126

The north and south fields had been recently tilled/harvested creating ground visibility more than 70%. Both areas were subjected to pedestrian survey as described in section 5.0. The north field yielded no finds (Figure 12).

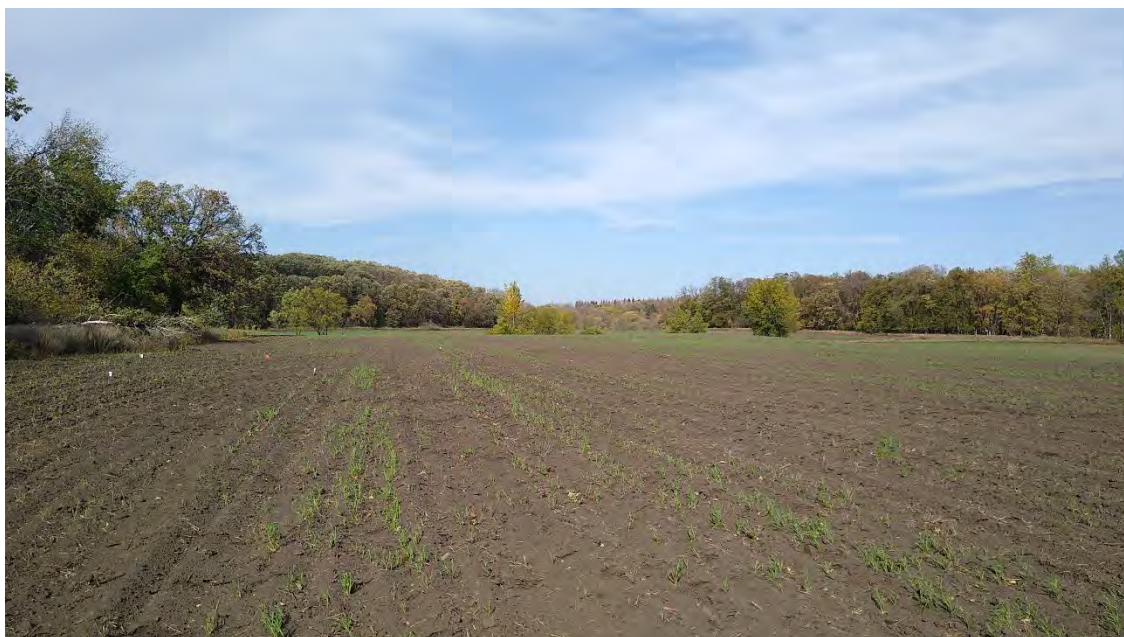
*Figure 13: South Field visibility with pin flags marking find spots*  
Lat/Lon 47.9391, -97.5862

The South Field (Figure 13) had a medium dense concentration in a sparse scatter of surface artifacts. The material included knife river flint (KRF) and chert flakes with visible conchoidal fractures, one large core and multiple heat-treated quartzite flakes. Debitage was strewn across the area in no discernable pattern (Figure 14). A KRF “bird point” was discovered by a team member late in the afternoon but due to overnight heavy rain and wind causing a tree fall on the location, the projectile point could not be relocated the next day. The find, excluding debitage, was recorded and reported to NDSHPO on a site form with the “Further Work” recommendation and a Not eligible for NRHP Listing. NDSPHO assigned number 32GF3851 to this site.

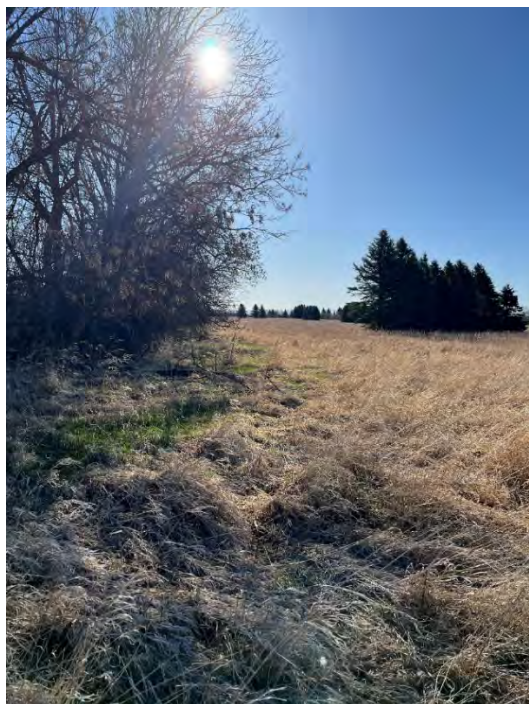
Figure 15 Haul Road Visibility looking east (47.941395, -97.583776)

The haul road and Larimore Dam surveys were conducted on April 29, 2025. There was zero ground visibility at the haul road site due to the thick tame grass/grass residue cover (Figure 15). The area is a level area and may have been disturbed by the original dam construction. Six shovel probes (Figure 16) were conducted at the site of a haul road running E-W for approximately 0.25 miles.

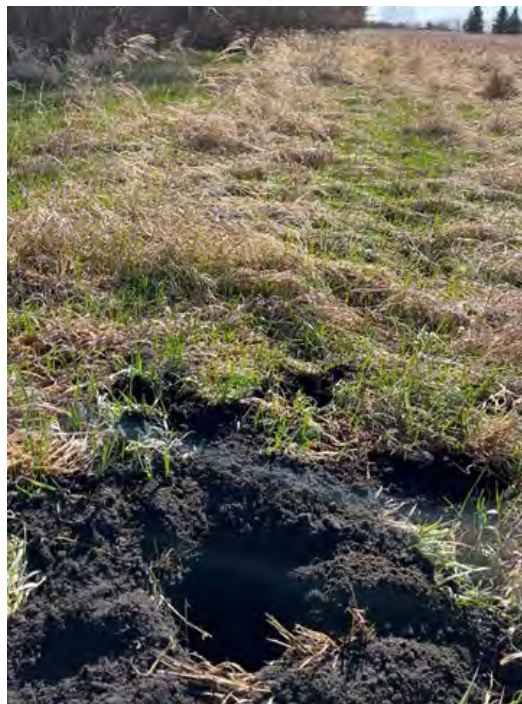
Figure 16 Shovel Probe (47.941356, -97.583781)

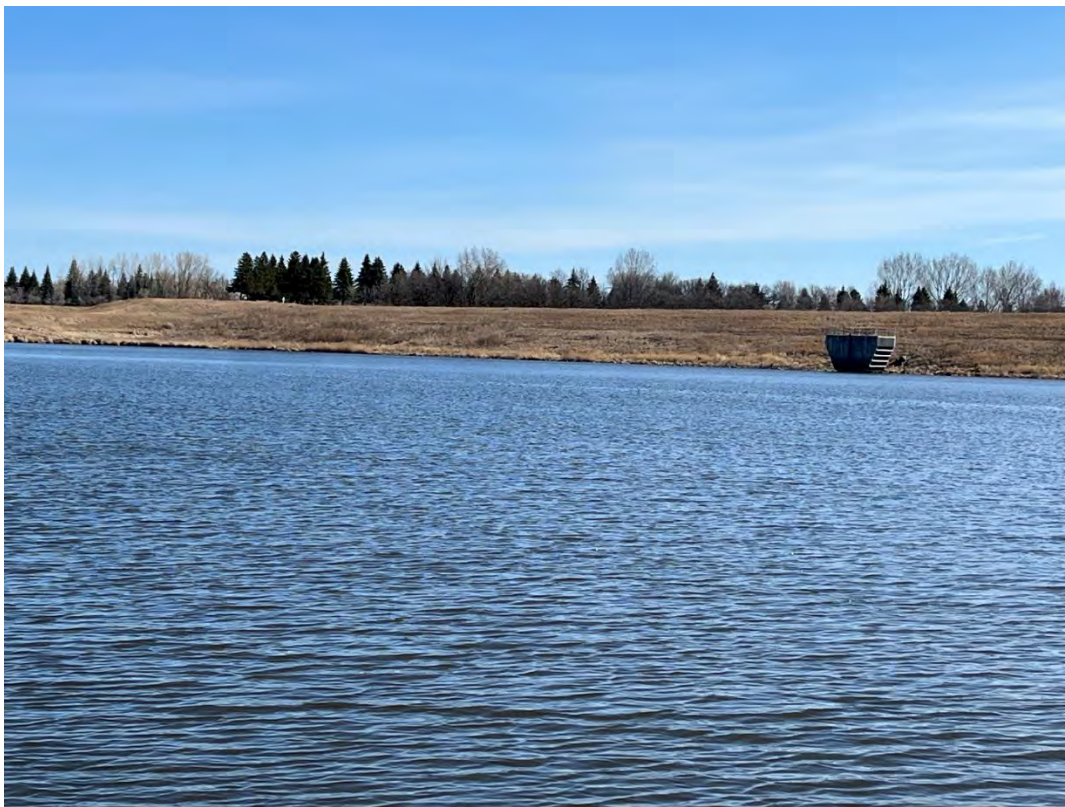
*Figure 17 Larimore Dam Secondary Intake 2/29/2025*

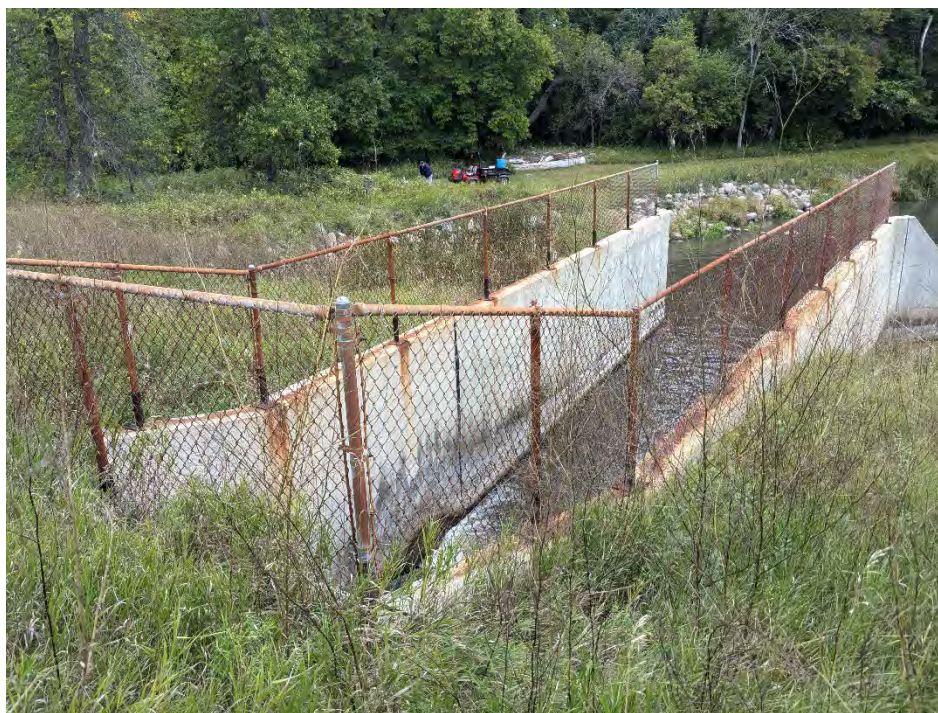
The 2022 Geotechnical investigation found the embankment consists of 70 feet of sandy lean clay fill underlain by 30 feet of glacial till, further underlain by a harder pre-consolidated glacial till. The top of the dam is 66 feet high and 20 feet wide. The auxiliary spillway is 300-foot-wide earthen spillway with a 15% average slope cut into the hillside north of the embankment. The principal spillway consists of a two-stage reinforced concrete riser that is connected to a 6 ft X 6 ft concrete conduit that carries flow through the embankment (Figures 18-21). The pipe

*Figure 18 Larimore Dam Concrete Outlet structure - looking northeast*

The most recent site review and detailed inspection of Larimore Dam was conducted by HDR Engineering Inc. (HDR) staff in November of 2022. The inspection showed that the principal spillway concrete inlet structure was in good condition. The conduit had minor deficiencies and it was recommended to replace or repair the steel plates at the joints. The condition of the dam embankment and earthen auxiliary spillway were also determined to be adequate with only minor issues such as tree growth within the dam abutments, gopher holes in the auxiliary spillway and an erosion area on the left side slope of the auxiliary spillway. Additionally, a conduit inspection was performed by the NRCS in November 2021 to look at the corrosion condition of the reinforcing steel in the box culvert. Results indicated a moderate rate of corrosion with a potential lifespan of 6-20 years remaining for the conduit.

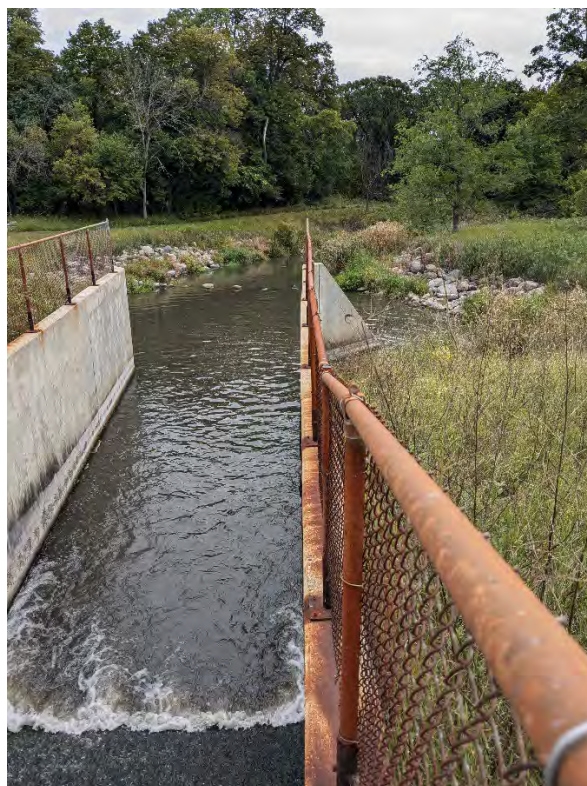
*Figure 19 Larimore Dam Outlet structure looking east*

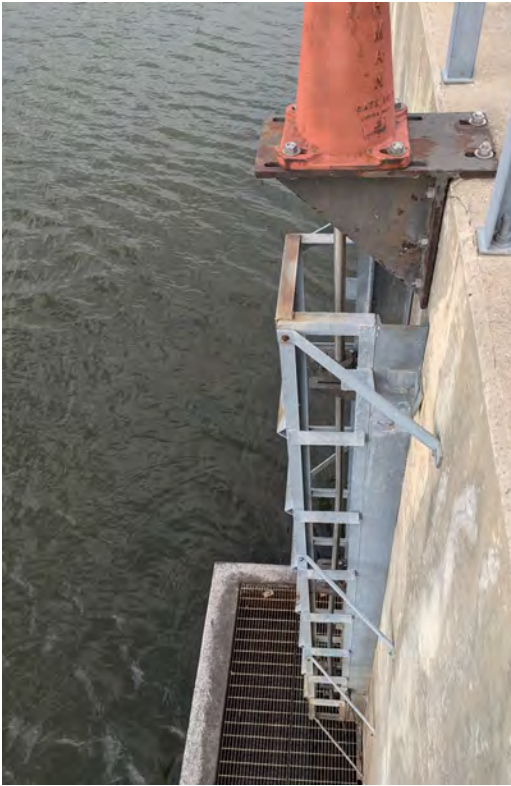
*Figure 21 Larimore Dam Primary Inlet and Riser*

The most recent site review and detailed inspection of Larimore Dam was conducted by HDR Engineering Inc. (HDR) staff in November of 2022. The inspection showed that the principal spillway concrete inlet structure was in good condition. The conduit had minor deficiencies and it was recommended to replace or repair the steel plates at the joints. The condition of the dam embankment and earthen auxiliary spillway were also determined to be adequate with only minor issues such as tree growth within the dam abutments, gopher holes in the auxiliary spillway and an erosion area on the left side slope of the auxiliary spillway. Additionally, a conduit inspection was performed by the NRCS in November 2021 to look at the corrosion condition of the reinforcing steel in the box culvert. Results indicated a moderate rate of corrosion with a potential lifespan of 6-20 years remaining for the conduit.

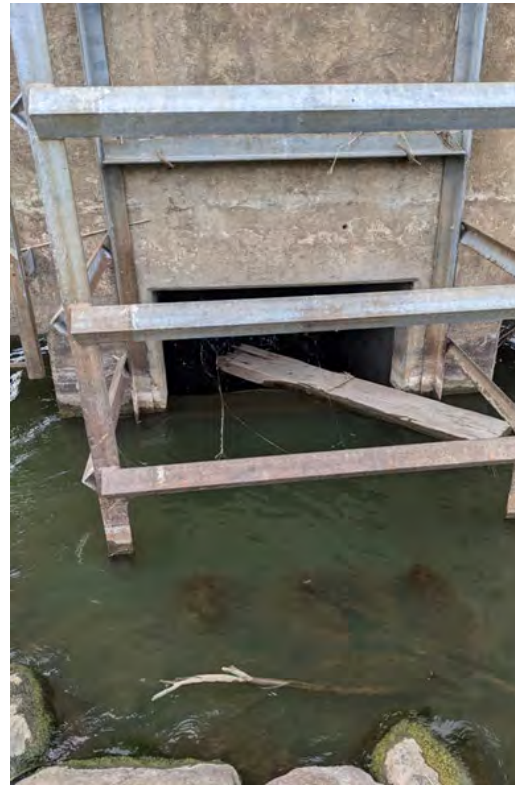
*Figure 20 Larimore Dam Primary Inlet with trash*

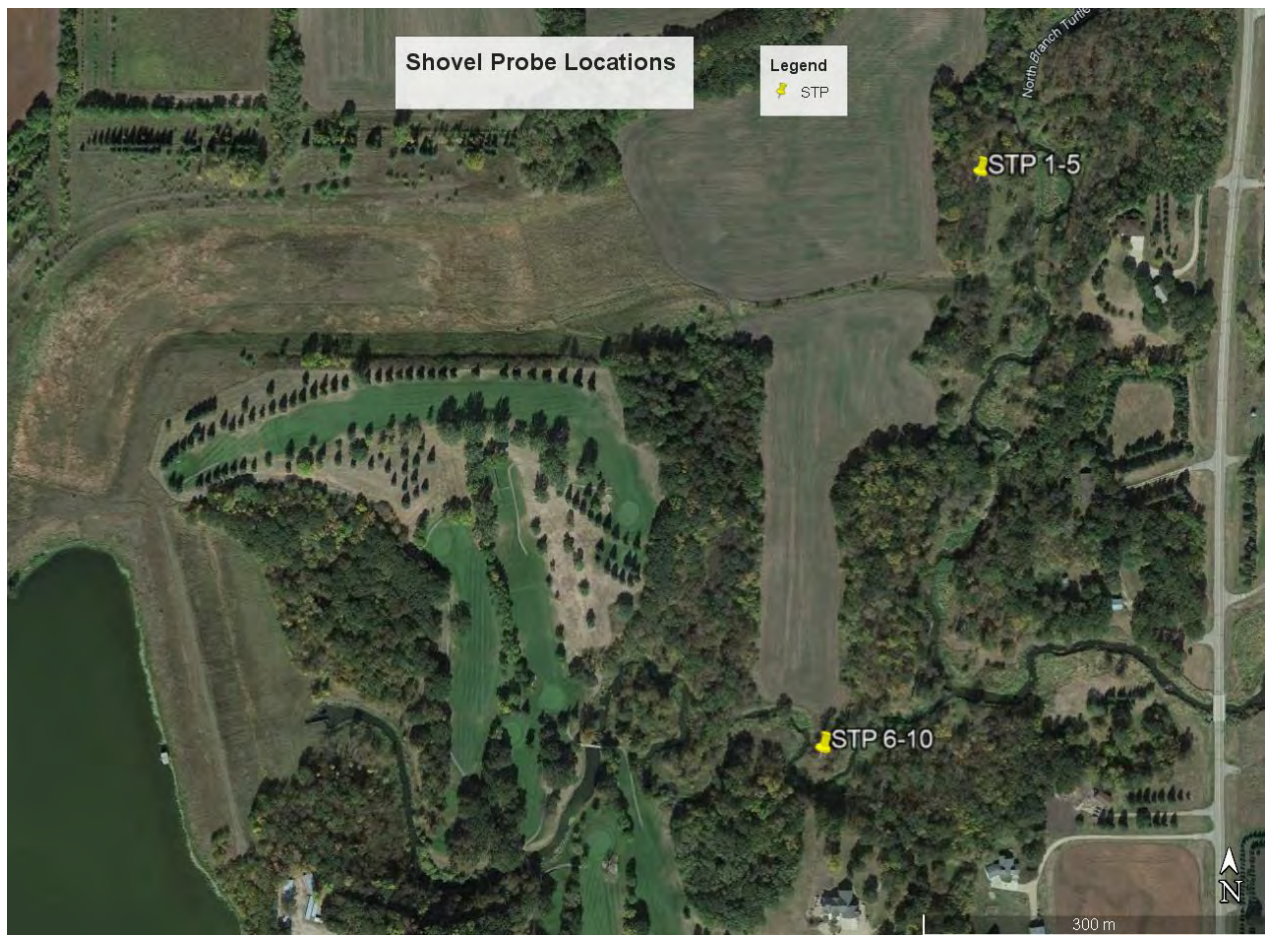
Ten (10) shovel probes, equally split into two locations, were conducted on October 11, 2021 (Figure 22). Each location was chosen for its relatively undisturbed location and proximity to a permanent source of water. Each was dug with a 30 (+/-) centimeter diameter in arbitrary 10-centimeter (+/-) levels. The matrix was screened through a 0.25-inch wire mesh over a tarpaulin and any artifacts discovered were photographed, documented, and returned. All shovel probes were negative (Table 4).

Figure 22: Shovel probe locations  
Image Source: Google Earth.

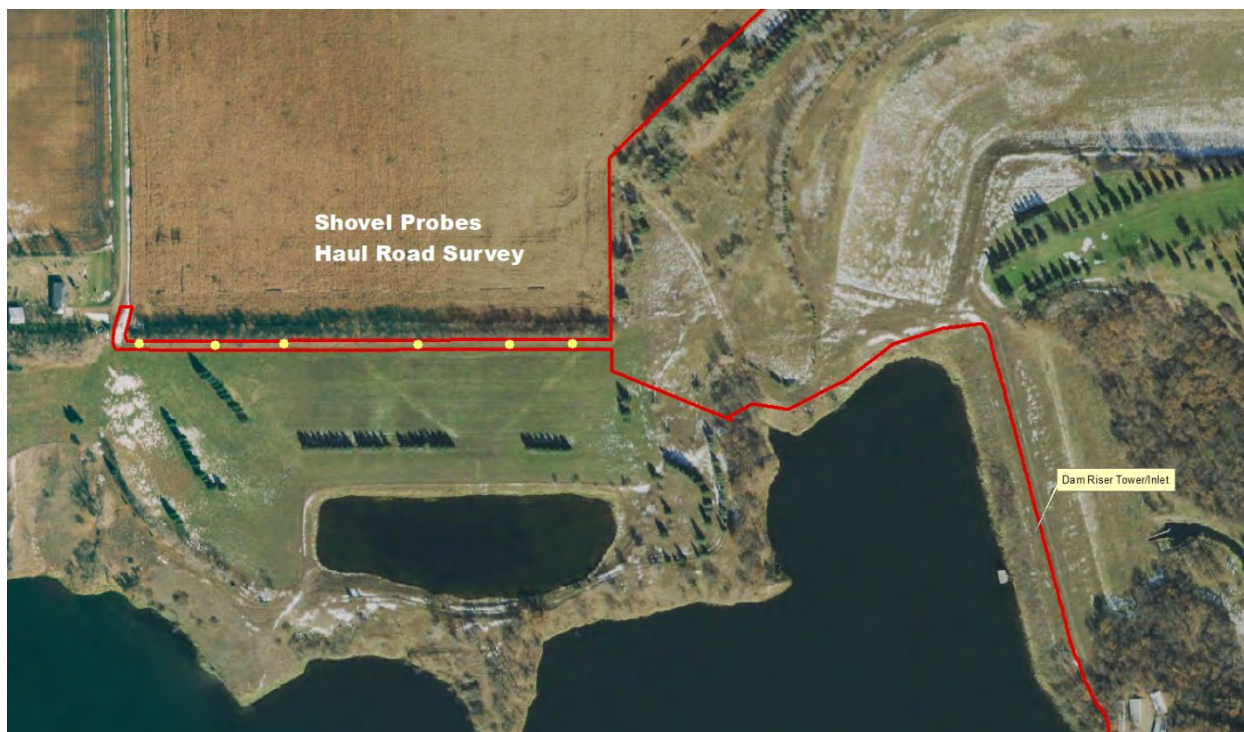
Six (six) shovel probes were conducted on 4/229/2025. (Figure 23). Each was dug with a 30 (+/-) centimeter diameter in arbitrary 10-centimeter (+/-) levels. The matrix was screened through a 0.25-inch wire mesh over a tarpaulin. All shovel probes were negative (Table 5).

Figure 23 Haul Road probe locations and results

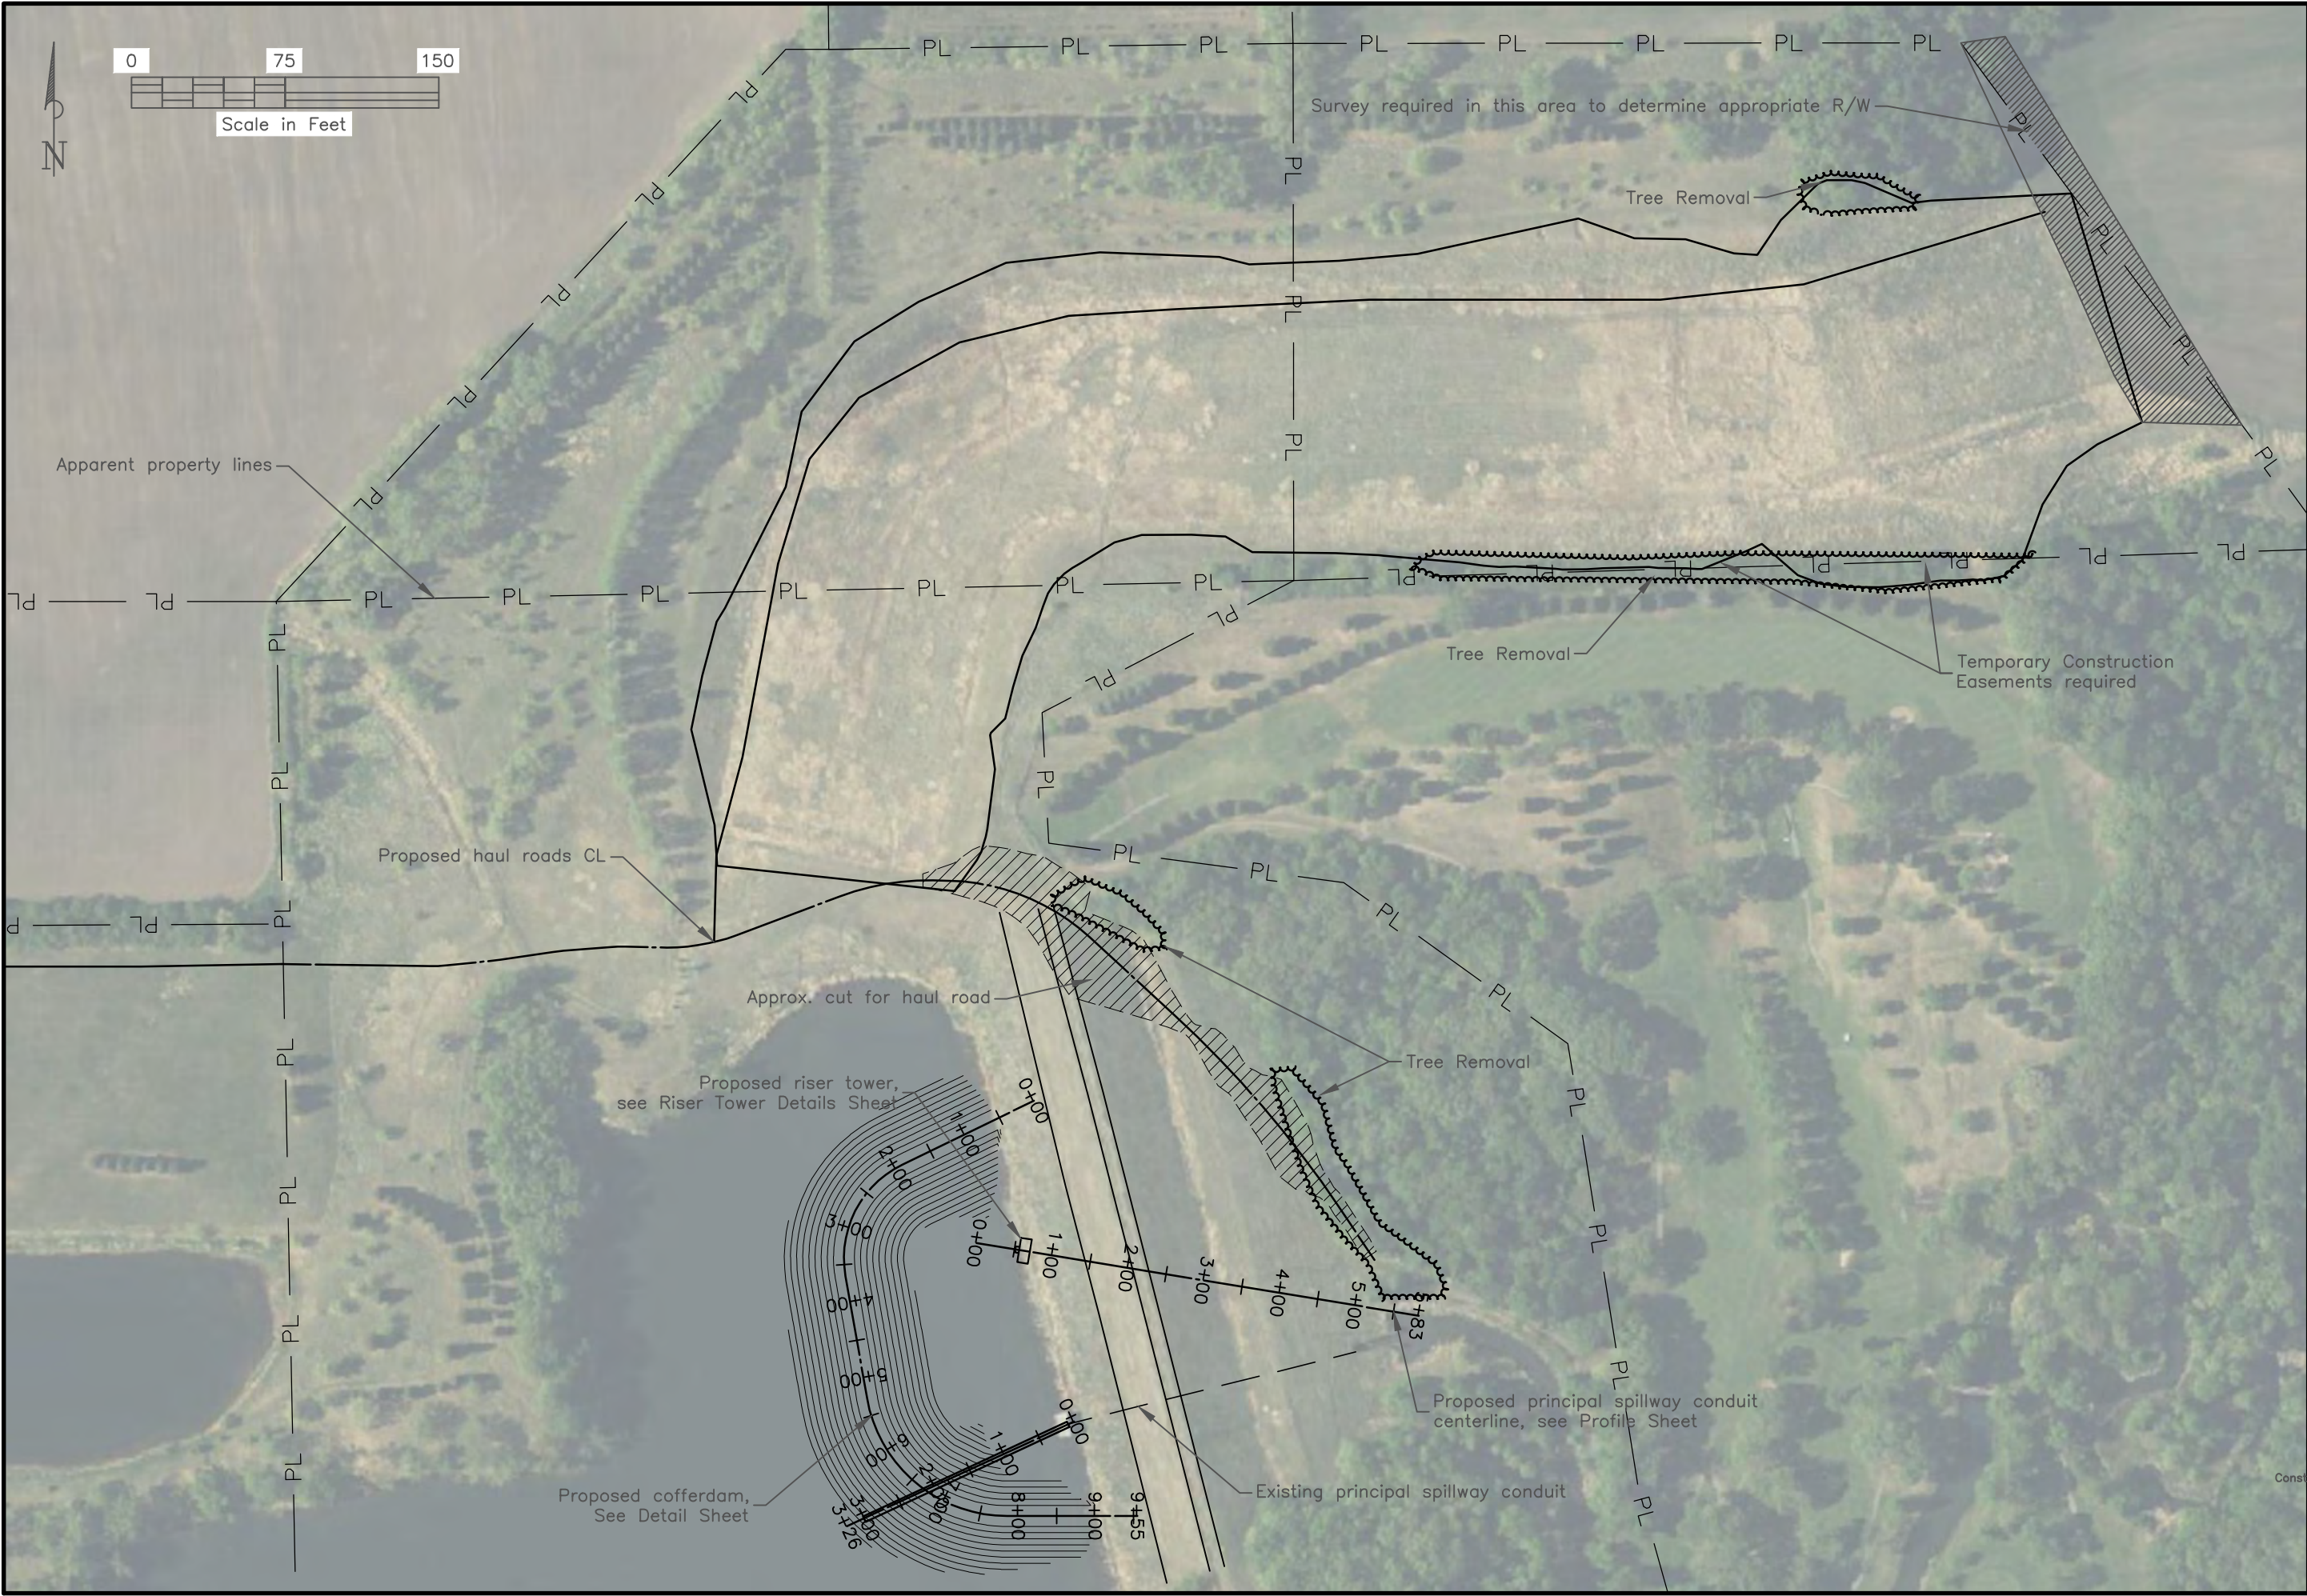
| <br>United States<br>Department of<br>Agriculture<br><br>Natural Resources<br>Conservation Service | UPPER TURTLE RIVER DAM NO. 9 REHAB<br>CONSTRUCTION LAYOUT | | Date<br>3/12/25 | |

The proposed rehabilitation undertaking will change the appearance of the dam slightly as the existing riser tower will be removed and replaced in a different location. The embankment height and pool elevation will remain the same. The auxiliary spillway will remain in the same location, but some of the appearance will change due to the addition of articulated concrete block in the downstream section. The dam will retain most elements of integrity as it has not been subject to significant alterations to its design and the surrounding setting has undergone little change over the years in terms of land use and/or alterations to the built environment. The 1977 construction of the dam is more contemporary than the defined period of 1931-1943 of the ND SHPO historic context for federal relief construction in North Dakota. It does not fall under the context of the New Deal initiated public works aimed at recovering the Nation from the effects of the Great Depression (Criterion A). Nor does it fall into any other historical context that can be shown to be of similar significance locally. The dam structure and its construction are not associated with any historically significant person(s) (Criterion B), is of common and ubiquitous design (Criterion C), and does not possess the potential to yield additional historically significant information (Criterion D).
