# **Wetland Delineation Report**

## ***Upper Maple River Watershed– Site 2A***

Prepared for  
Moore Engineering, Inc.

December 2017

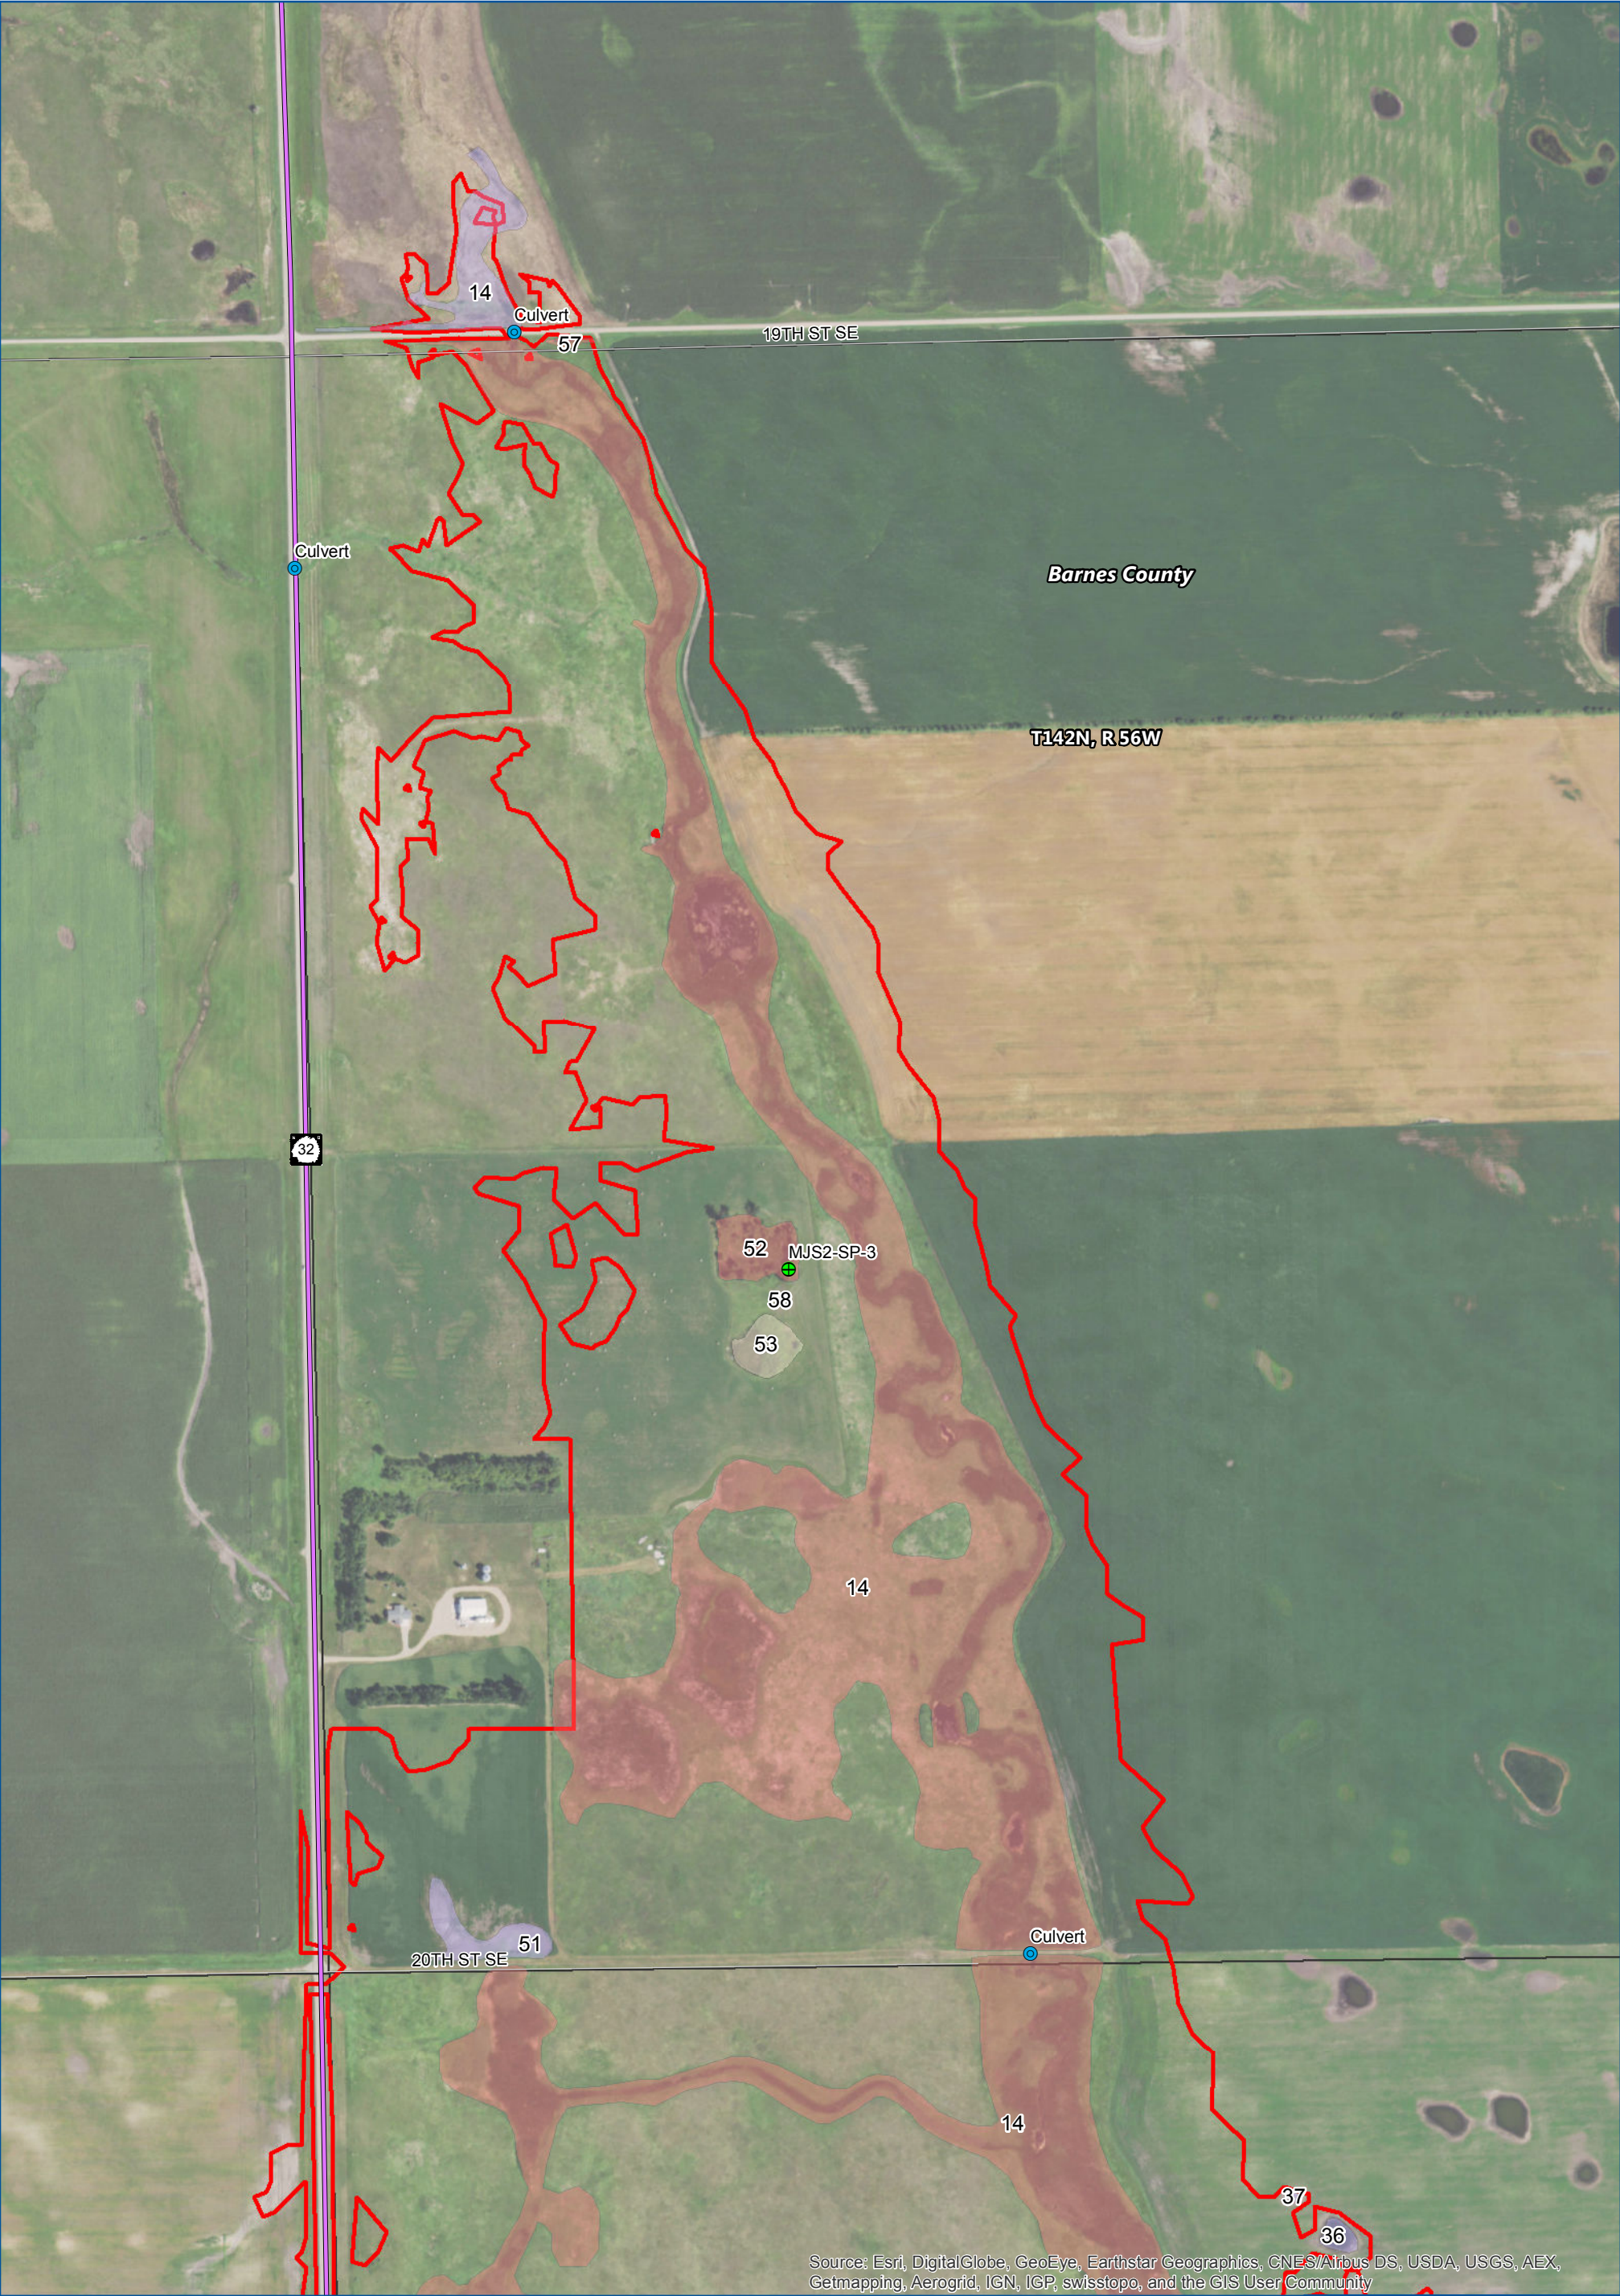
FIGURE 5.1

The delineated wetland boundaries and sample points were surveyed using a Global Positioning System (GPS) with sub-meter accuracy (**Figures 5.1, 5.2, and 5.3 provide the location of each wetland in relation to the evaluation area**).

The shrub-carr community within the study area is located in the northern part of the study area (**Figure 5.1**). Dominant vegetation in the shrub-carr community consists of sandbar willow (*Salix interior*) and an unidentified grass. Soils consist of a mucky modified cap and met the F1 hydric soil indicator for loamy mucky mineral. Hydrology for the shrub-carr communities is precipitation and overland flow. At the time of the site visit on September 20, 2017, hydrology was observed as the secondary hydrology indicators for geomorphic position (D2) and a positive FAC-neutral test (D5).

DELINEATED WETLANDS  
Upper Maple Watershed  
Alternative Site 2A  
Wetland Delineation

Fifty-three wetlands were delineated within the wetland evaluation area. These wetlands consisted of four different community types: shallow marsh, fresh (wet) meadow, seasonally flooded basin, and shrub-carr. A description of each wetland community is provided below, with representative photographs in **Appendix B**. A Wetland Summary Table is provided in **Table 3**. Wetland IDs are labeled on the wetland delineation maps (**Figures 5.1, 5.2, and 5.3**).

The seasonally flooded basin communities within the study area are located in the agricultural fields (**Figures 5.1, 5.2, and 5.3**). Vegetation in the seasonally flooded basin communities consists of stunted corn or soy beans, smartweed, or an absence of vegetation. Typical soils consist of a mucky modified cap at varying depth and met the F1 hydric soil criteria for loamy mucky mineral. The hydrology source for the seasonally flooded basin wetlands is precipitation and overland flow. The seasonally flooded basins usually met the wetland hydrology indicators for inundation visible on aerial imagery (B7), sparsely vegetated concave surface (B8), saturation visible on aerial imagery (C9), and geomorphic position (D2). Areas of the site that were not accessible due to corn crop relied on an aerial imagery review for wetland determination (**Appendix C**). In situations where the aerial imagery review results require field verification, which was not completed within inaccessible corn crop, the wetland was kept in the map. These questionable wetlands are all isolated and would not be jurisdictional (**Figure 6**).
