## **D-6 Class III Cultural Resources Survey**

**A Class III Cultural Resources Survey of the  
Upper Maple River Watershed Alternative 2A  
T142N; R56W, Portions of Section 8, 9, 15, 16, 17, 20, 21 and  
22  
Barnes County, North Dakota**

**US Department of Agriculture  
Natural Resources Conservation Service  
North Dakota State Office**

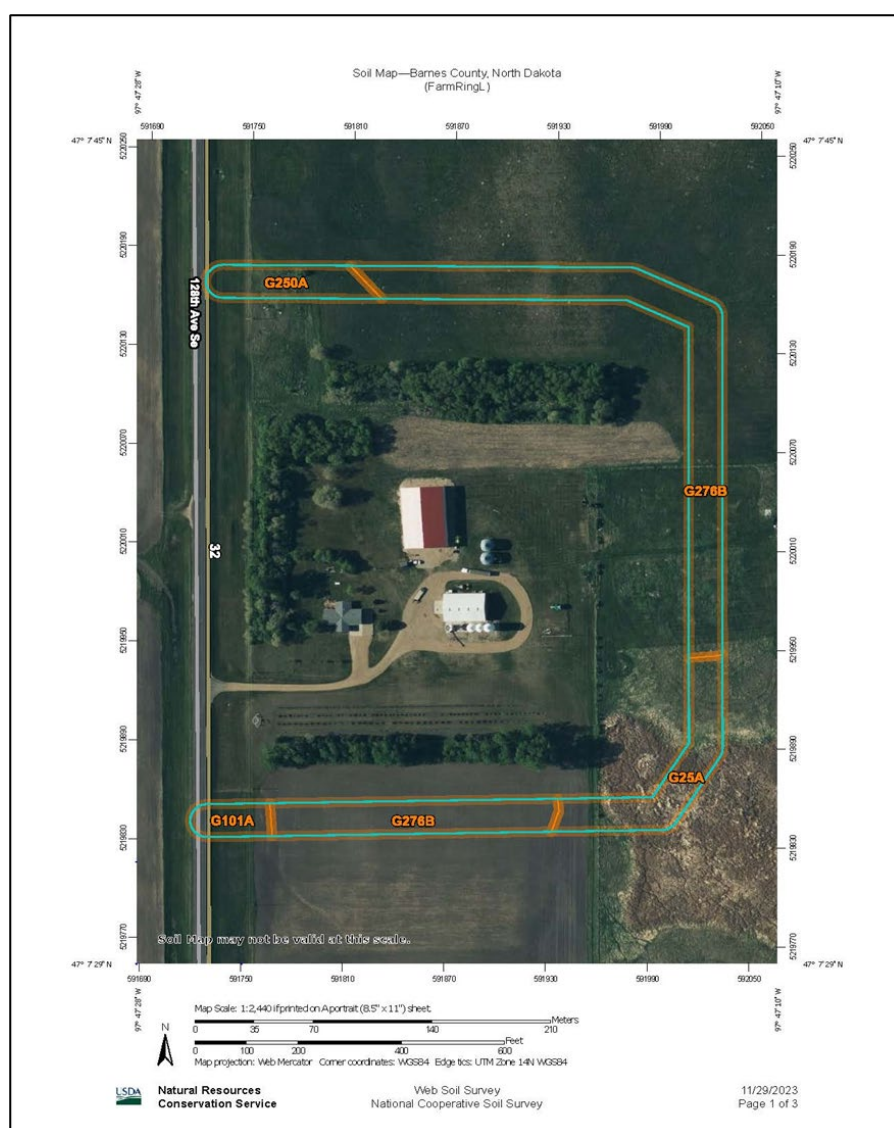
Figure 5 Soil Map of Farm Ring Levee

The undertaking SW Section 9 (Figure 5, Table 2) will create a three-sided flood barrier for an active homestead and industrial operation, a satellite distribution point for Peterson Seed Company. It is surrounded on the north, east and south by reclaimed wetlands. The western boundary abuts the heavily disturbed drainage ditch constructed during the State Highway 32 rebuild. The farm ring levee in will consist of an earthen embankment 2,578 feet long, with an average height of 2.7 feet and maximum height of 8 feet and 3H:1V side slopes to be seeded to grass. The Farm Ring Levee intersects four soil types: Marysland Loam (G25A), Divide Loam (G250A) and Renshaw-Sioux Complex (G276B). The embankment will surround a single-family home and the industrial infrastructure for the Peterson Seed Company (Figure 5).

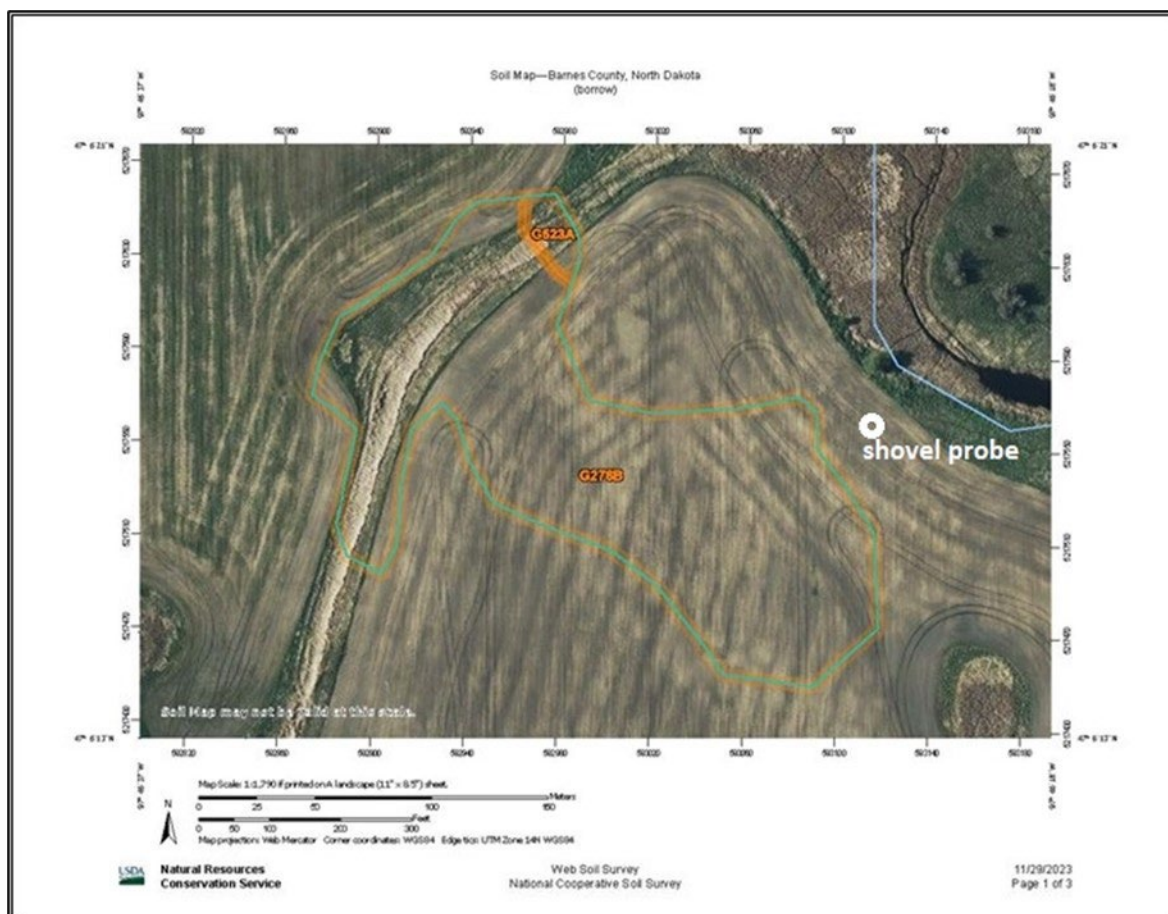
Figure 7 Soils Map for Wetland Creation (Borrow)

The wetland creation in Section 21 (Figure 7, Table 4) will involve 1-3 feet of excavation to form a depressional area, which will be seeded to grass. Soils excavated from this area will be utilized as fill for the dam. The glacial outwash soil (G276B) Renshaw-Sioux Complex dominates the excavation area.

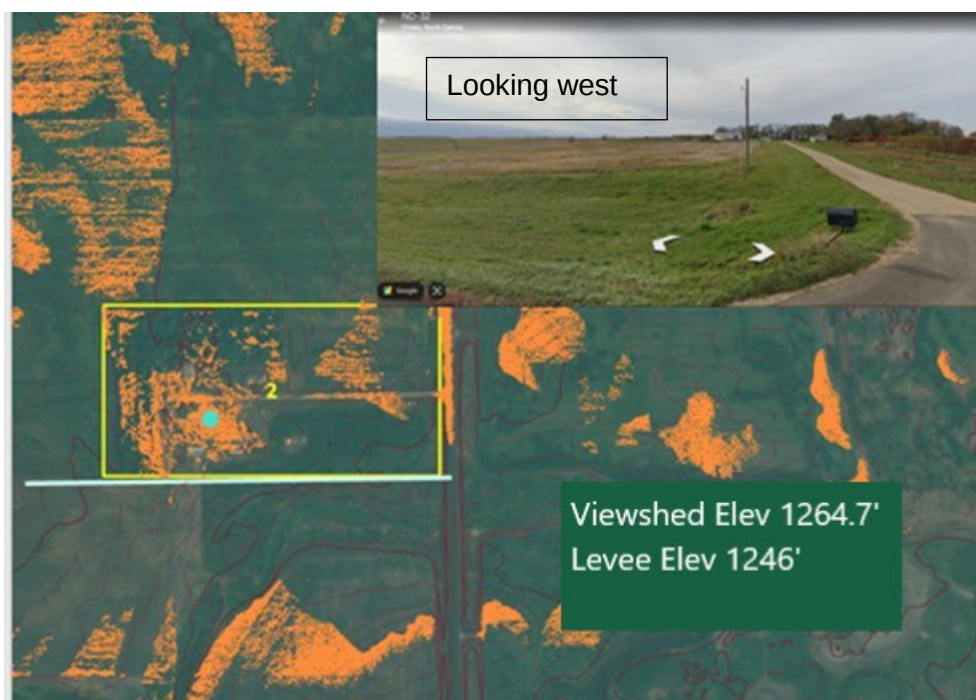
Five existing farmstead adjacent to the APE may be visually impacted by the project. Viewsheds were assessed with ArcPro viewshed software which illustrates the viewshed at a height of 1.75 meters (5.74 ft). Their locations, proximity and summarized impacts are noted in Table 10 and Figures 13-18.

| Farmstead | Location | Relationship to Project | Visual Impacts |
|---|---|---|---|
| 4 | W2 NW4 22-142-56 | Embankment runs N-S approximately 60 feet west of farmstead property boundary, then turns to the SW. | Uninhabited farmstead recently converted to cropland. Viewpoint is 1247.7, embankment height is 1251'. The existing farmstead shelterbelts obstruct views from most angles. |
| 5 | NW4 SW4 21-142-56 | Embankment to the north and east impacts long distance views to the Northeast. NDSHPO recommended submitting this as a site lead - assigned # 32BAX353 | Farmstead uninhabited in recent years. Embankment slightly impacts view to the Northeast where grassed levee will be visible at .5- .75 miles. Viewshed point is 1263.7' embankment 1251'. |

- note all buildings have been removed and current landuse is cropland

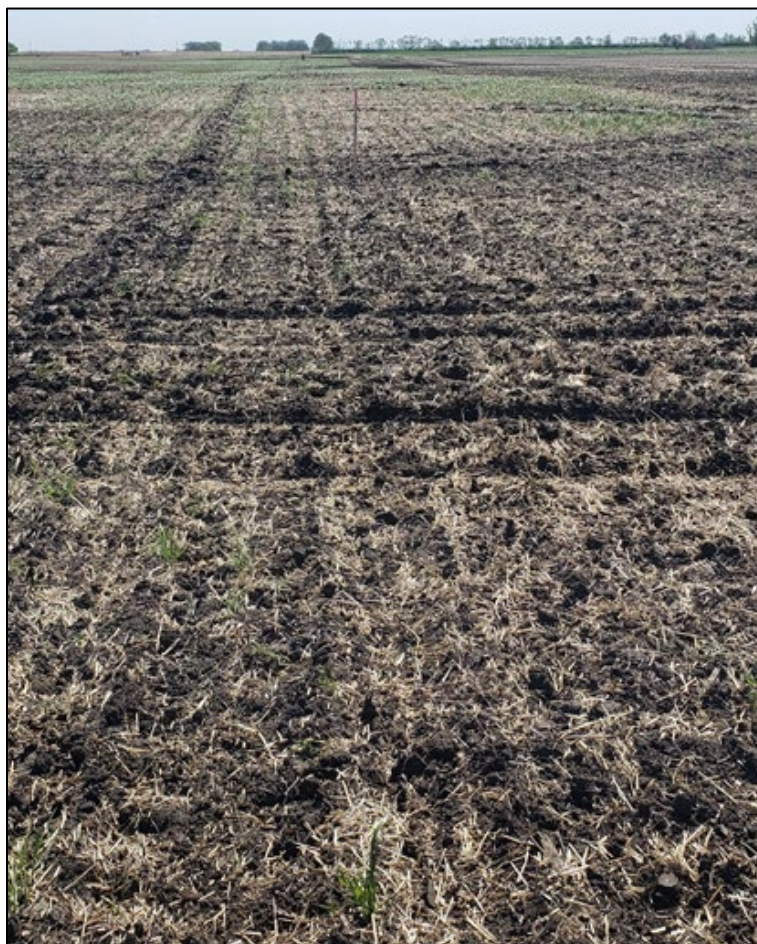
**Figure 23 Ground Visibility (facing east, survey stake at middle distance). Photo coordinates - UTM14T 591855.33, 5217249.23)**

bottom termination end). The top portion of the U-shaped secondary spillway ends in the east at approx. 14T 593325, 5217246. The secondary spillway was surveyed in 2020. The survey area is the same as what's described for the Embankment in Section 21. Visibility throughout the North ½ of Section 21 was excellent (Figure 23). No cultural material was observed.

The two biomass areas in section 16 were not surveyed in their entirety due the wet field conditions. The visibility throughout the BHA in the North  $\frac{1}{2}$  of Section 21 was excellent (Figure 23). No cultural material was observed. The three biomass harvest areas begin in the north at approx. UTM 14T 592181, 5217577 and terminate in the south at UTM 14T 592424, 5217495.

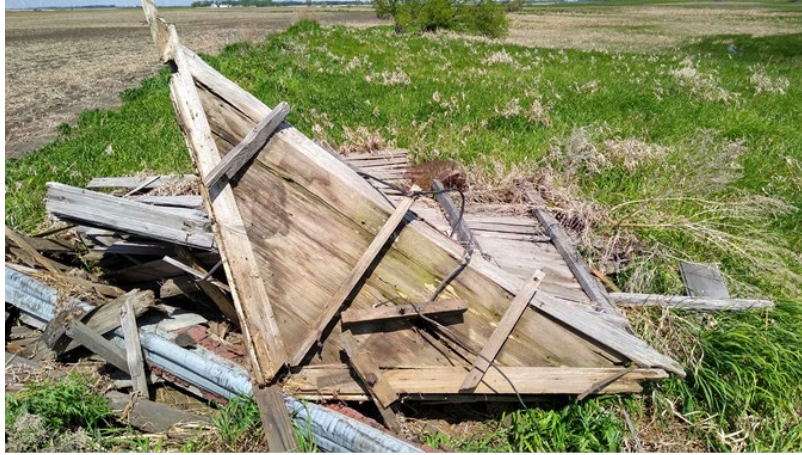
Figure 25. Destroyed Pumphouse

The destroyed pumphouse (Figure 25) is approximately 50 feet southwest of a stream that crosses the NE corner of Section 21. The asphalt shingling, visible wiring and incongruous support material imply that the structure had been repurposed multiple times and now has little historic value. No other structures or foundations were found. Upon recommendation from NDSHPO, the site was revisited in 2023 by Janelle Harrison and a shovel probe was completed, no additional data was gathered by the probe. No artifacts were found with the shovel probe (Table 11). 100% grass cover obscured visibility in the groundcover surrounding the pumphouse.

The pumphouse is assumed to be part of a farmstead visible on 1959 photography and from which buildings are indicated in 1967 topographic maps. Only two structures remained visible on 1985 photography – the pumphouse and another structure which abuts the wetland creation area. The second structure is no longer visible on 2017 photography and no remnants were found either in the 2020 survey or when Harrison re-surveyed this area in 2023. A site monitor is recommended for all disturbances within and immediately adjacent to the 1959 Farmstead polygon including portions of the wetland creation, embankment, pipeline, primary and secondary spillways and biomass harvest area.

1. A Cultural Resource Monitor is recommended during construction work near 32BA1212.
