Natural Resource Conservation Service EAXX-005-53-48-1295190583 August 2026

# Appendix F: Environmental Assessment for the Supplemental Watershed Plan No. 3 Rehabilitation of Olmitos and Garcia Watershed Dam No. 5

**Proposal Name:** Supplemental Watershed Plan No. 3 – for the Rehabilitation of Olmitos and Garcia Watershed Dam No. 5

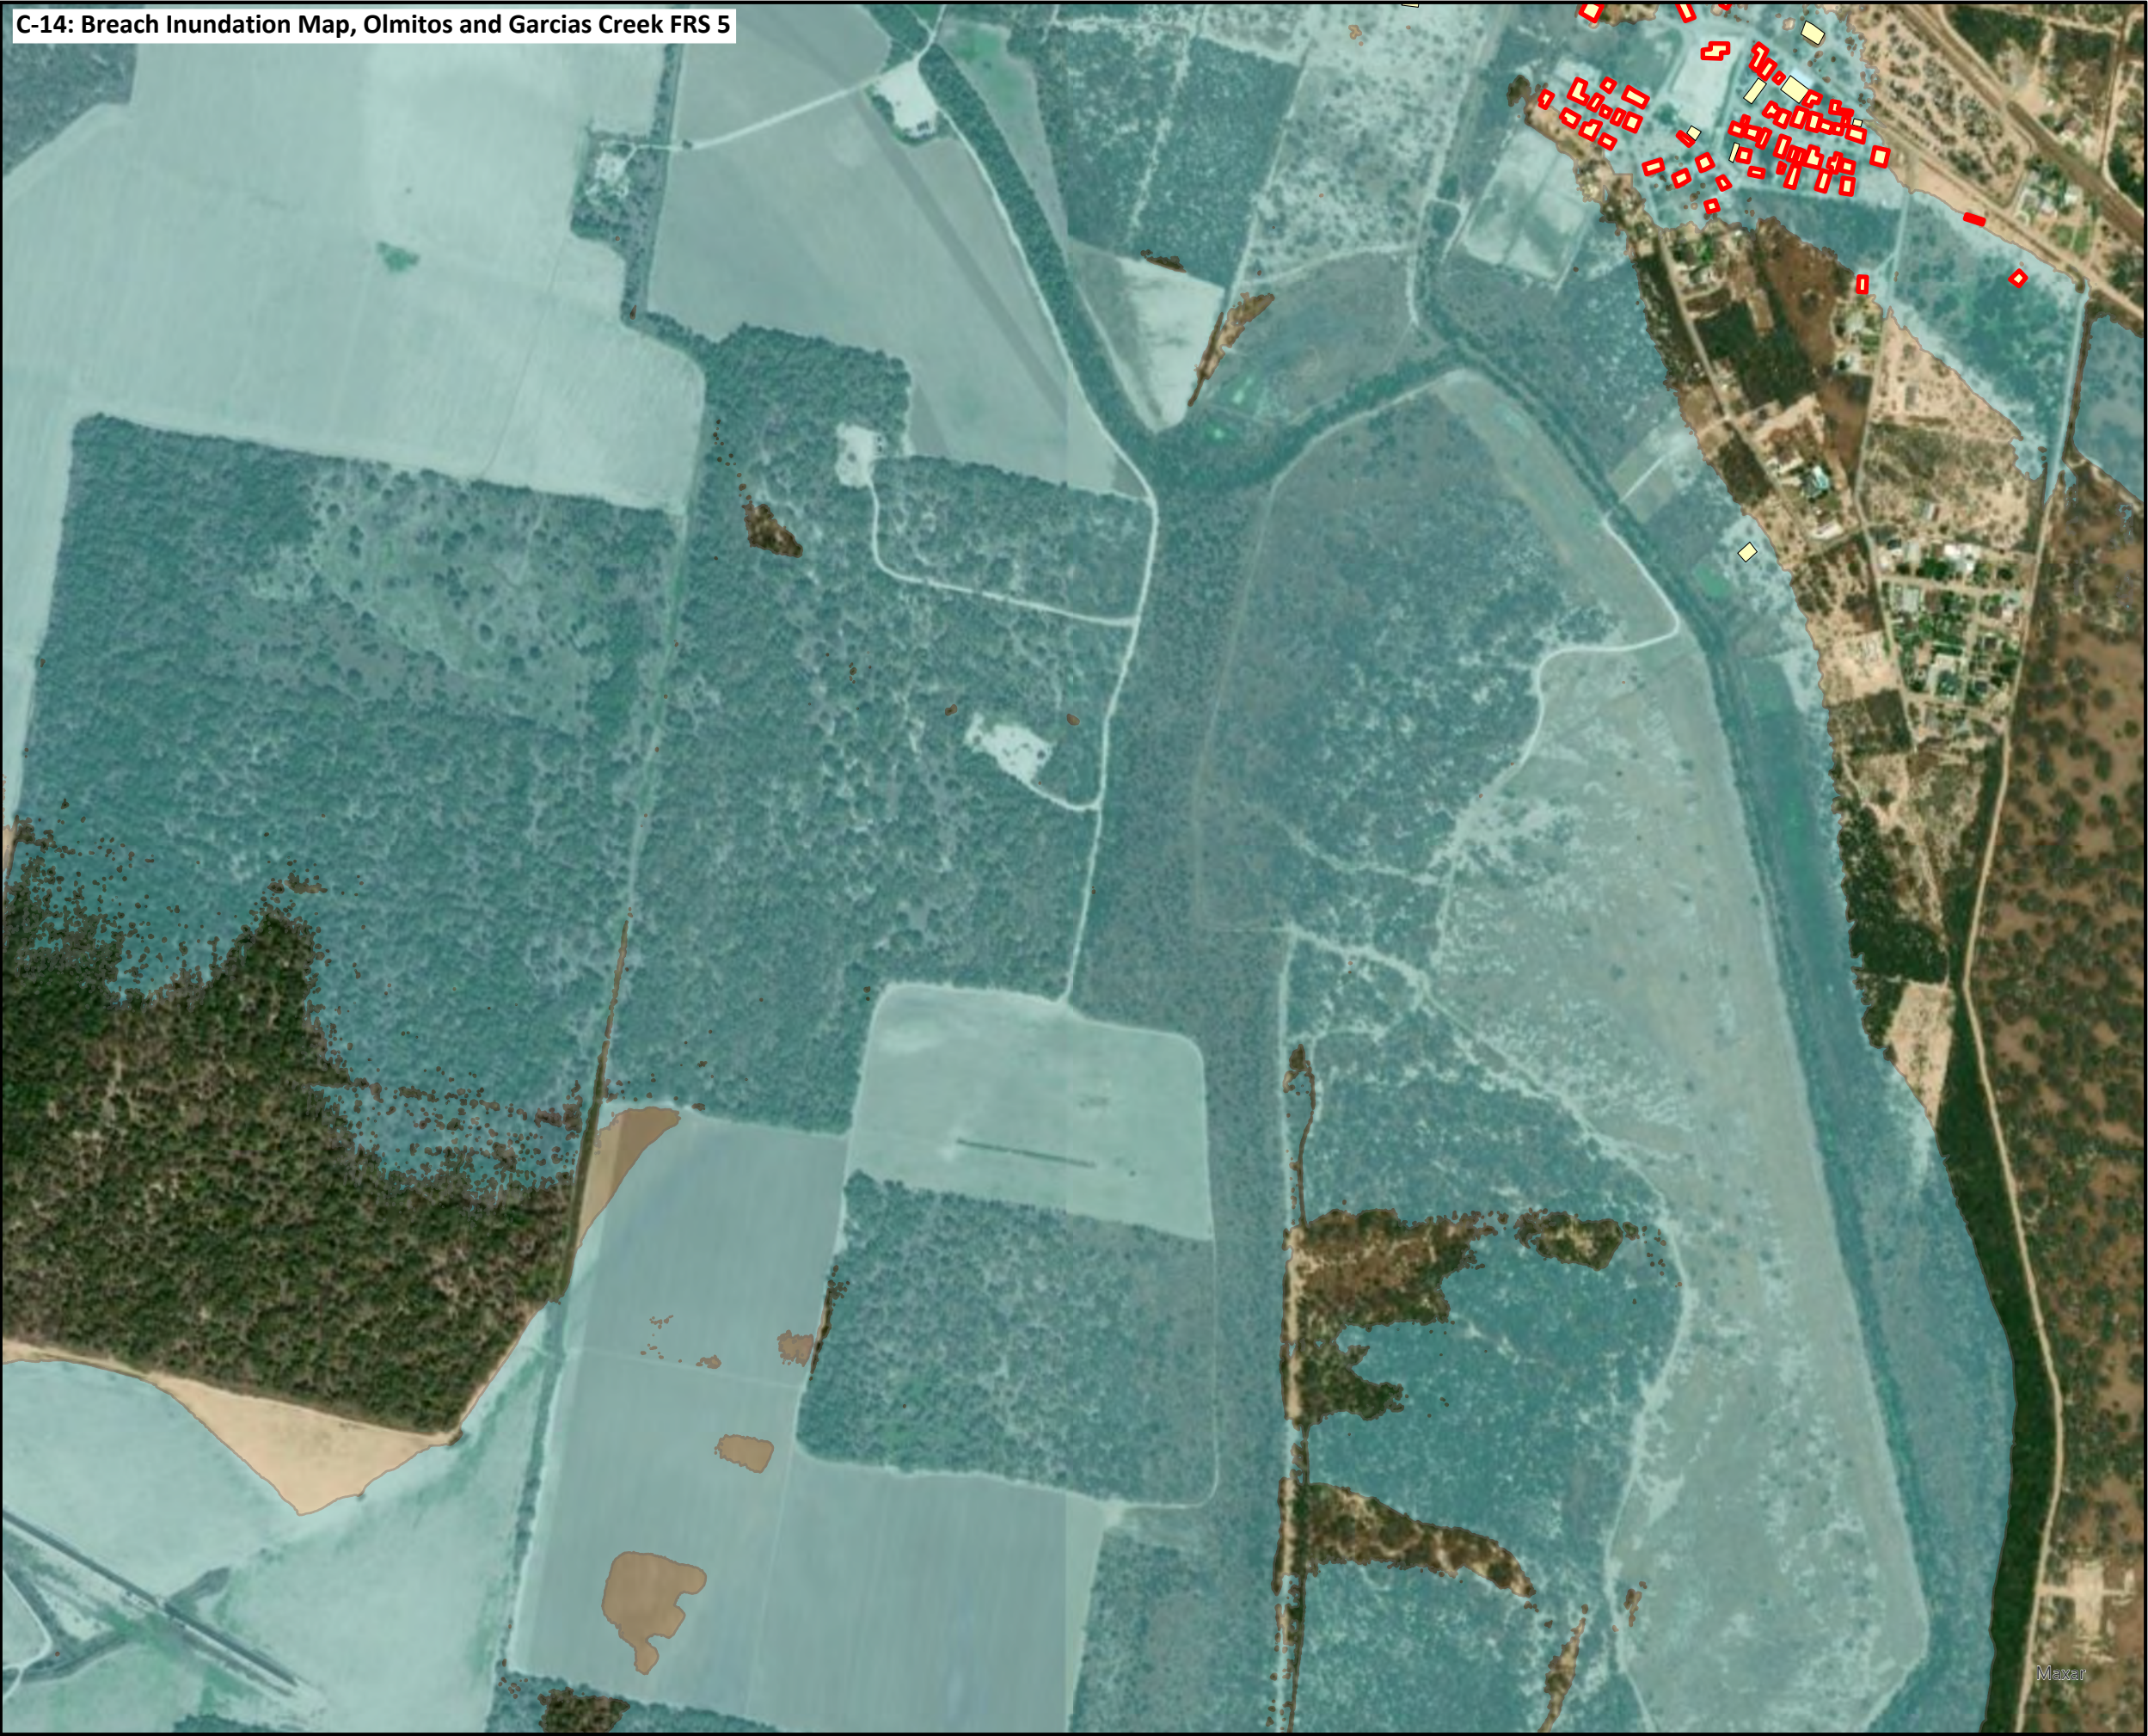
Panel 4 of 8

*The methods used to develop inundation zones and flood wave arrival times are approximate and should only be used as guidance for establishing evacuation zones. Actual areas inundated will depend on actual failure and pre-failure hydrologic conditions and may differ significantly from information shown on maps.*

**OLMITOS & GARCIAS CREEK #5  
DAM FAILURE MAPPING**

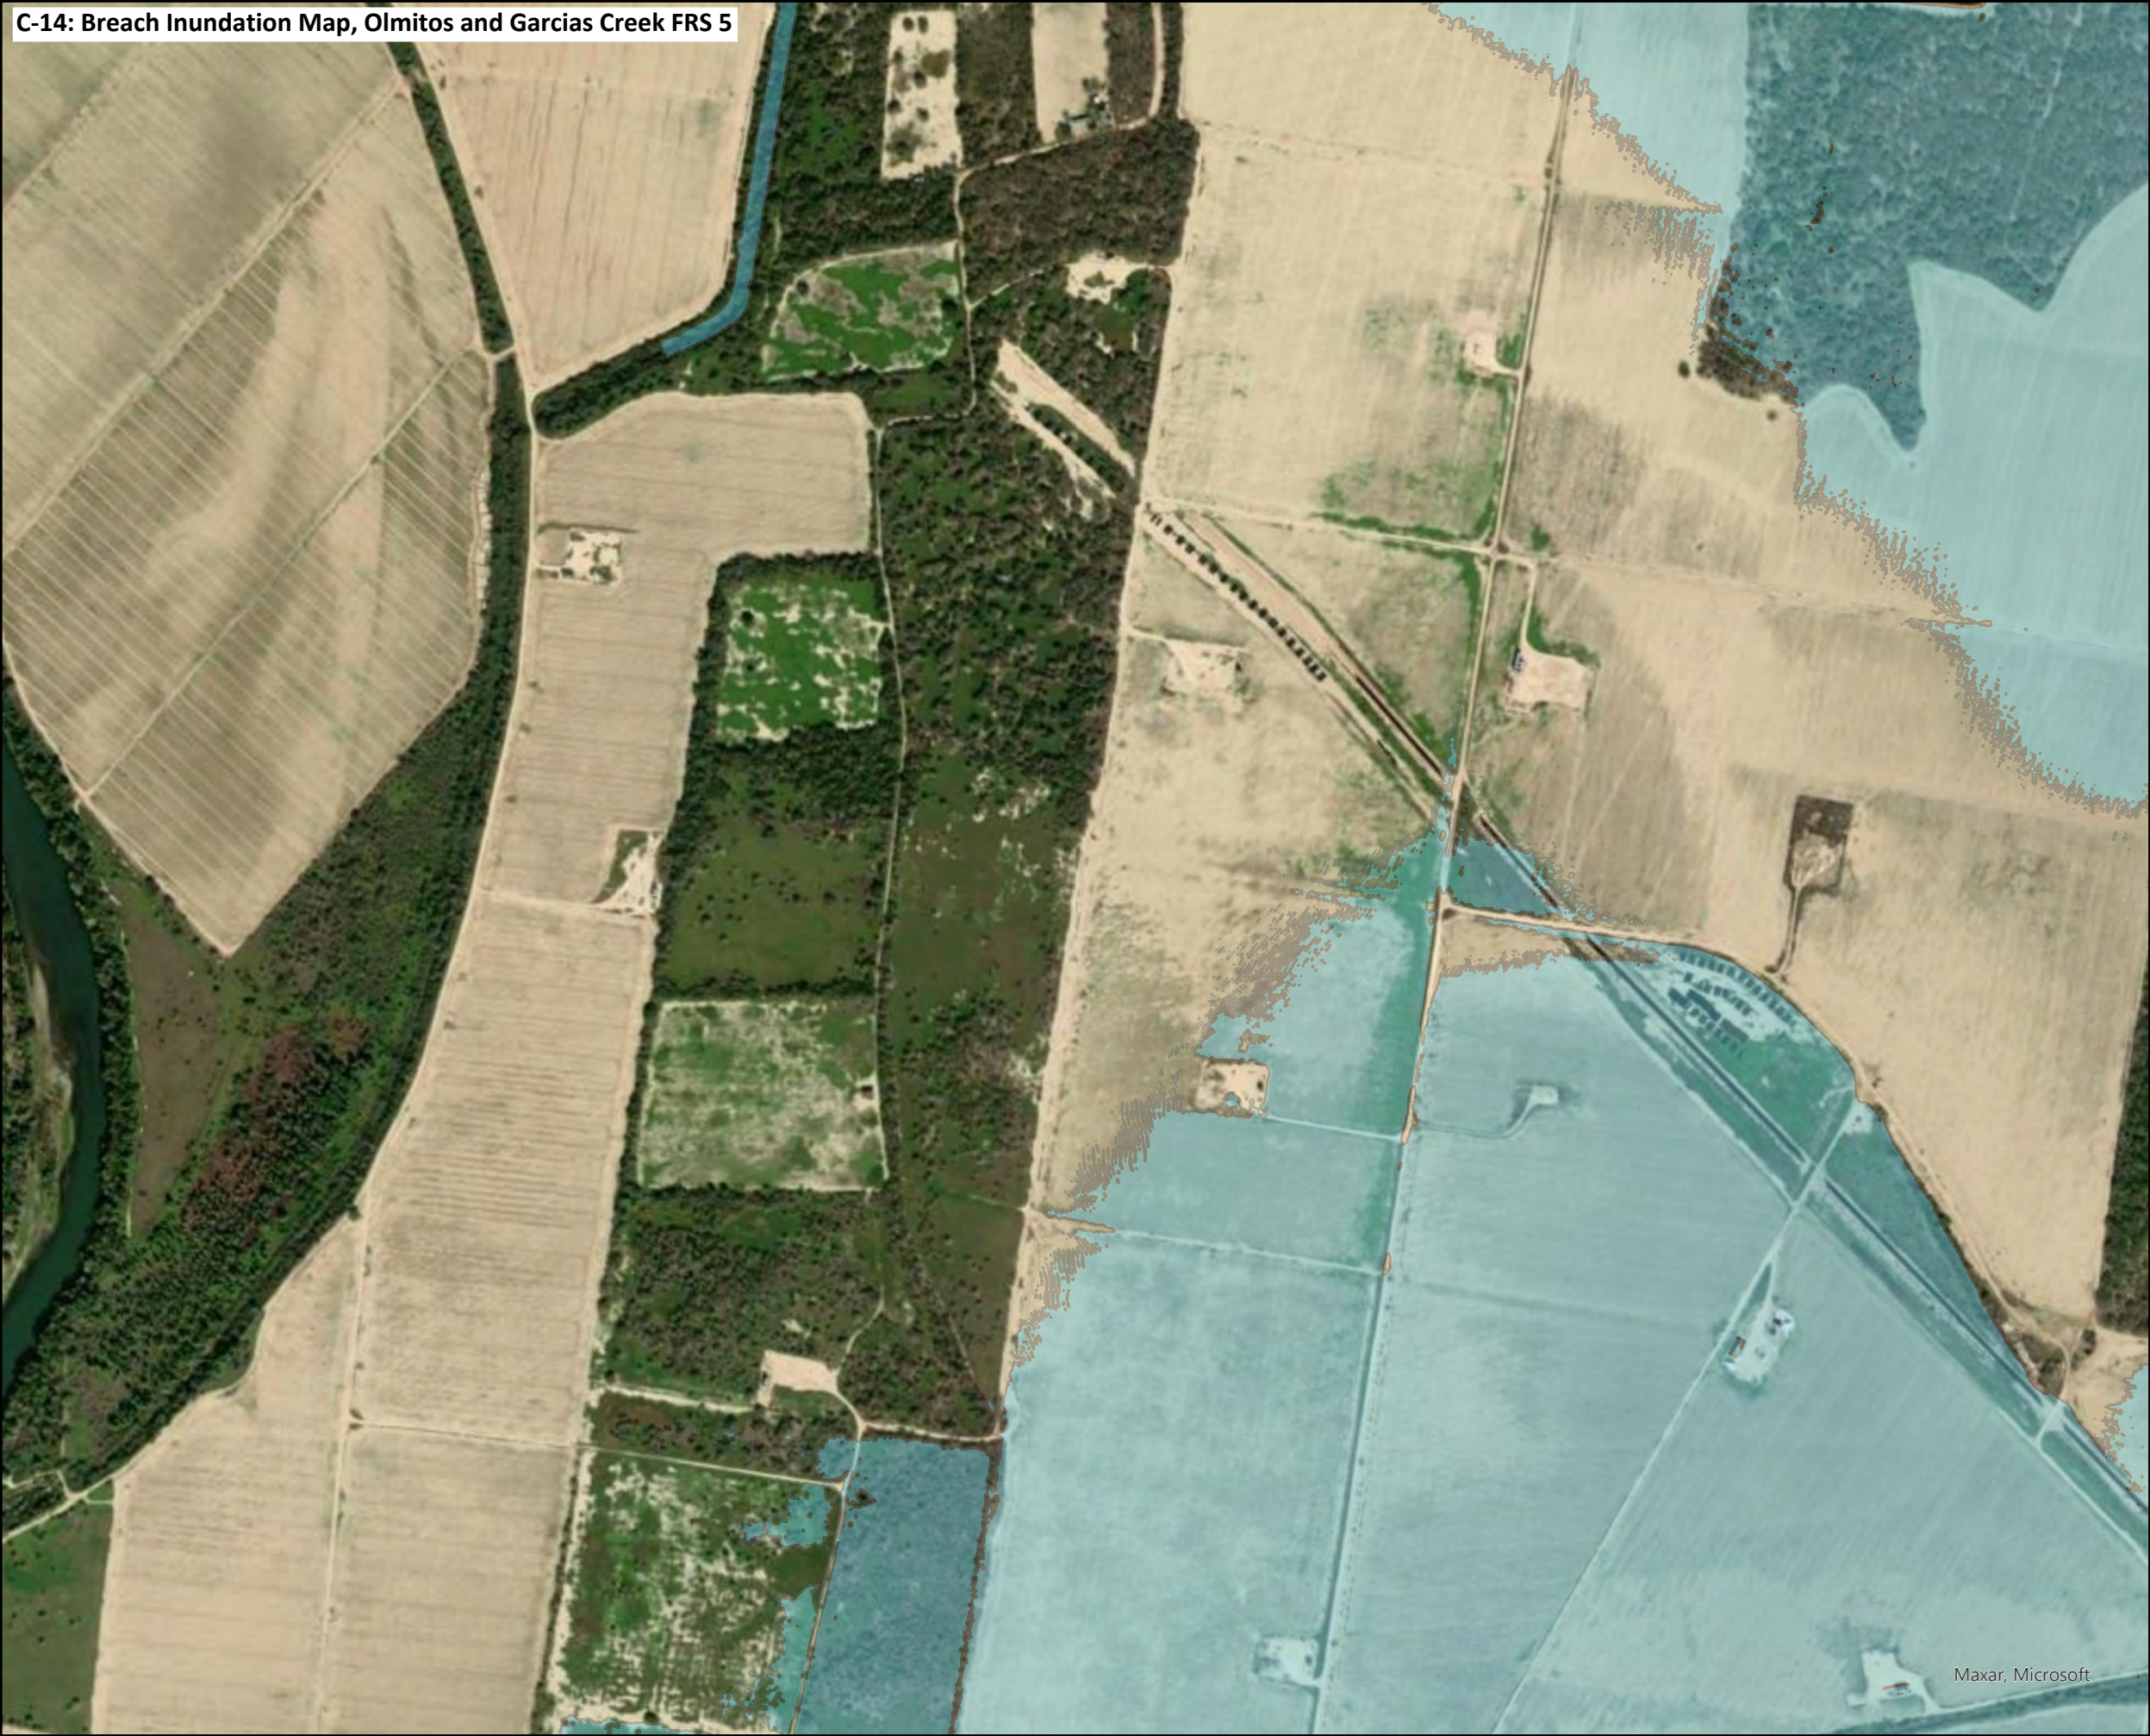
Panel 5 of 8

*The methods used to develop inundation zones and flood wave arrival times are approximate and should only be used as guidance for establishing evacuation zones. Actual areas inundated will depend on actual failure and pre-failure hydrologic conditions and may differ significantly from information shown on maps.*

**OLMITOS & GARCIAS CREEK #5  
DAM FAILURE MAPPING**

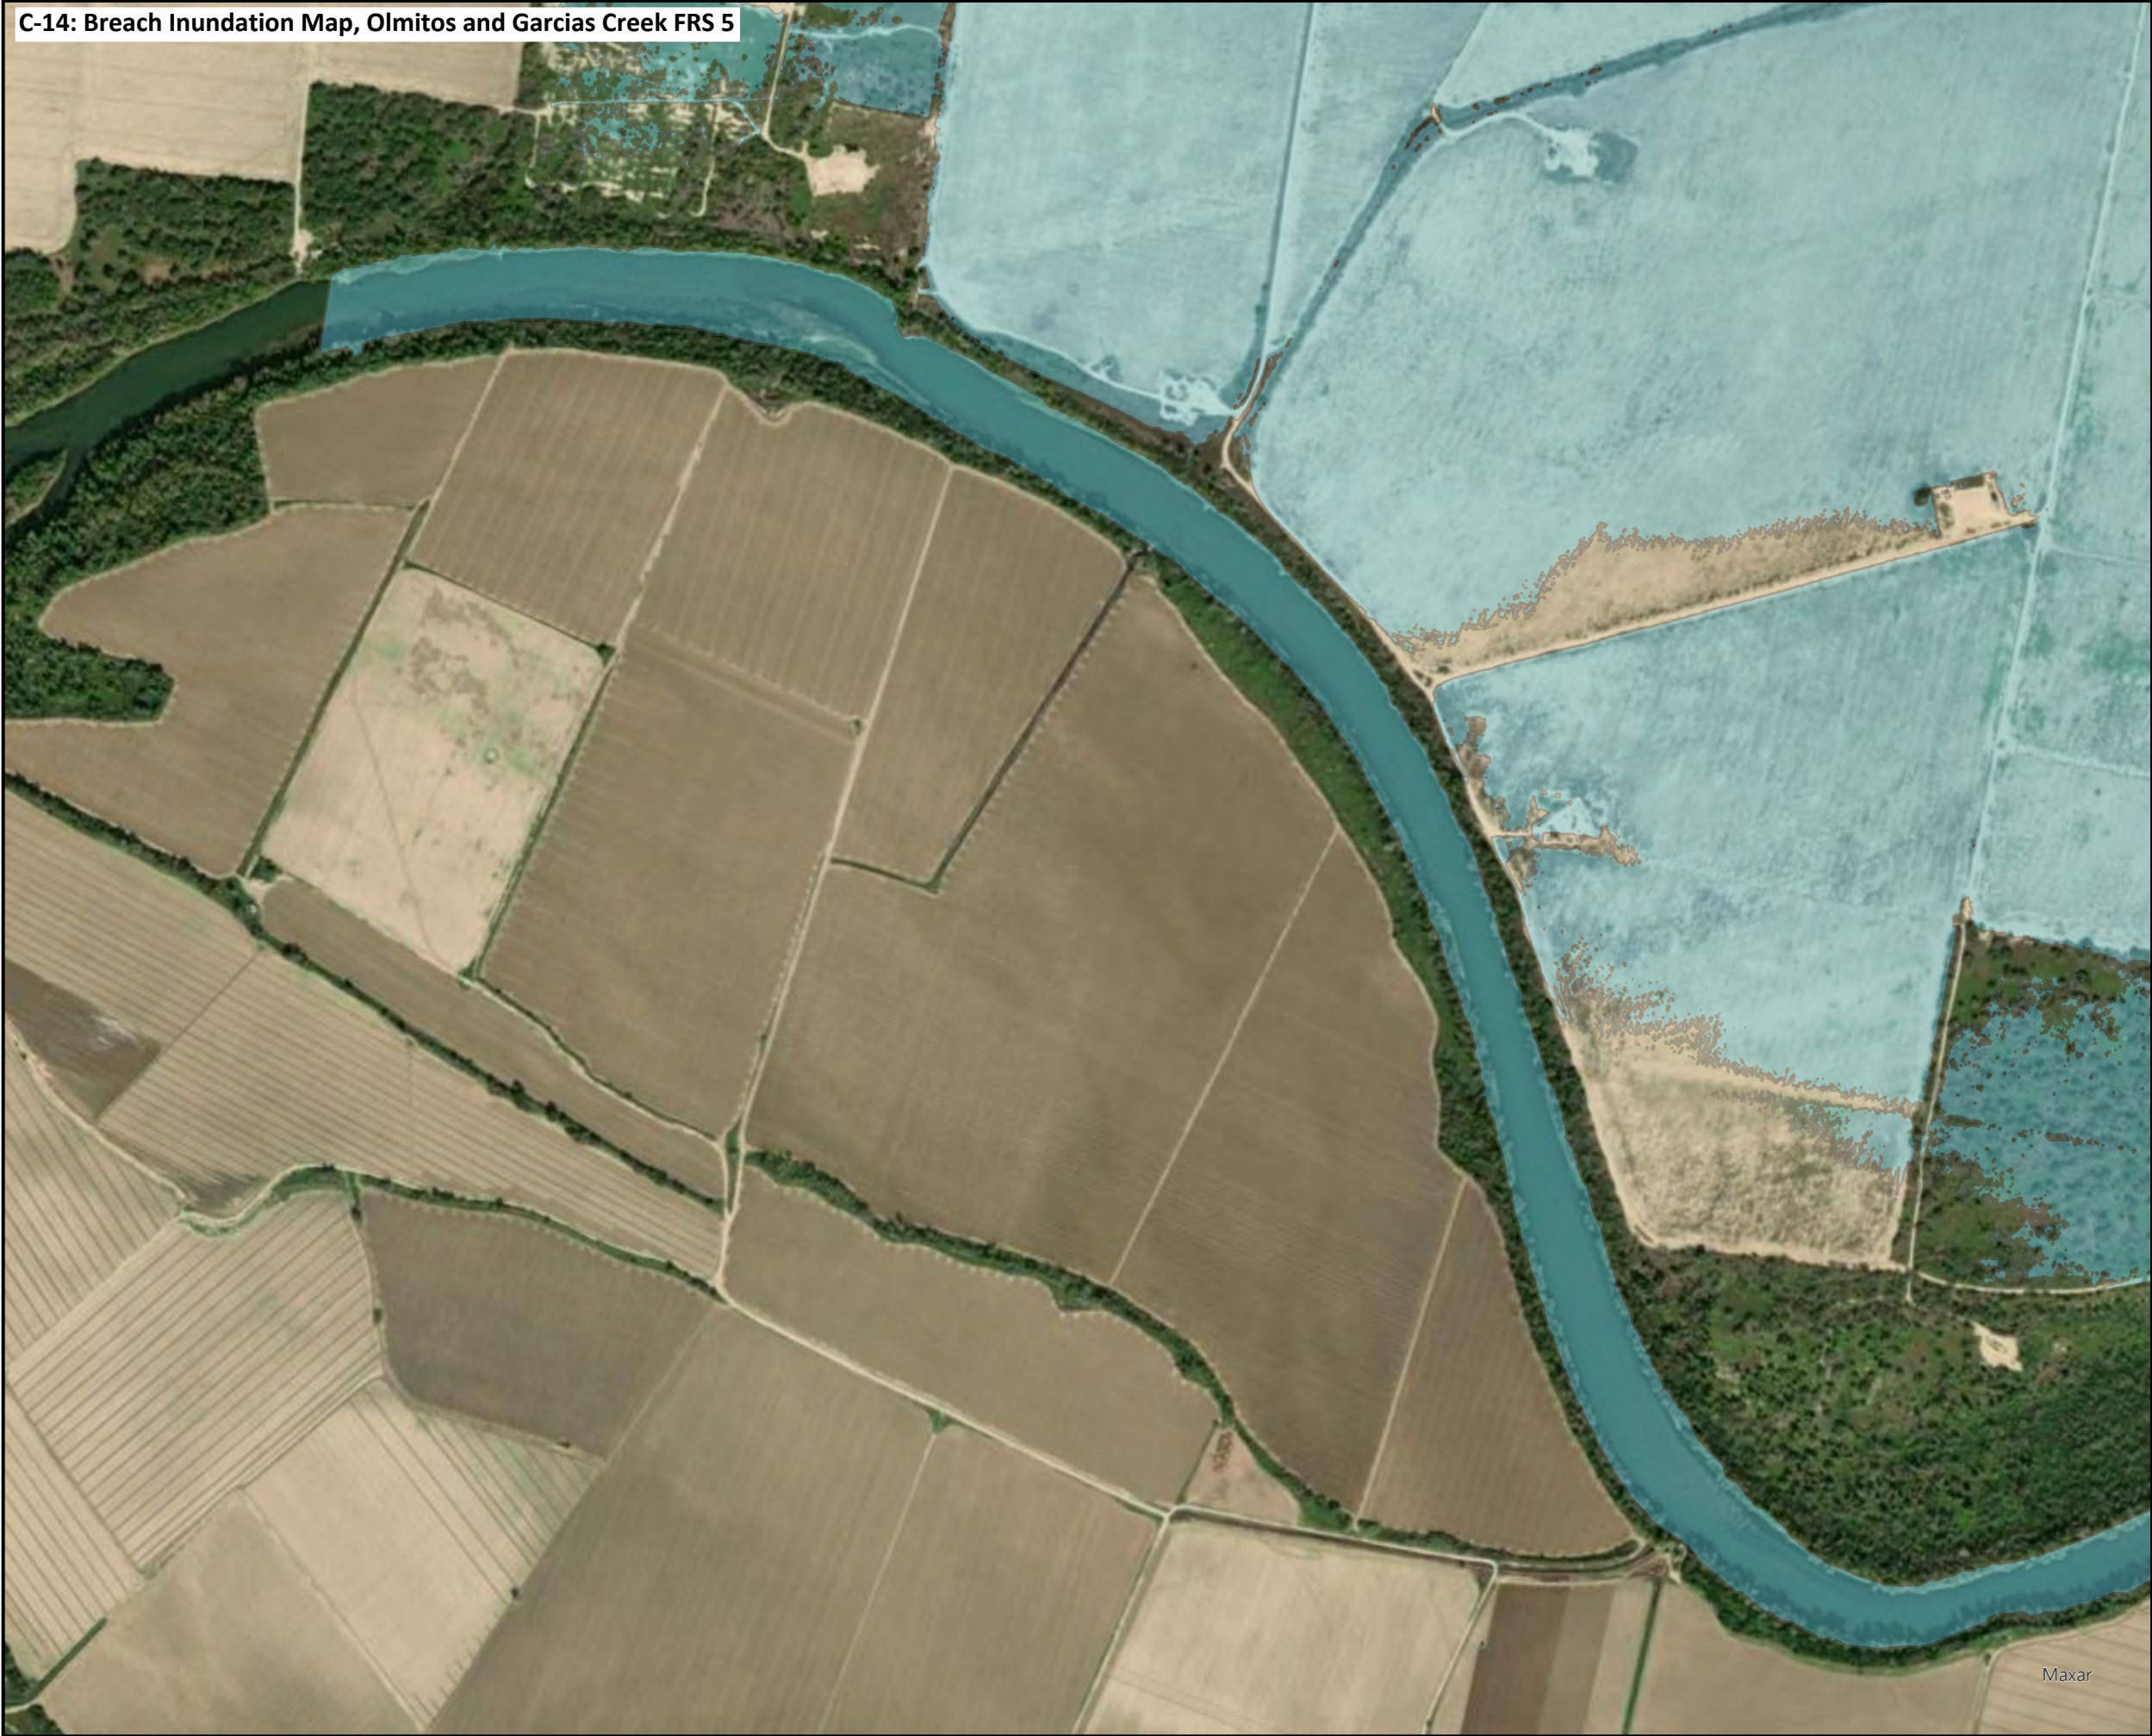
Panel 8 of 8

*The methods used to develop inundation zones and flood wave arrival times are approximate and should only be used as guidance for establishing evacuation zones. Actual areas inundated will depend on actual failure and pre-failure hydrologic conditions and may differ significantly from information shown on maps.*

**OLMITOS & GARCIAS CREEK #5  
DAM FAILURE MAPPING**

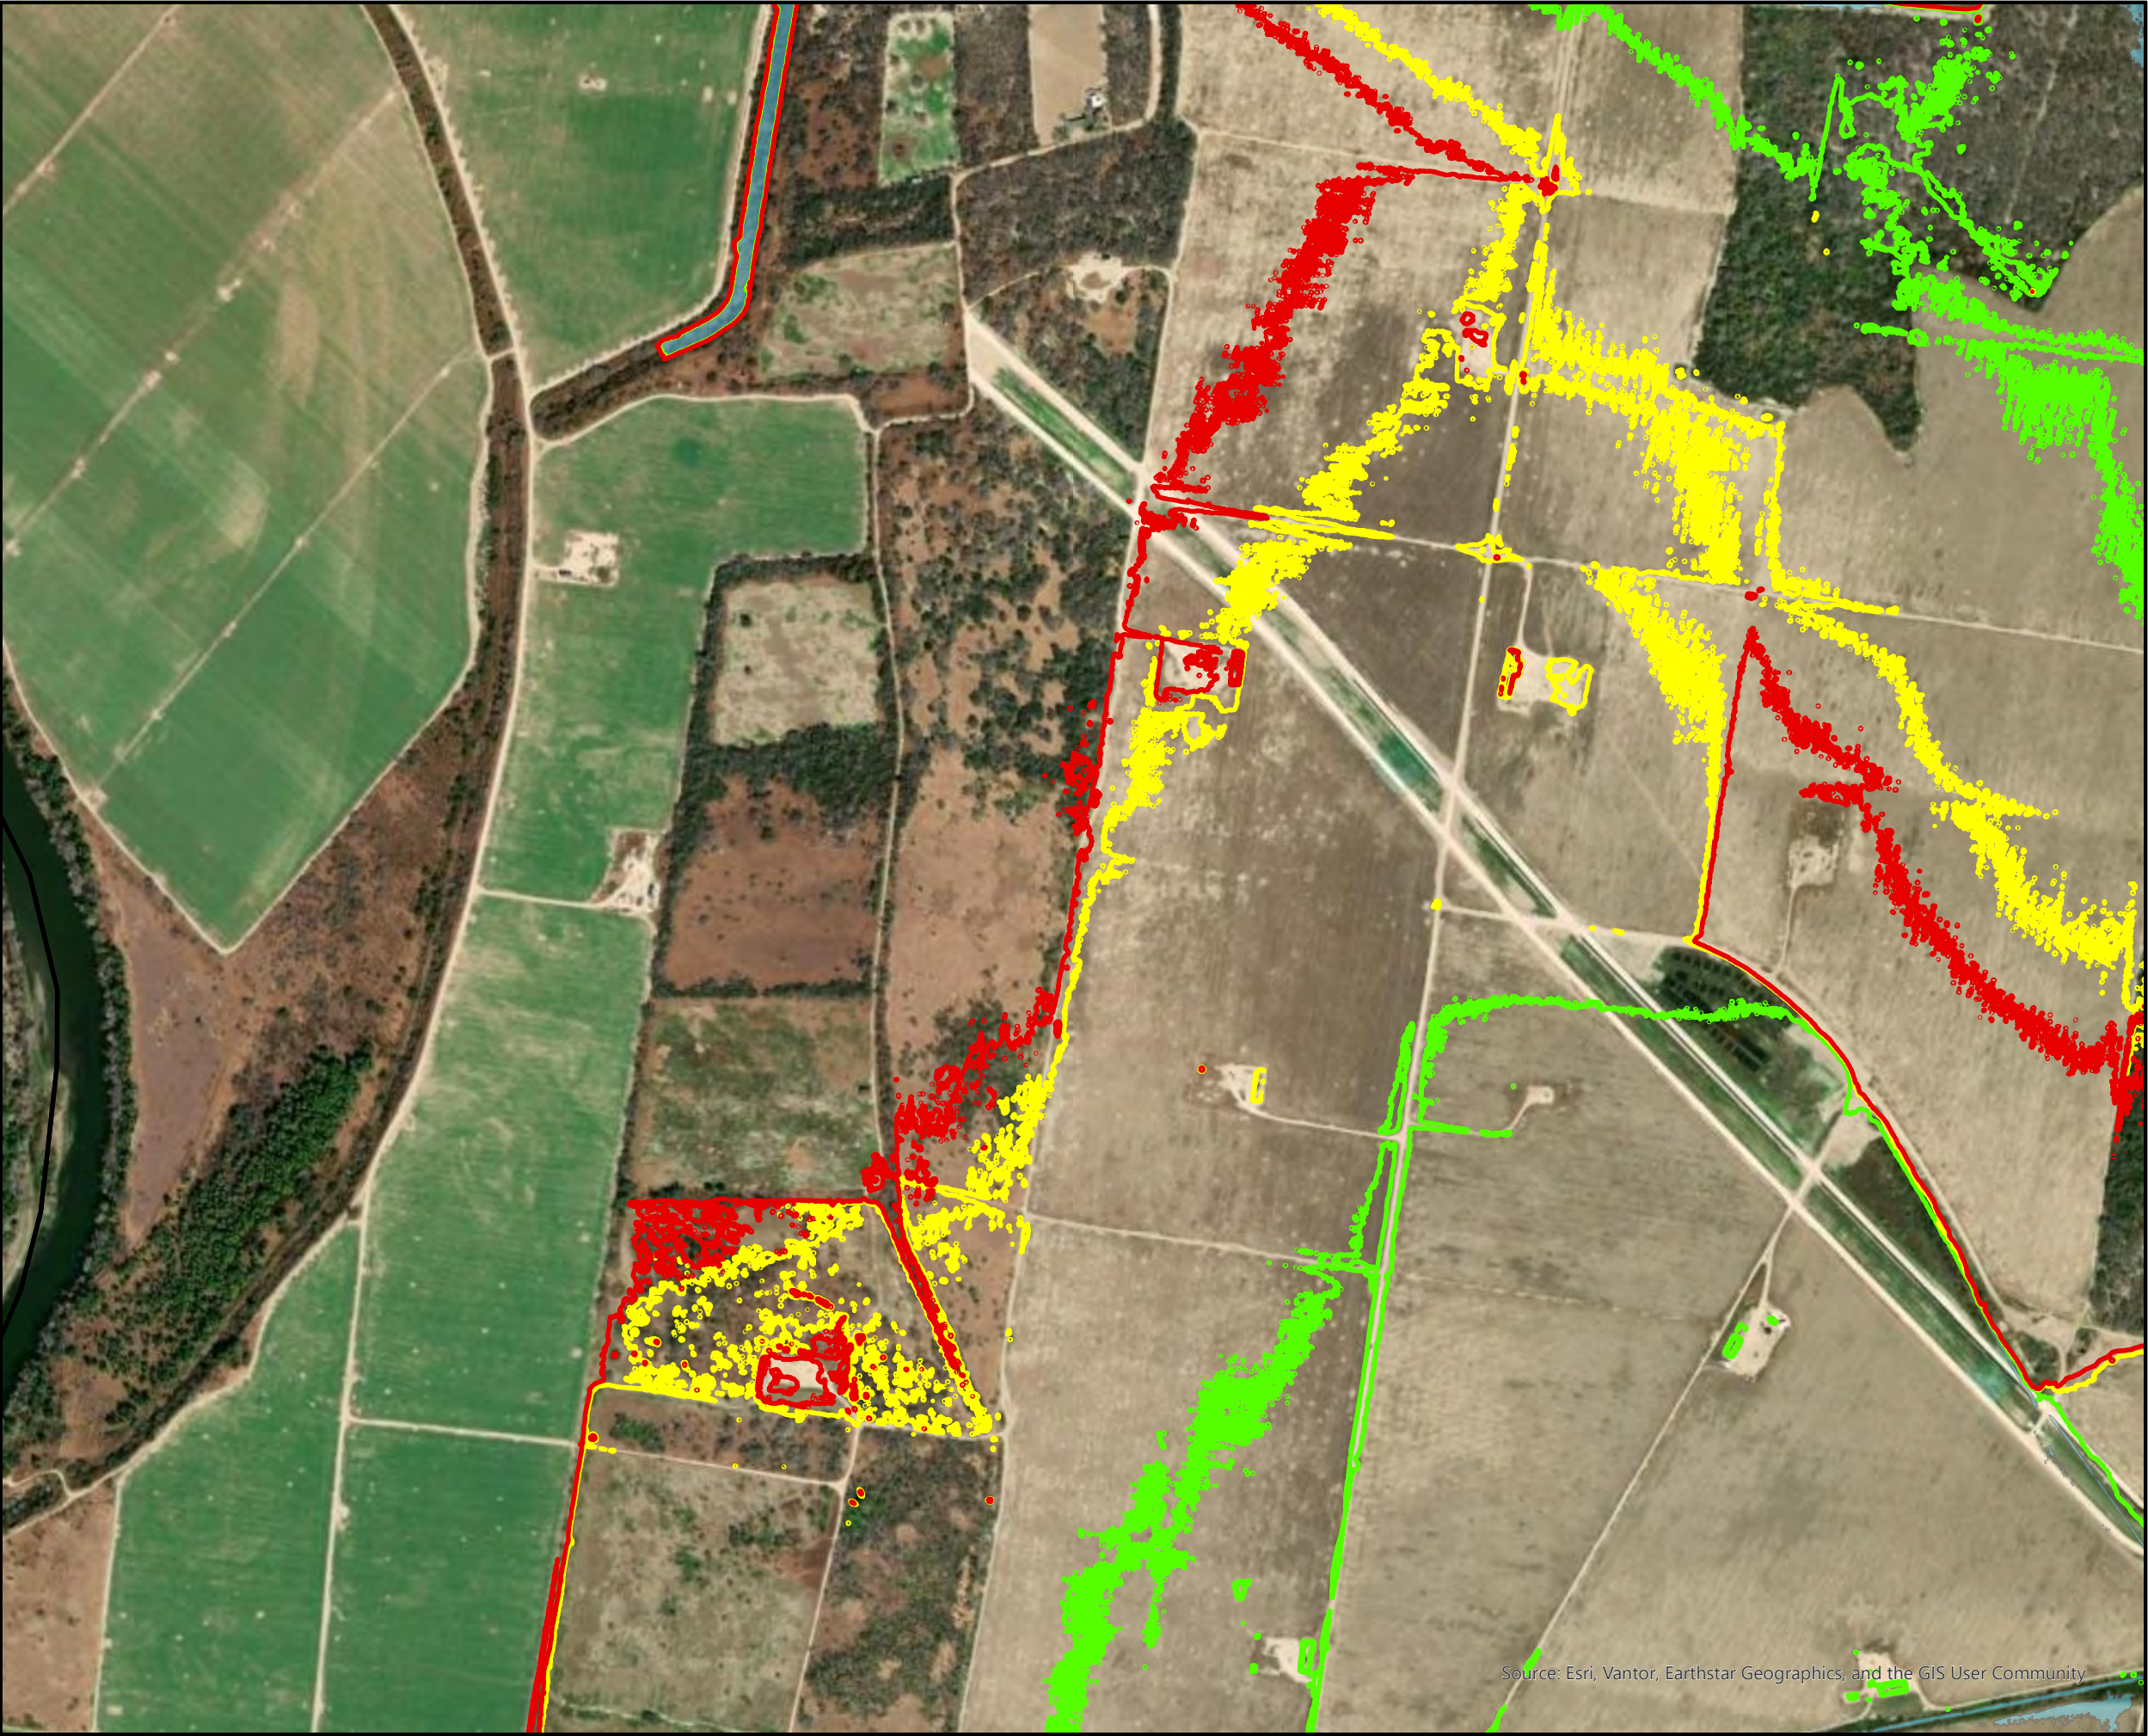
**OLMITOS & GARCIAS CREEK #5  
FREQUENCY EVENTS  
INUNDATION MAP**  
Panel 5 of 8

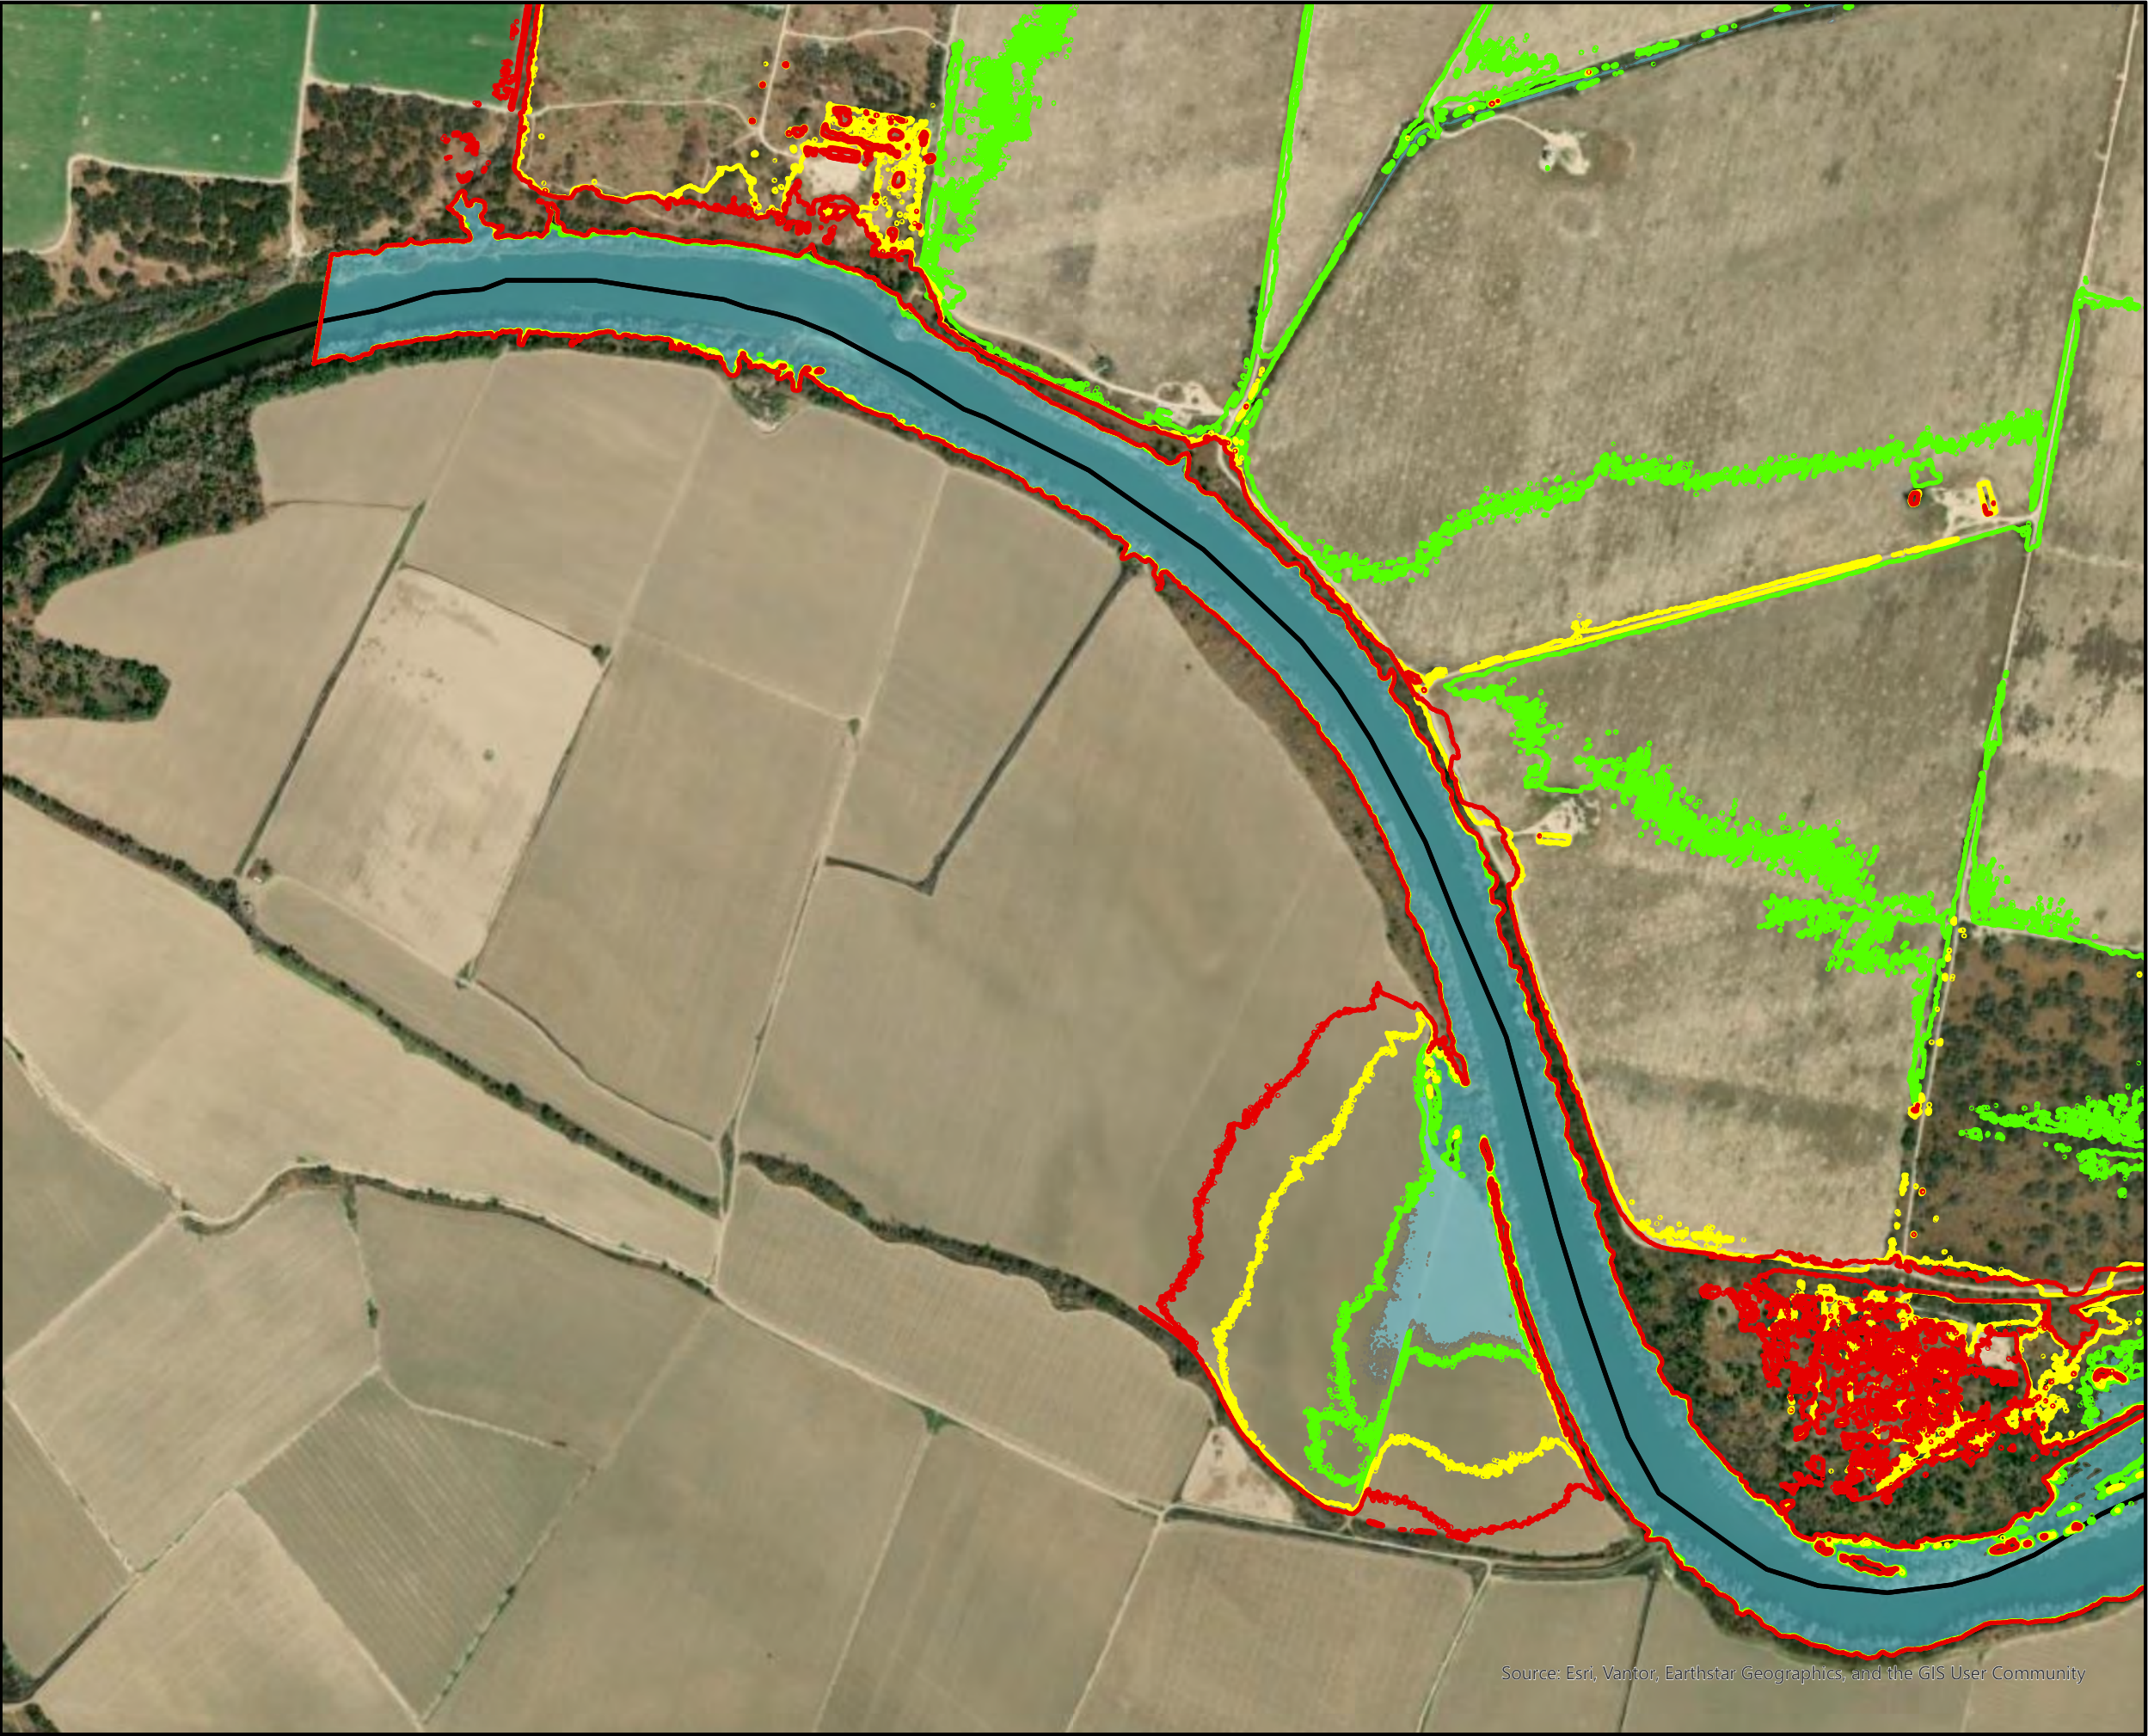
**OLMITOS & GARCIAS CREEK #5  
FREQUENCY EVENTS  
INUNDATION MAP**  
Panel 8 of 8
