**USDA NRCS Bismarck State Office**

**Dam Assessment Report**

## **English Coulee Dam**

**Grand Forks County, North Dakota**

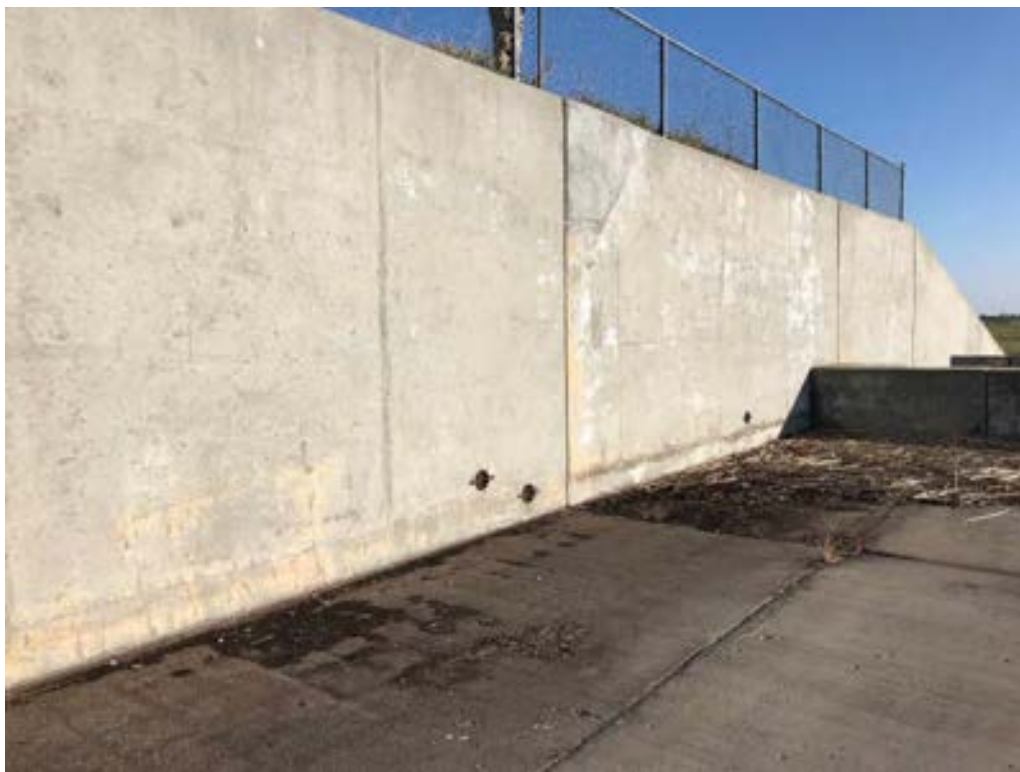
A concrete patch had been applied to the left wall near Joint #5 (numbered from as-builts; wall section located in the spillway inlet) (see photo 3). In reviewing older inspections, this area had been patched before but still experienced cracking. The new patch appears to be adequately applied but should be monitored for any issues.

*Photo 3 Left, upstream wall of auxiliary spillway; concrete patch located at Joint 5 of wall*

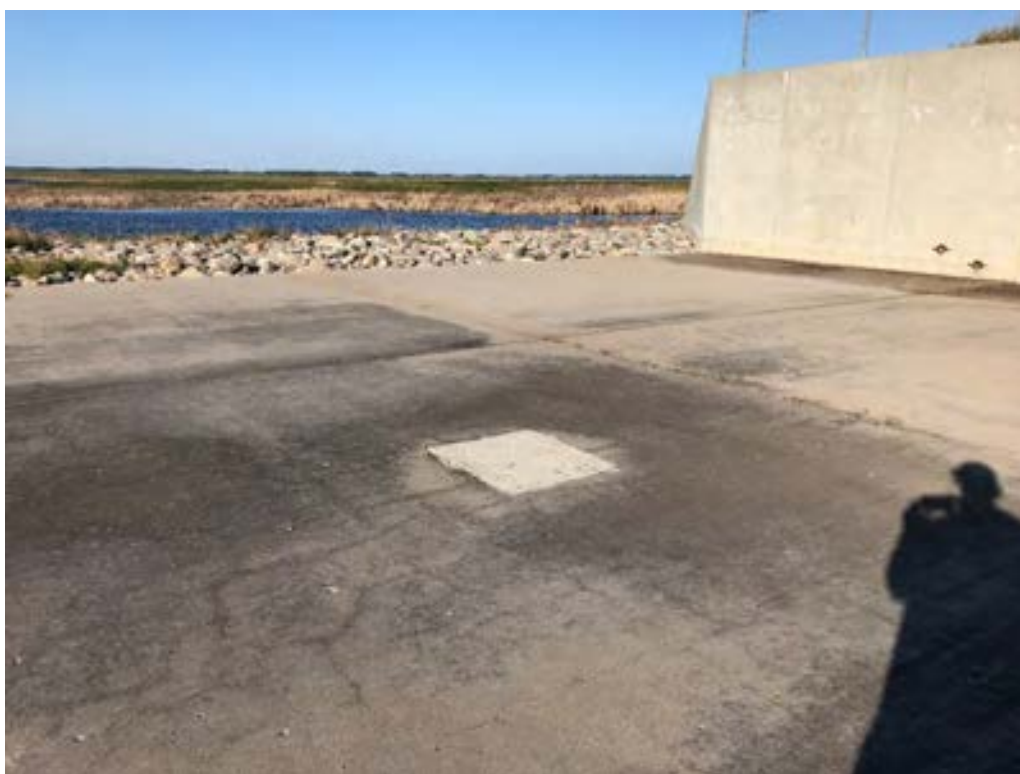
- Vehicle ruts are located in locations along the dam crest.
- Prior concrete repair in the approach floor of the auxiliary spillway is not adhered to surrounding structure.

There is a concrete patch in the floor of the spillway inlet that did not have good adherence to the surrounding structure (see photo 4). By inspection, the patch was hollow underneath. This patch should be removed and replaced in a manner that ensures a good bond to surrounding concrete. If the patch is not properly bonded, this would create potential for water to flow beneath the structure in manner that it was not designed for.

*Photo 4 Concrete patch in floor of AS approach; patch is hollow and not adhered to surrounding concrete*

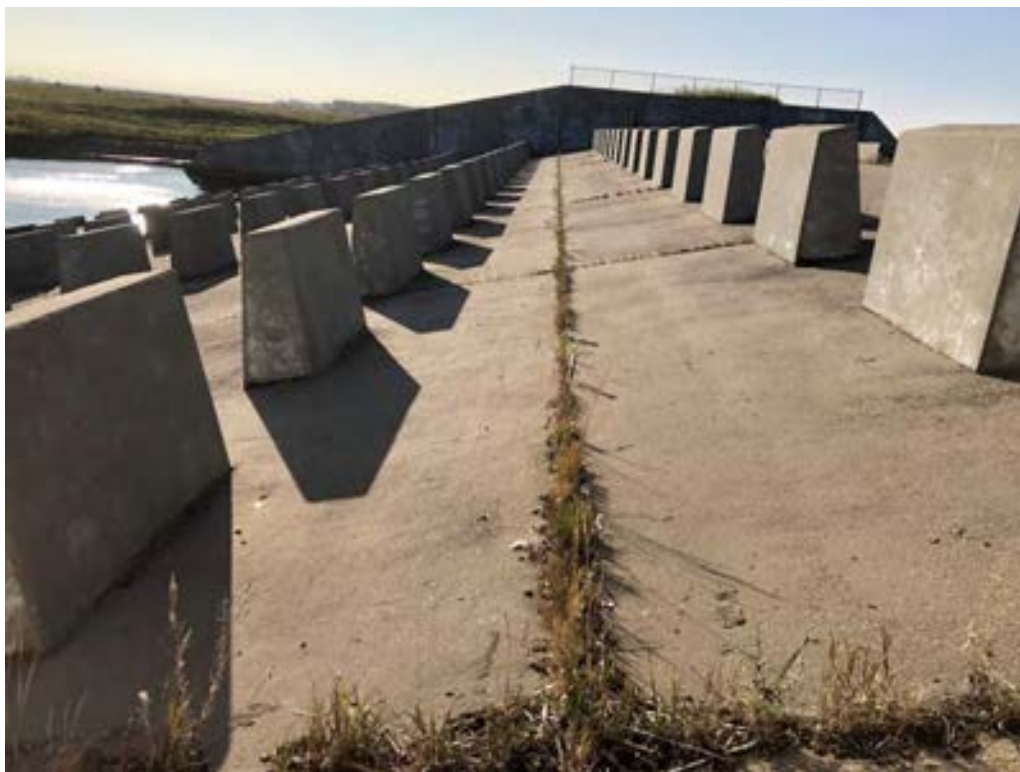
Excessive vegetation is currently growing in the floor joints of chute spillway (see photos 5 and 16). The establishment of roots in these areas can lead to potential issues with water infiltration and hydraulic pumping should the spillway be activated. Although the as-builts indicate that waterstops are present along the lengths of these floor joints, vegetation should still be removed, and joints sealed to prevent issues associated with freeze-thaw cycles.

*Photo 5 Heavy vegetation in floor joint of auxiliary spillway*

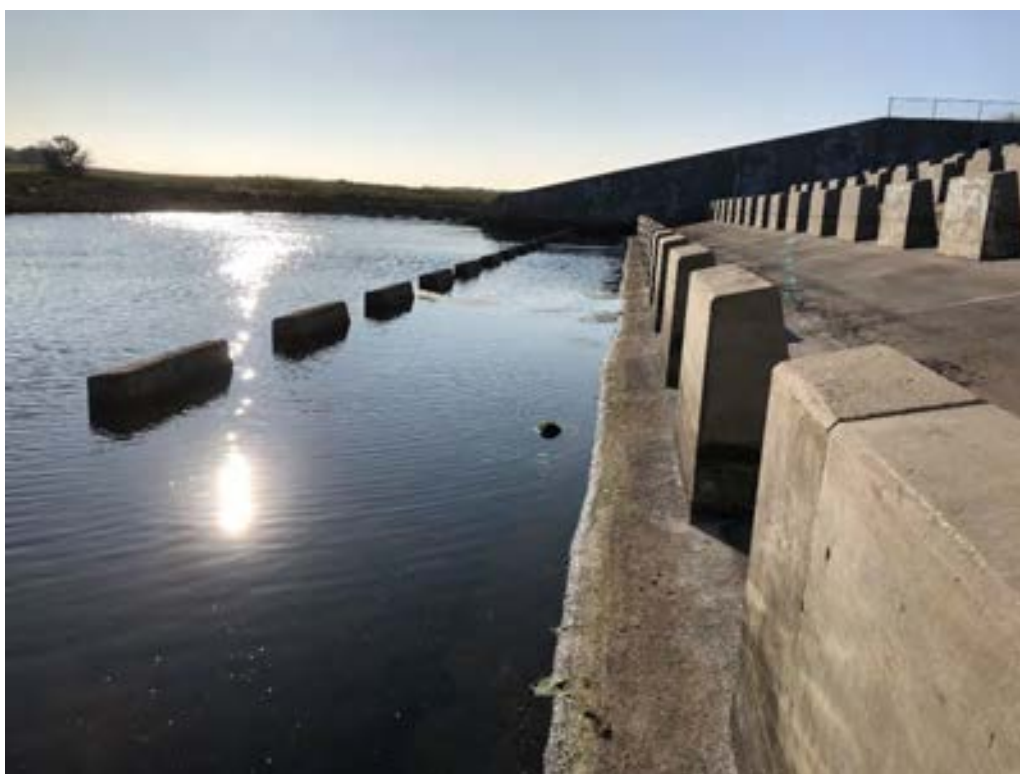
The bottom of the auxiliary spillway, the lower access manholes, and outlet drains were submerged at the time of inspection (see photos 6, 11, 12, and 17). The stilling basin does not appear to be properly draining due to excessive growth of cattails at the outlet. This area should be cleared in a manner that promotes proper drainage.

*Photo 6 Bottom of auxiliary spillway is continuously submerged due to cattail growth impeding proper flow*

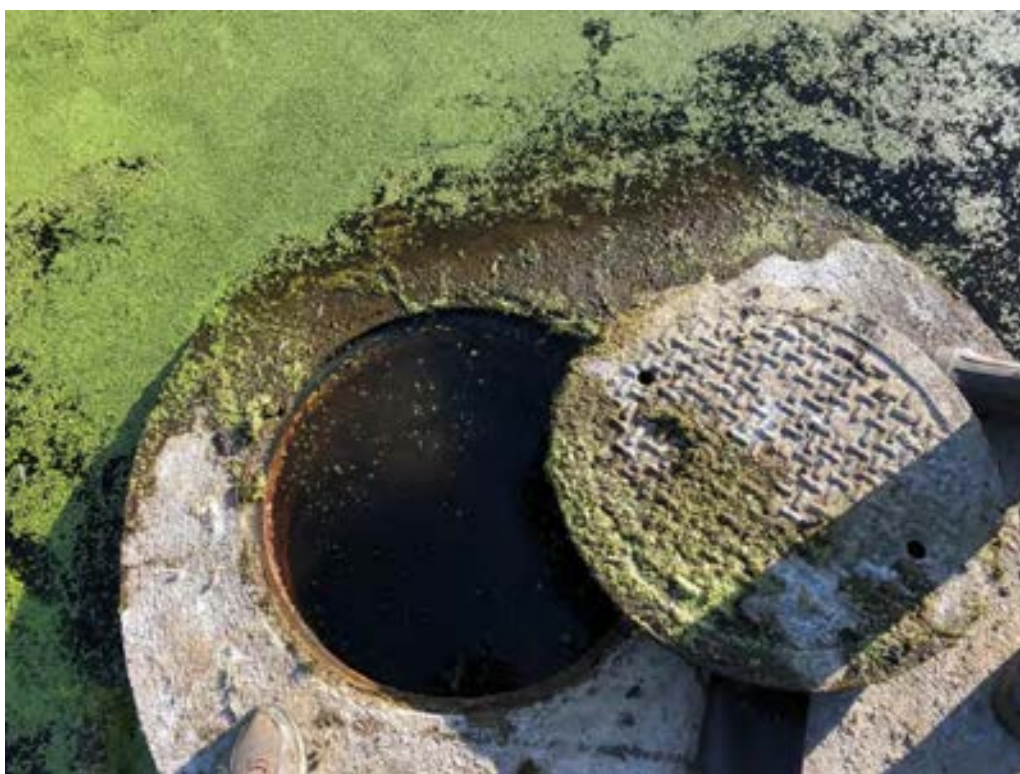
*Photo 12 Drain access manhole submerged in stilling basin of auxiliary spillway*

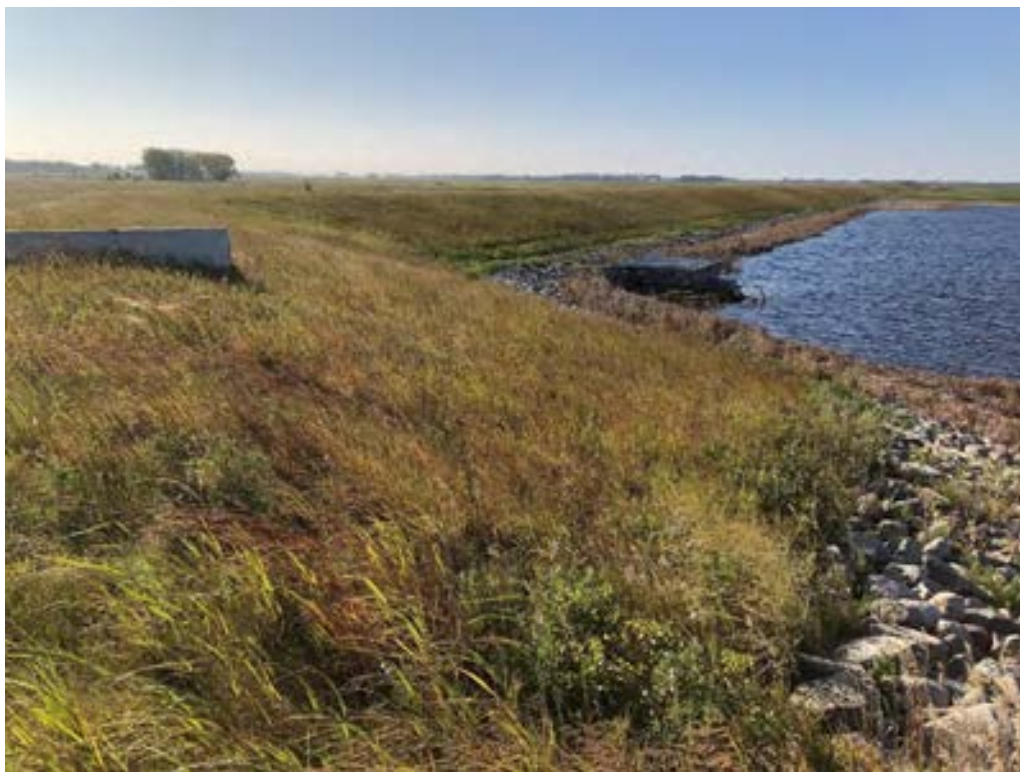
Concrete traffic barriers have been placed at locations along the dam crest to prevent/discourage vehicular traffic (see photos 19 and 38). In discussing with Tom Purdue, these are considered to have been effective. It should be noted that during an overtopping event, these barriers would create areas of turbulence and concentrated flow.

*Photo 19 Principle spillway inlet structure; concrete barrier on top of dam to discourage vehicle activity*

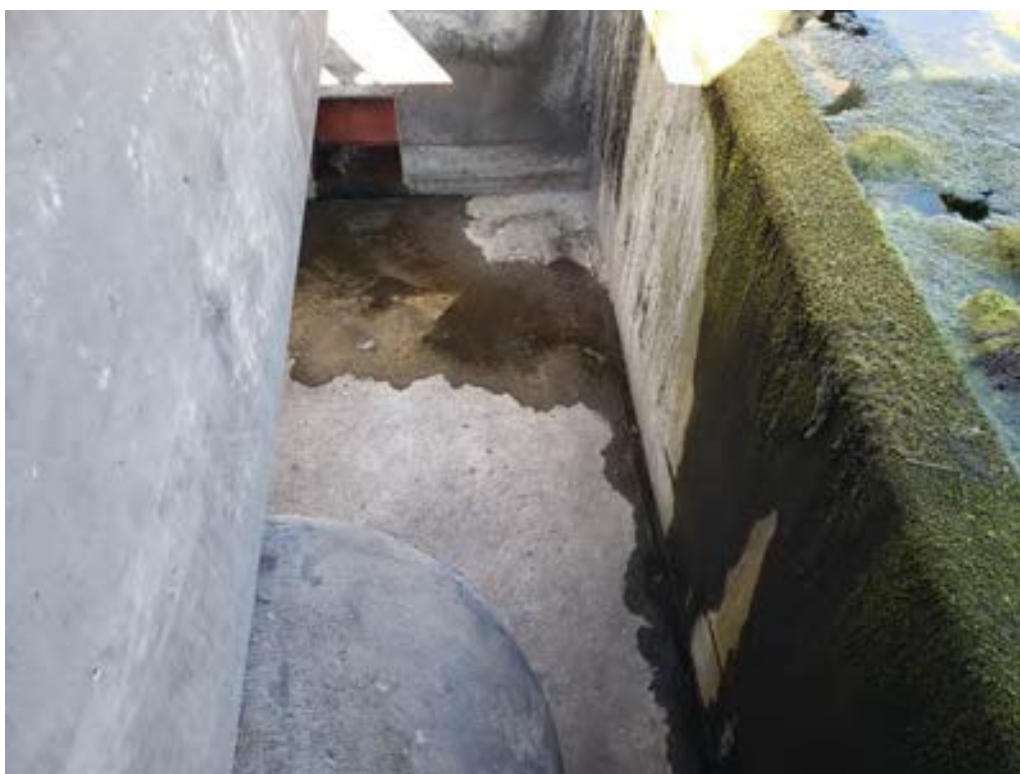
The weir crests had some algae growth (see photo 20). Other than the algae presences, the weir crests appeared to be in good condition.

*Photo 20 Principle spillway inlet: weir invert and low level drawdown gate*

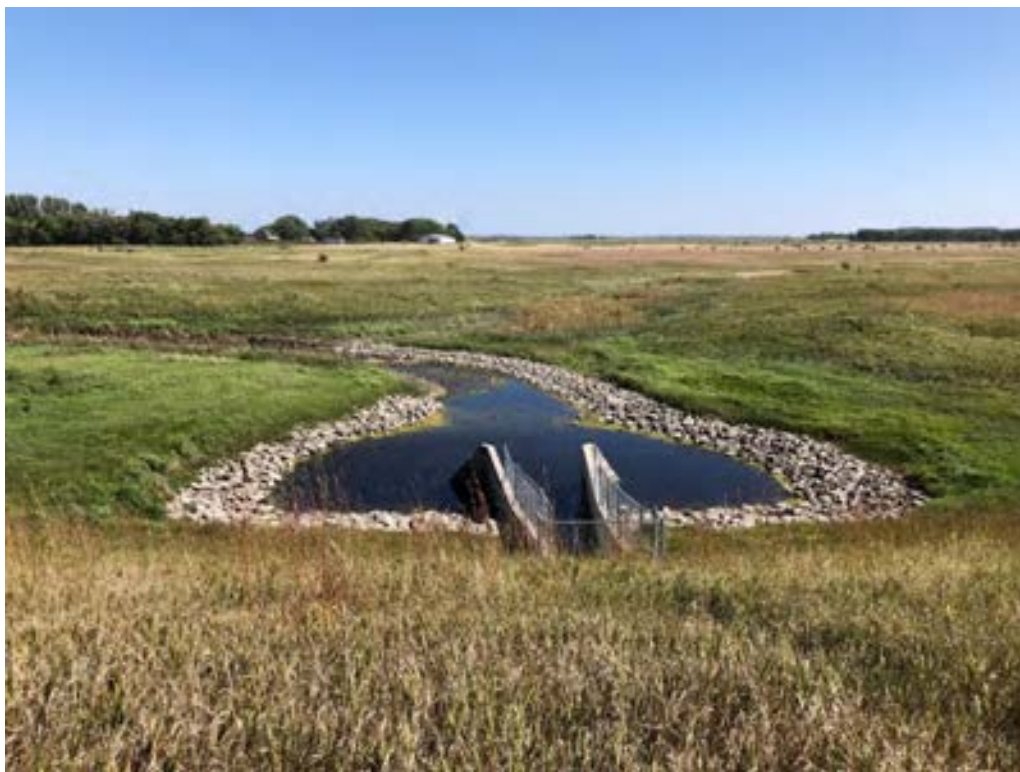
*Photo 23 Plunge pool at the PS outlet; proper drainage is impeded by sediment and vegetative growth*

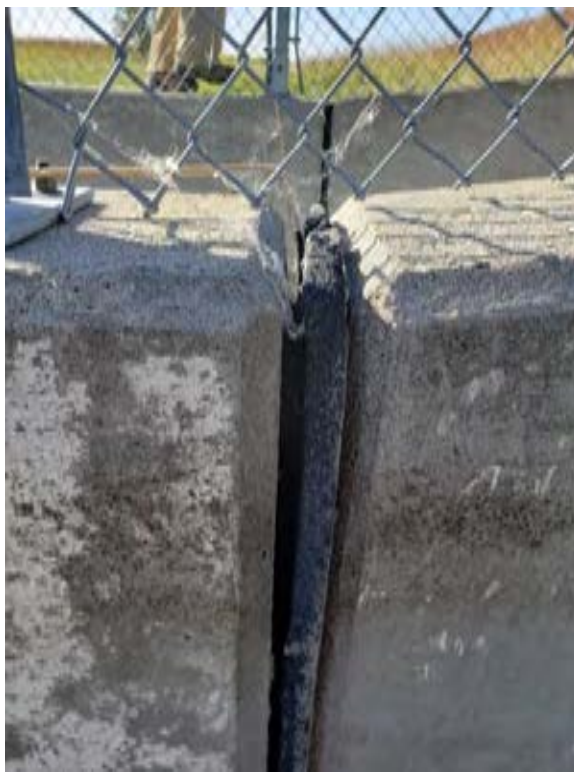
The joints in the principal spillway outlet wall were identified as having noticeable separation at the top. They had separated beyond the thickness of the expansion foam filler (see photo 25). The installed waterstops appeared to be intact and functioning properly.

*Photo 25 Joint separation of PS outlet wall; waterstops appear to be intact*

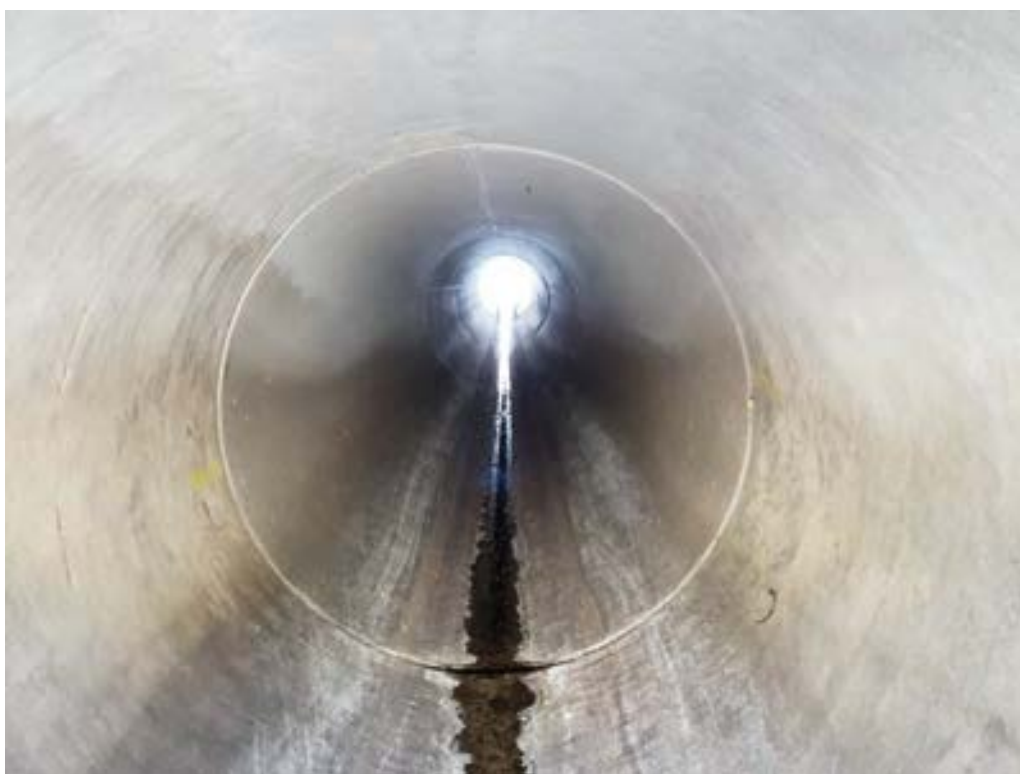
The PS conduit was physically inspected, and the conduit joint gaps were measured. It was visually noted that the conduit did not have a constant grade (see photo 26). Review of the as-builts and discussions with the construction inspector, John Suchor, confirmed that initial conduit cradle sections at either end had been placed without accounting for the necessary camber designed for the conduit sections. These sections were left in place with the final sections being installed as a straight-line grade between the end sections. The conduit grade is consistently downhill with no reverse grade. Thus, there is no issue with the conduit grade. The joint gaps were measured as follows (position reference looking upstream, joints numbered in accordance with as-builts):

*Photo 26 Looking down the principle spillway conduit*

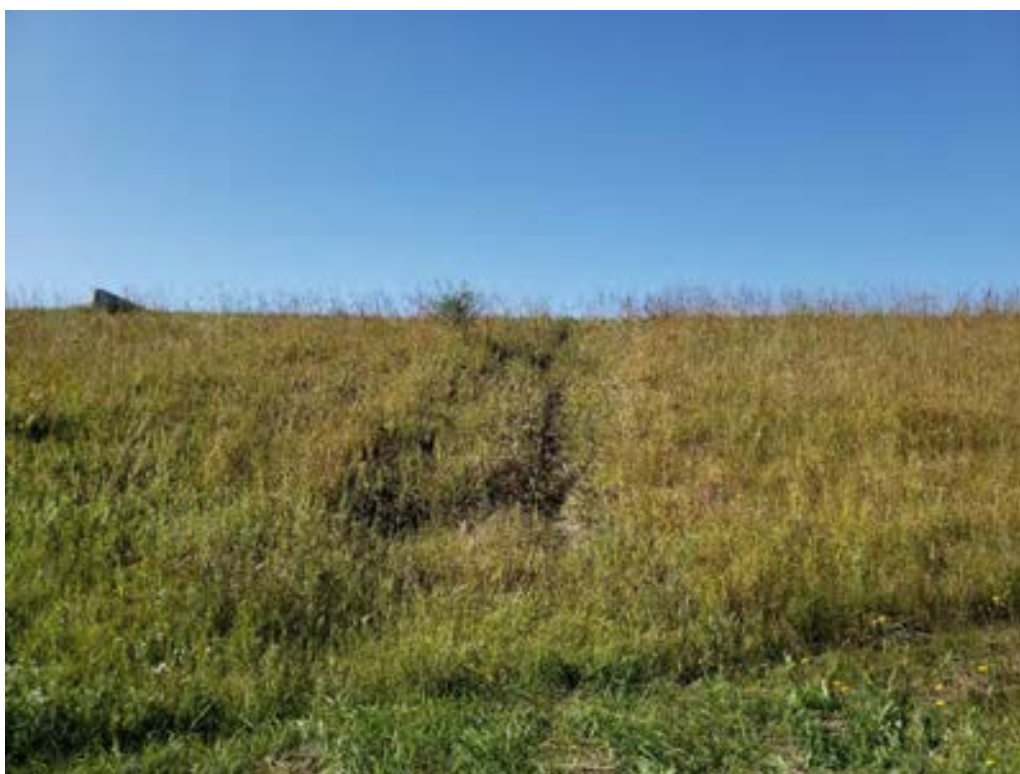
As indicated in the upstream slope, vehicle activity has resulted in worn tracks and rutting in certain locations. Near the left wall of the auxiliary spillway, active erosion has begun to occur (see photo 30). This eroded area would continue to erode at an accelerated rate during any type of flow event. This area should be filled to grade and seeded to reestablish vegetation.

*Photo 30 Erosion on downstream face of embankment near left wall of auxiliary spillway*

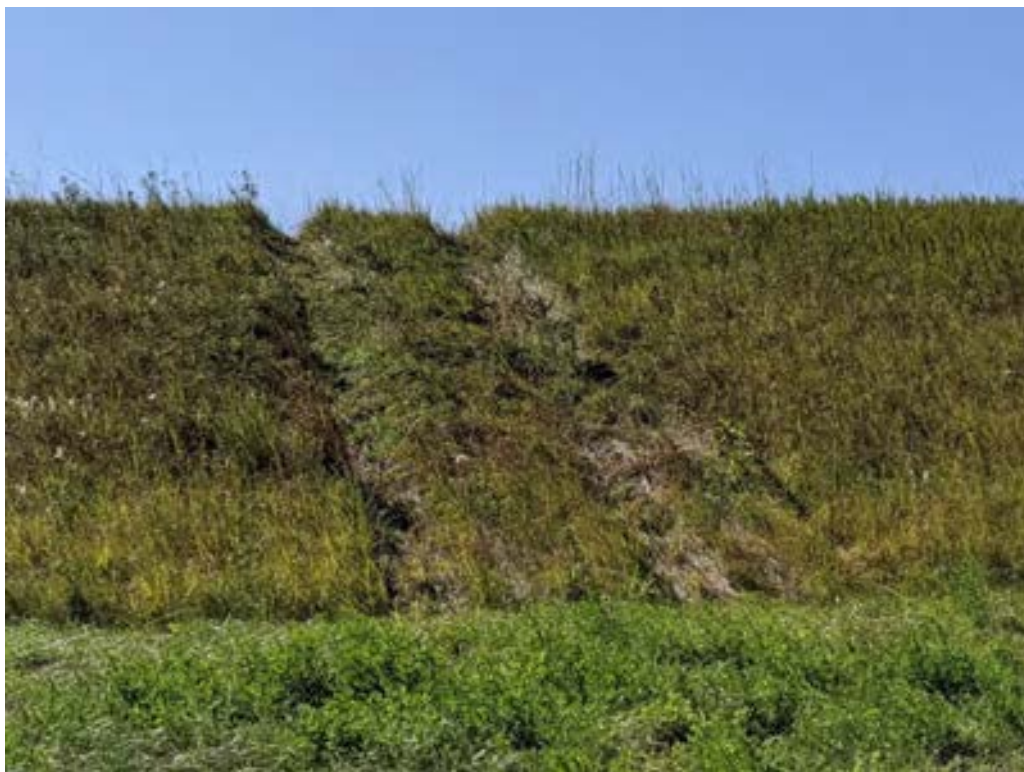
*Photo 33 Vehicle tracks and rutting on downstream face of embankment*

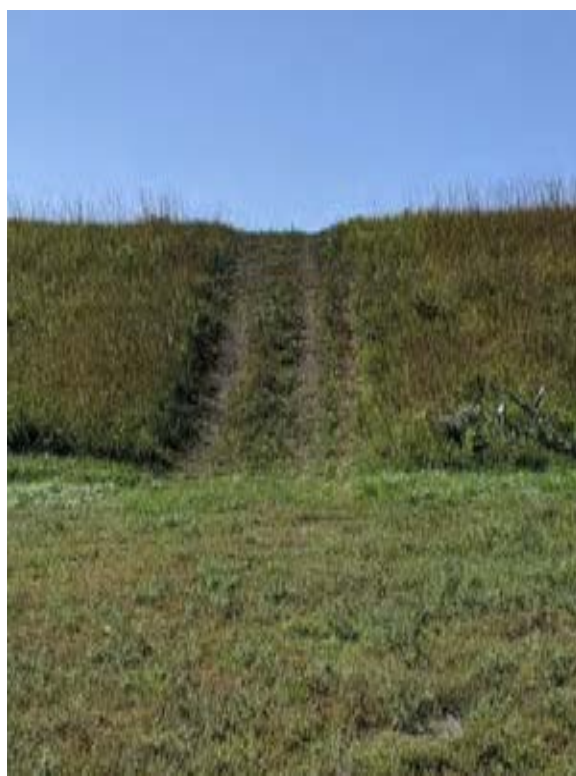
*Photo 34 Vehicle tracks and rutting on downstream face of embankment*

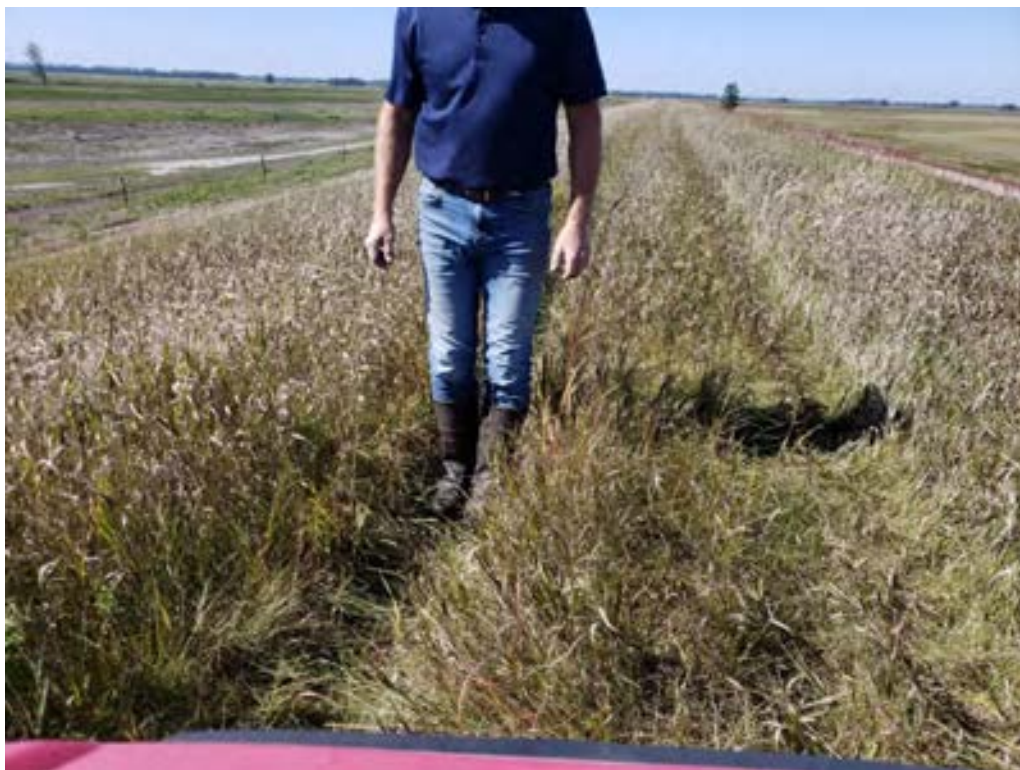
Vehicle rutting was identified along the crest of the embankment in a singular area (see photo 35). Rutting or other cavities on the crest of the dam can provide the potential for water collection during rain events. That water collection can provide potential seepage through the crest or surface erosion when overflowing. Ruts/potholes/cavities should be filled and graded to existing embankment.

*Photo 35 Vehicle rut on crest of dam*

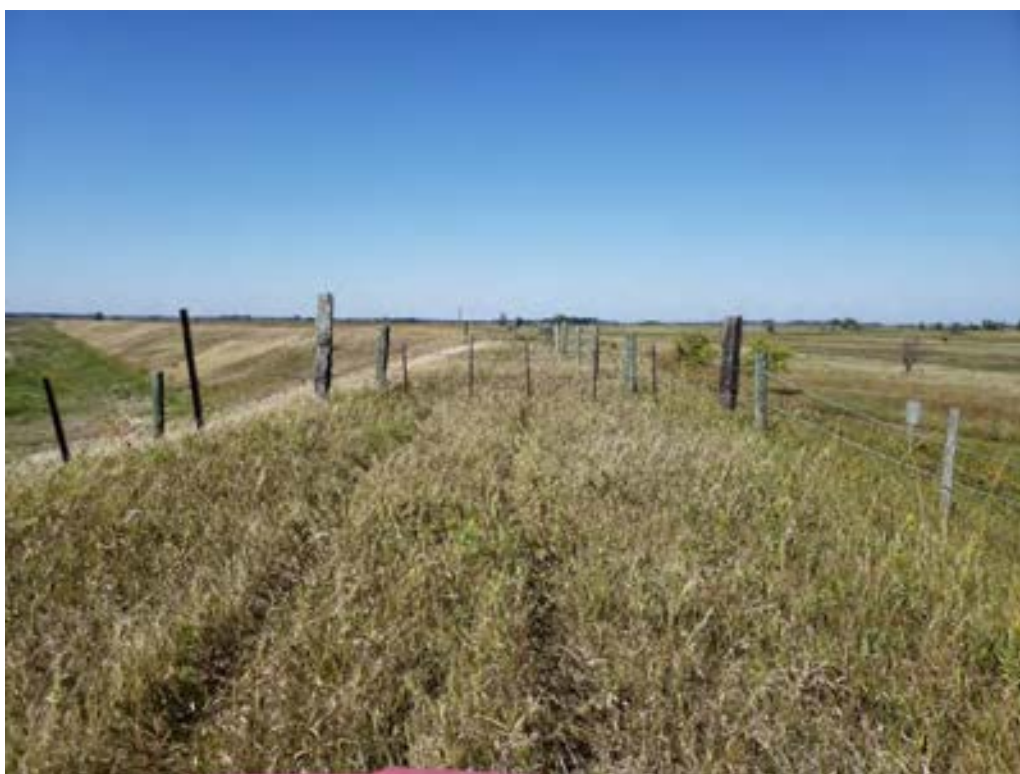
Given that the reservoir area is still used as pasture for livestock operations, there are locations of fencing across the embankment (see photos 36 and 39). Though these perform their

*Photo 36 Fencing across embankment*

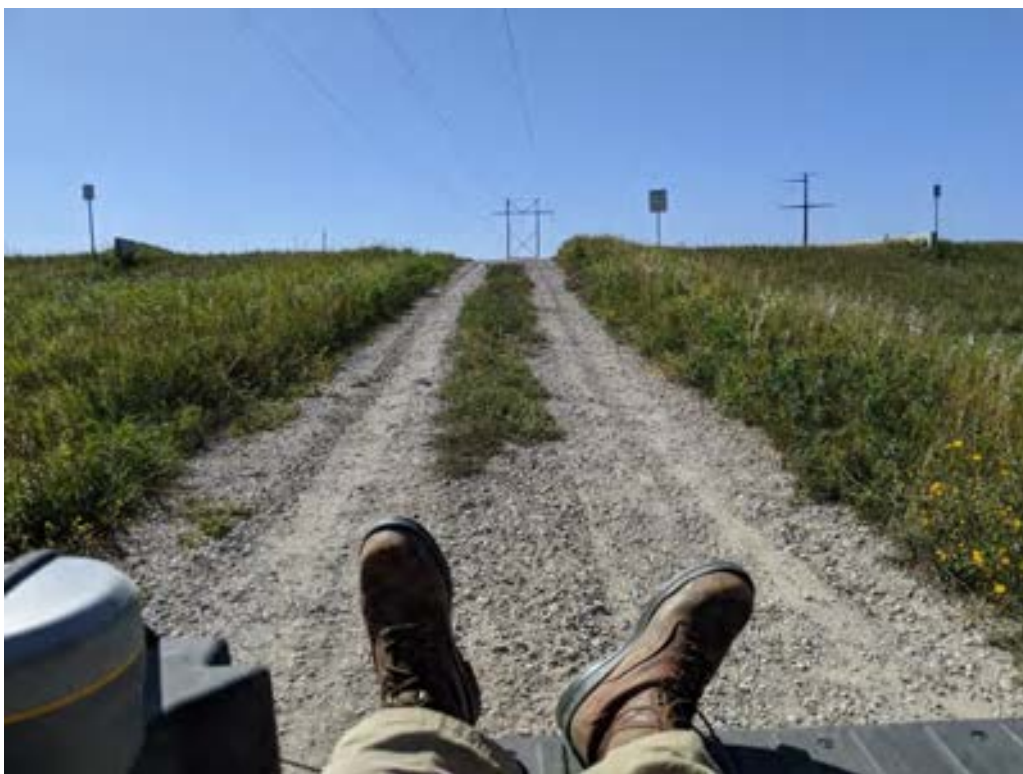
*Photo 38 Graveled vehicle access across embankment of dam*

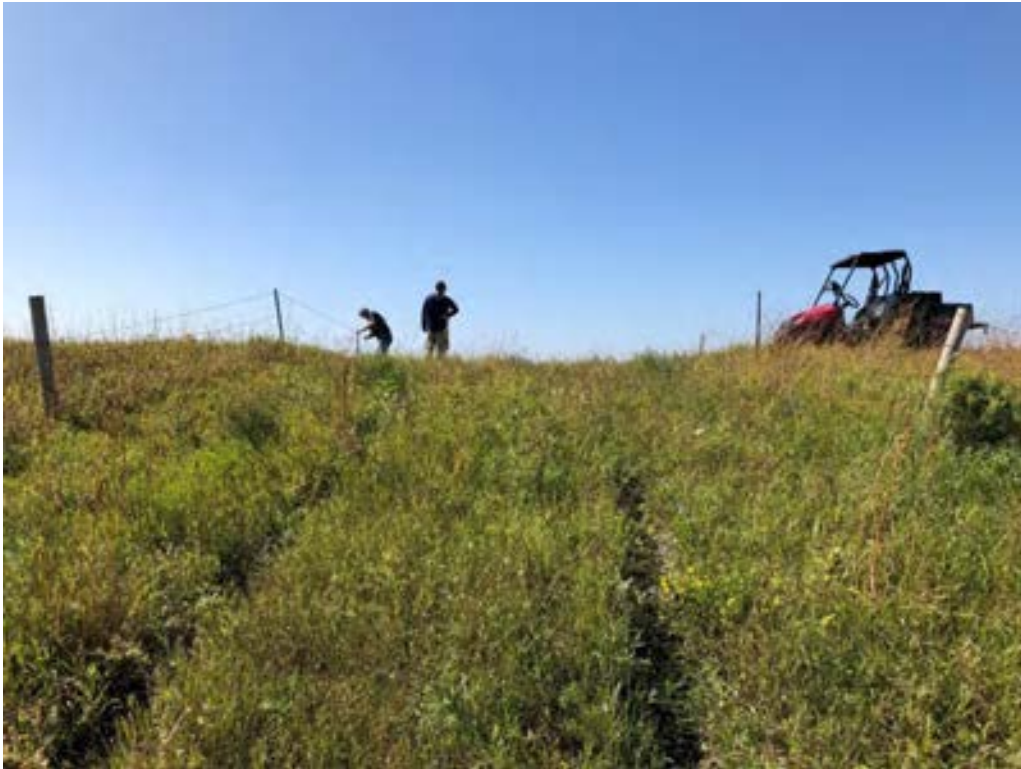
*Photo 39 Tracks and rutting on downstream face of embankment; fencing across embankment for cattle access*

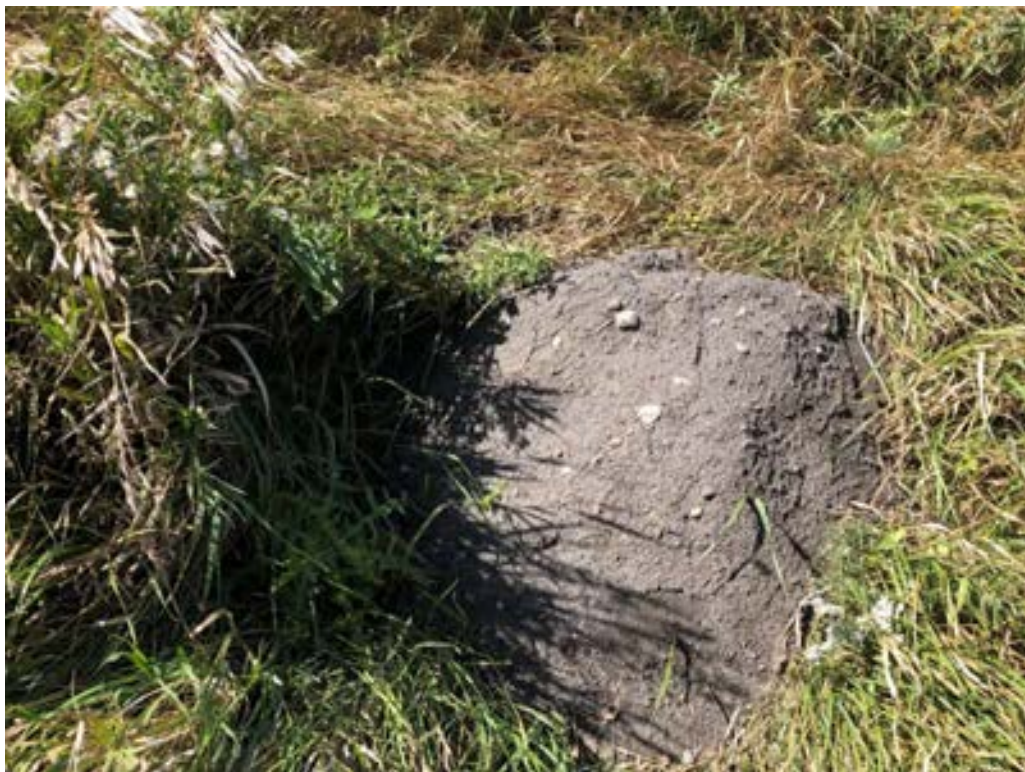
Animal burrows were also identified at points along the crest (see photo 42).

*Photo 42 Animal burrow on crest of dam*

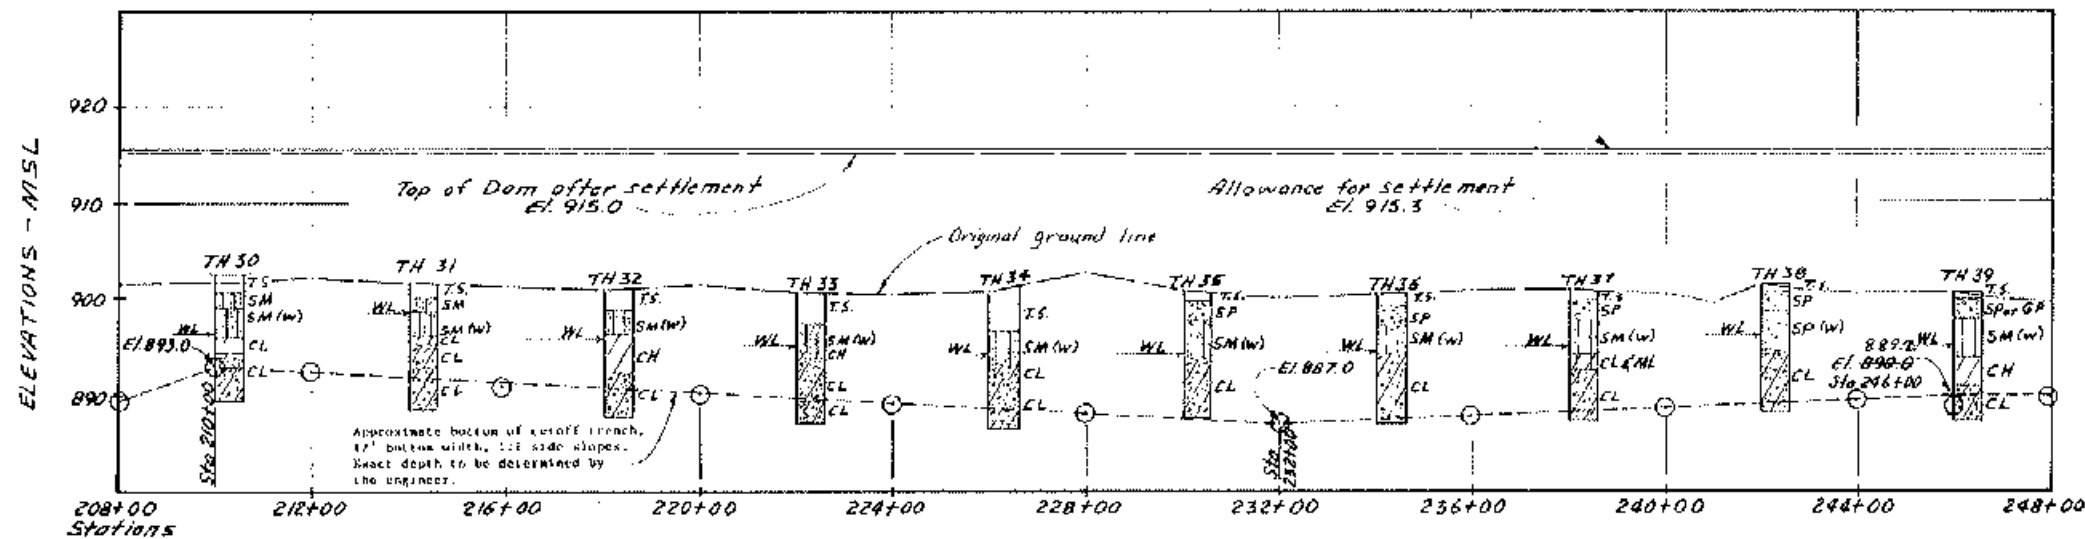
ENGLISH COULEE DAM PHASE I  
AS-BUILT GEOLOGY IN THE CORE TRENCH

| Job Diary Book No. | Report | Stations |
|---|---|---|
| 1 | 54 | 122+00 to 125+00 desiccation cracks |
| 2 | 77 | 131+00 to 139+00 minor desiccation cracks |
| 3 | 112 | 139+00 to 143+00 desiccation cracks in unweathered gray material approx. 1/2" wide at design bottom grade |
| | 126 | 150+00 to 153+00 minor desiccation cracks in the gray unweathered material |
| | 139 | 150+00 to 163+00 evidence of thin desiccation cracks, no gypsum visible, excavated 2.0' into the gray unweathered material |
| | 142 | 163+00 to 169+50 desiccation cracks 1/4" to 3/8" wide with gypsum crystals, design bottom approx. 2.3' into the gray unweathered material |
| 4 | 148 | 171+00 to 180+00 desiccation cracks 1/8" to 1/2" wide with gypsum along the sideslopes |
| | | 171+00 to 175+00 no desiccation cracks along the bottom |
| | | 175+00 to 180+00 desiccation cracks along the bottom, no gypsum visible, iron deposits 1/2" to 3" wide |
| | 150 | 180+00 to 183+00 desiccation cracks along the sideslopes (1/8" wide, along the bottom 1/2" to 2" wide with evidence of manganese and iron deposits) |
| | | 183+00 gypsum filled desiccation cracks 1/16" to 1/8" wide |
| 5 | 185 | 276+50 to 287+00 desiccation cracks along the bottom 3/8" to 1 1/2" wide, desiccation cracks along the sideslopes with gypsum deposits 1/8" to 1/4" wide, core excavated into gray unweathered material approx. 2.3' |
| | 188 | 292+50 to 287+00 desiccation cracks |
| | 191 | 278+00 to 273+00 desiccation cracks along the sideslopes 1/16" to 1/8" wide with isolated gypsum, core excavated into the gray unweathered material approx. 2.5' |

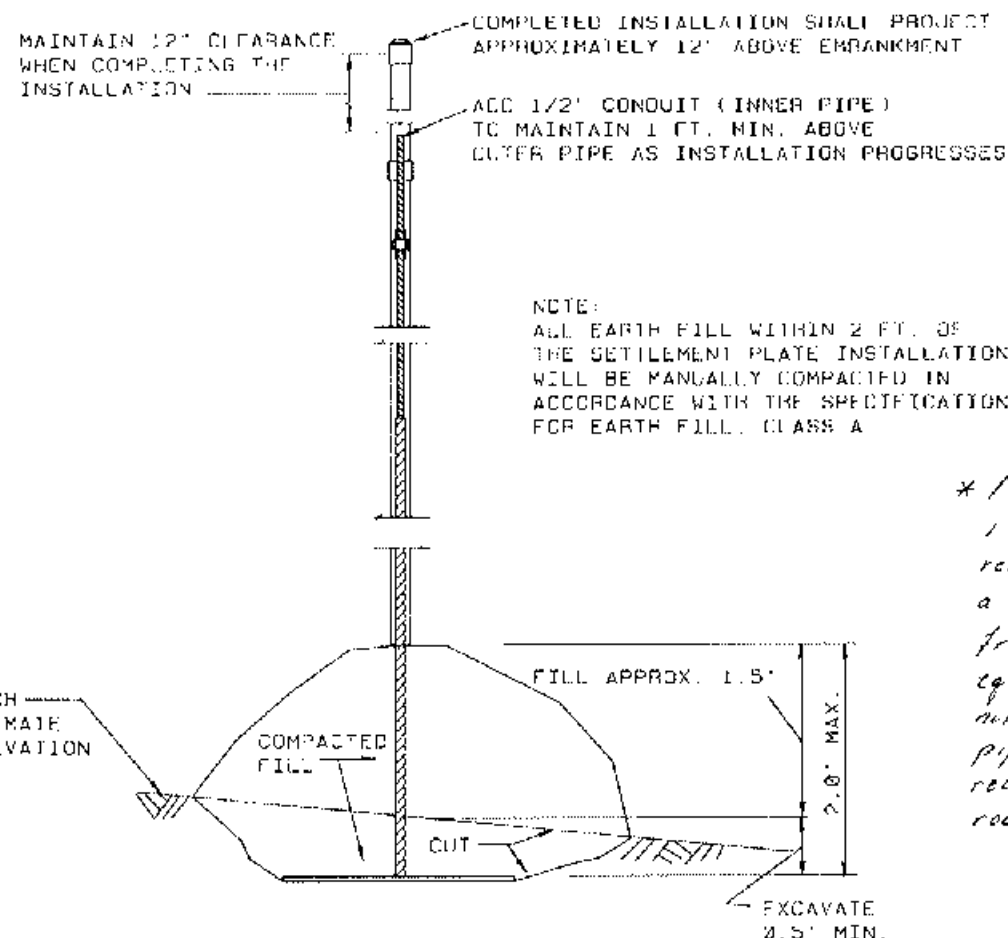
INSTALLATION DETAIL-SETTLEMENT PLATES

1 Settlement Plate at Sta. 278+00 remains intact. The pipe does have a slight bend, approx 4.5 feet down from the top, caused by heavy equipment operations. The bend will not hamper the sliding of the inner pipe. An elevation of 916.35 was recorded, on 8-24-90, atop the 5/8" rod.

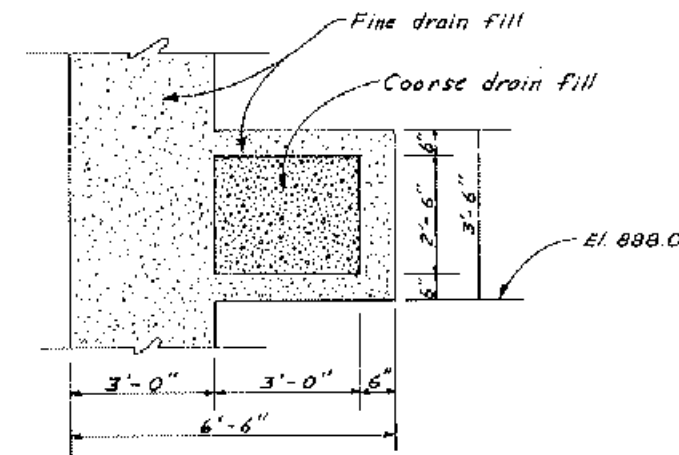
TRANSVERSE COLLECTOR  
SECTION C - C

This quantity reflects the contract paid item only.  
Actual quantity was considerably more due to  
modified change of seepage diaphragm at Contractor's  
expense, due to ease of construction.

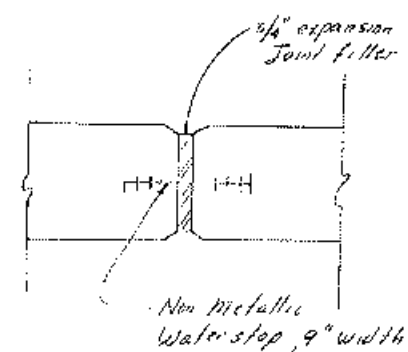
DETAIL OF JOINTS

Note: All rebar, affected by the 9" waterstop width, had to be field adjusted to clear waterstop during placement. Bars normally were to be spaced @ 3" from a joint. Bars were spaced between 5 and 6 inches. This note pertains to Chute Spillway & Principal Spillway.

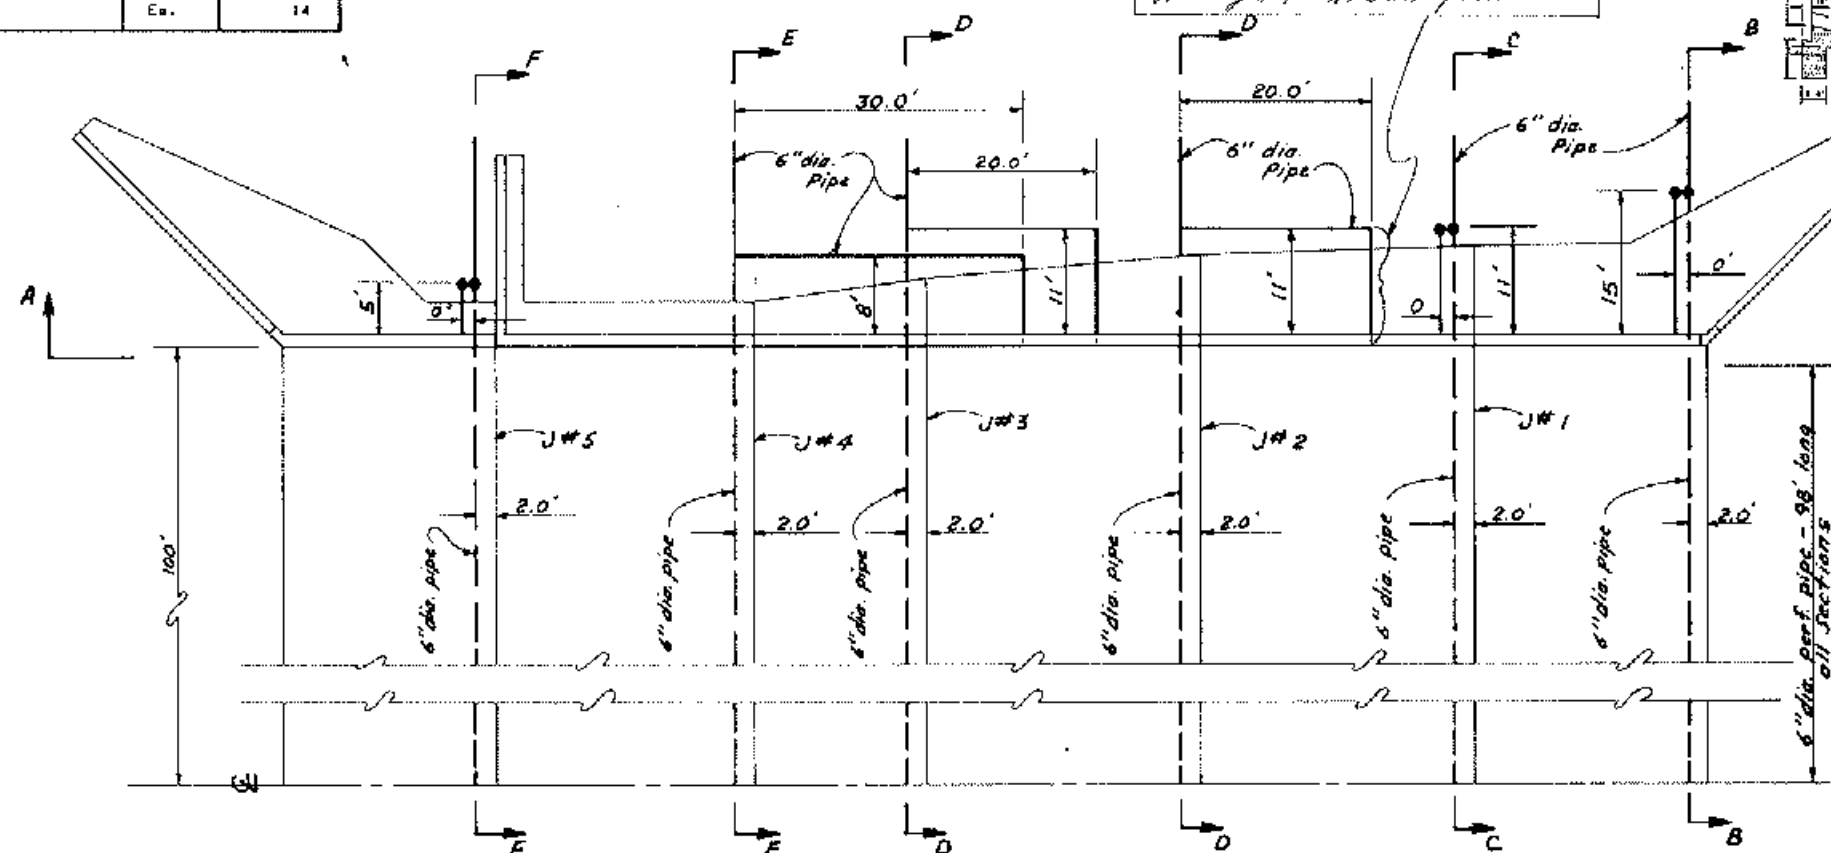
HALF PLAN VIEW - TRANSVERSE COLLECTORS  
(FLOOR BLOCKS NOT SHOWN)

These sidewall drains left and right of chute spillway sidewalls were not installed by the Contractor. To rectify the outlet drain problem @ J-2, another 20' length of 6" N.P. pipe was added on to the planned 20' length and installed to outlet into the rock rip rap @ elev. 991.0.

This section of pipe was deleted due to construction error of not installing drain outlet in chute sidewalls. Left Right. Note view right for As built plan.

Install 6" dia. flap gate on this outlet. All other drain outlets to have animal guards.
