# Upper Turtle River Watershed Dam #9, Larimore Dam

*Appendix D-1: Existing Conditions  
Assessment Report (DRAFT)*

**Grand Forks County Water Resource  
District  
USDA - NRCS**

February 19, 2026

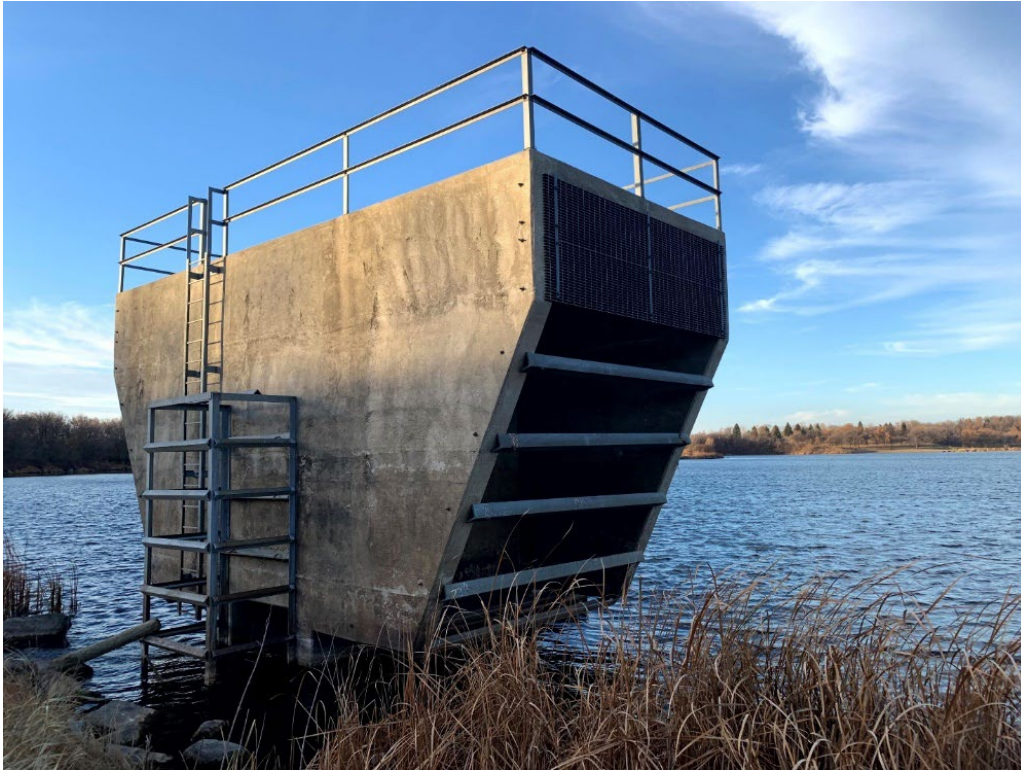
**Photo 1: Principal spillway inlet, looking southwest (note water level, above crest of weir).**

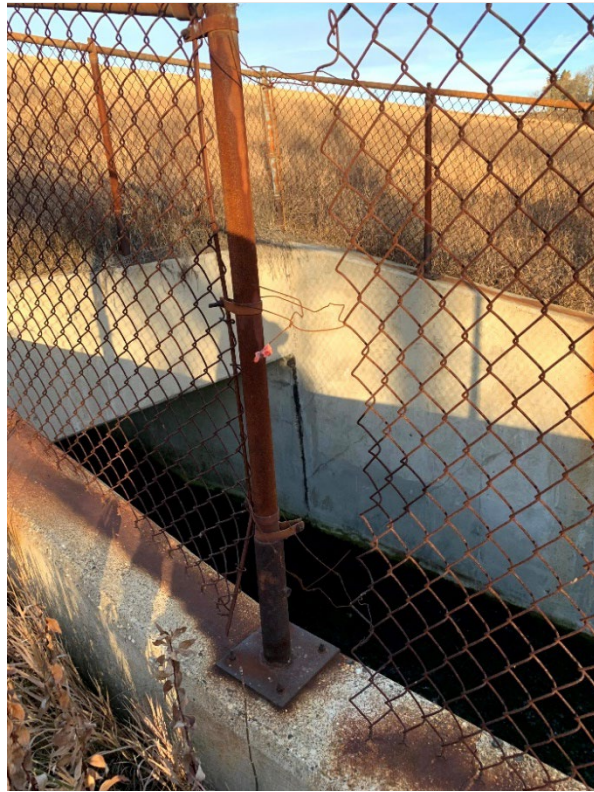
**Photo 3: Gap in chain link fence of principal spillway outlet.**

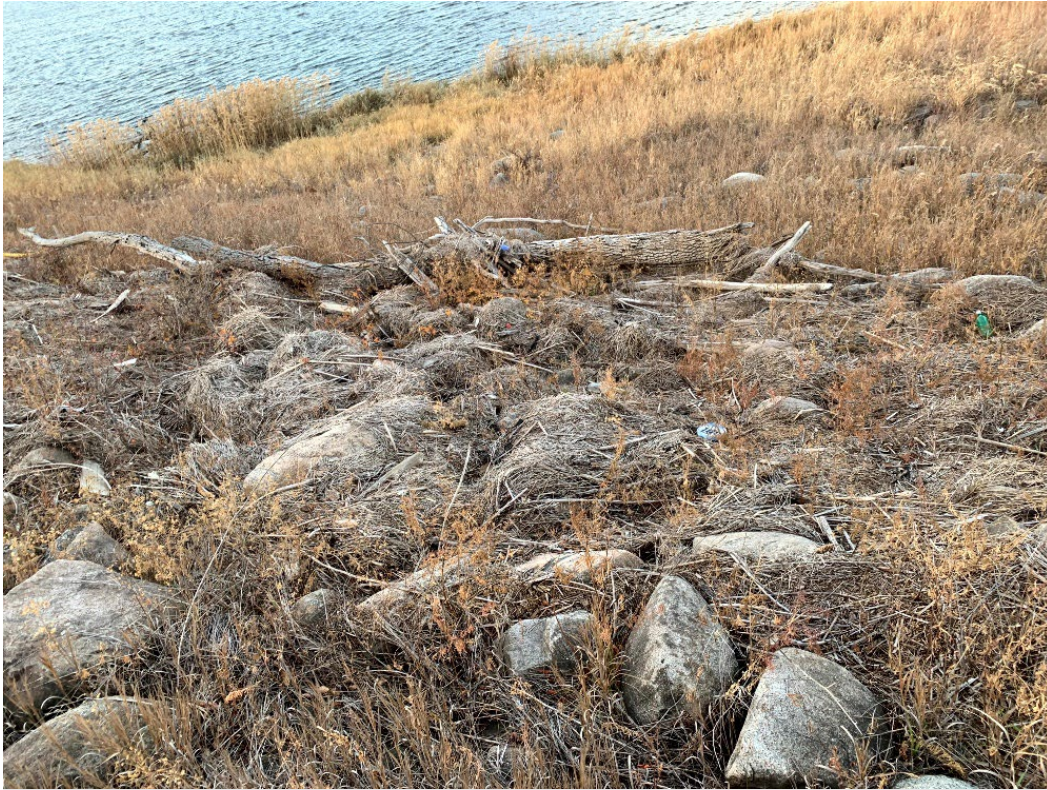
**Photo 11: Debris on upstream slope.**

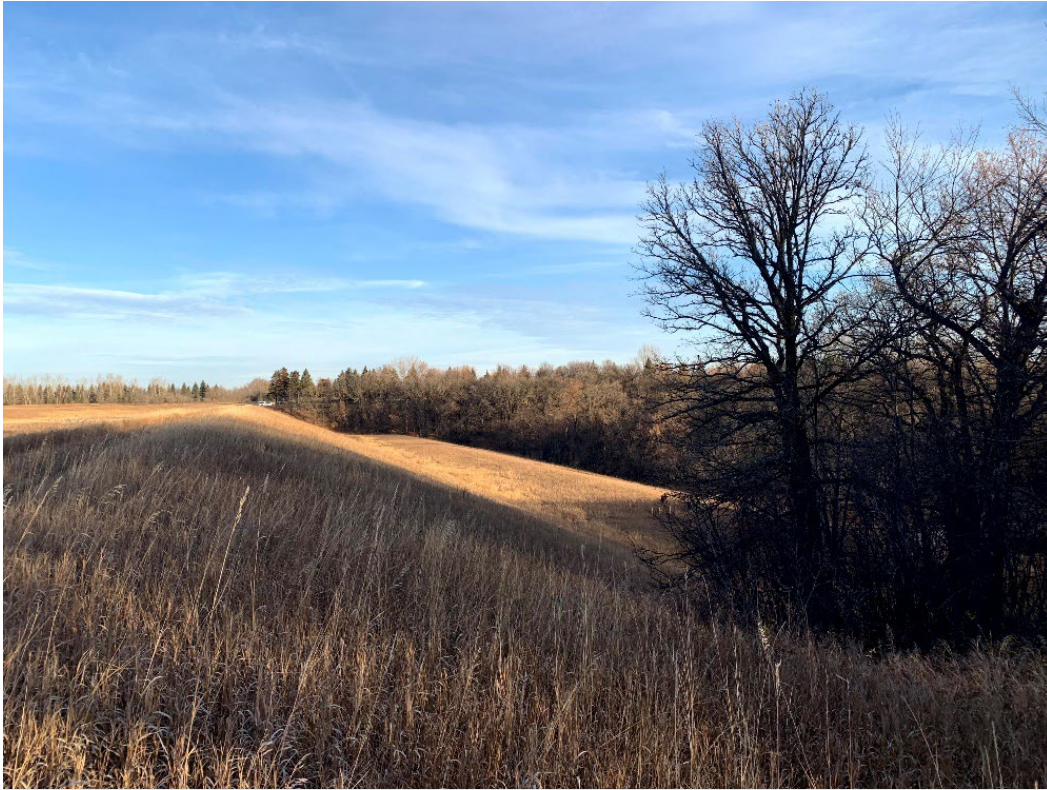
**Photo 13: Downstream slope with trees in right abutment, looking north.**

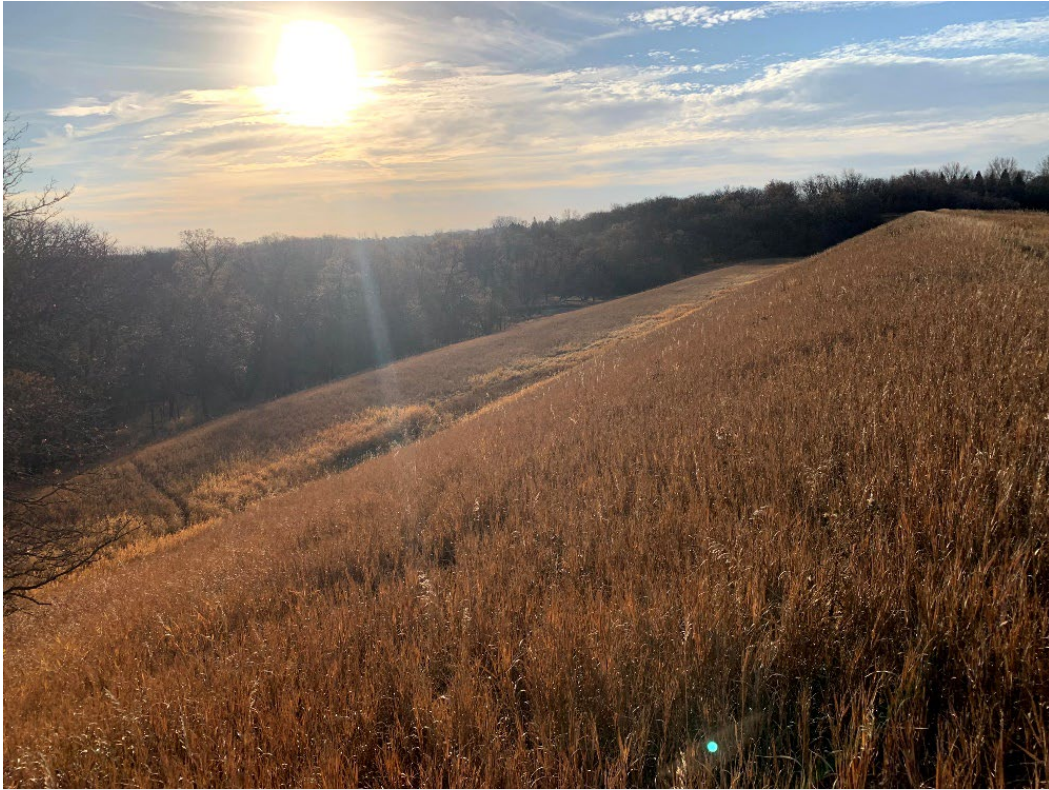
**Photo 14: Downstream slope, looking south.**

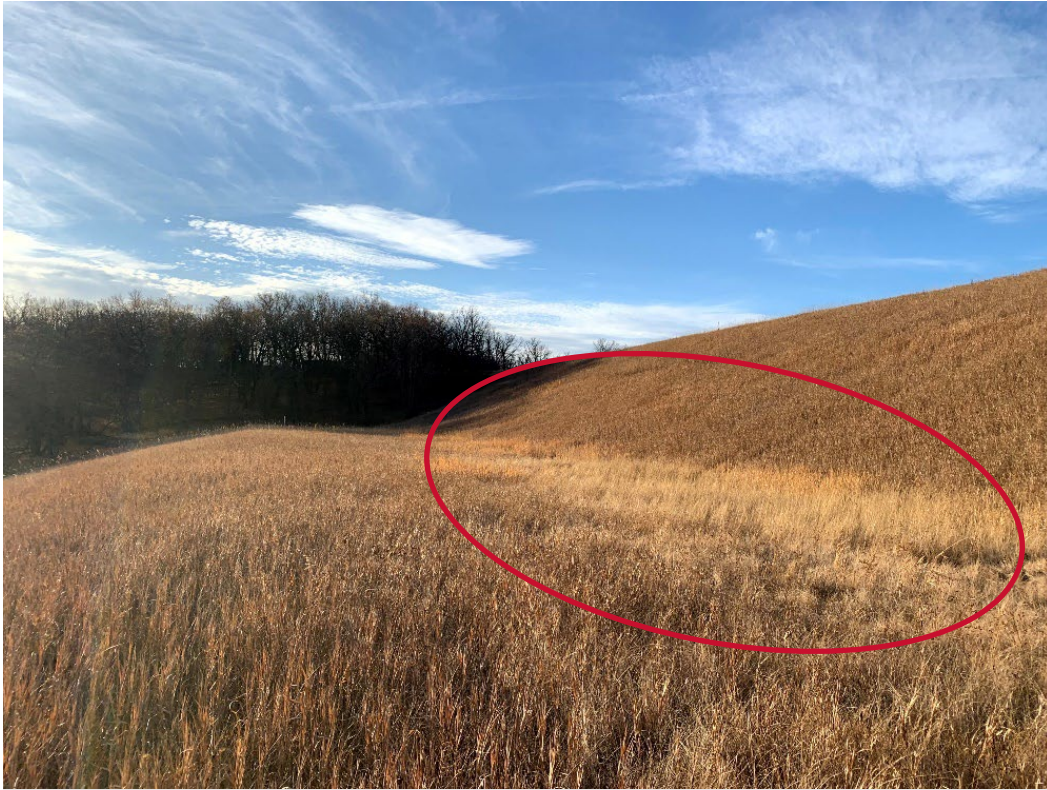
**Photo 15: Wetland vegetation on downstream berm, looking south.**

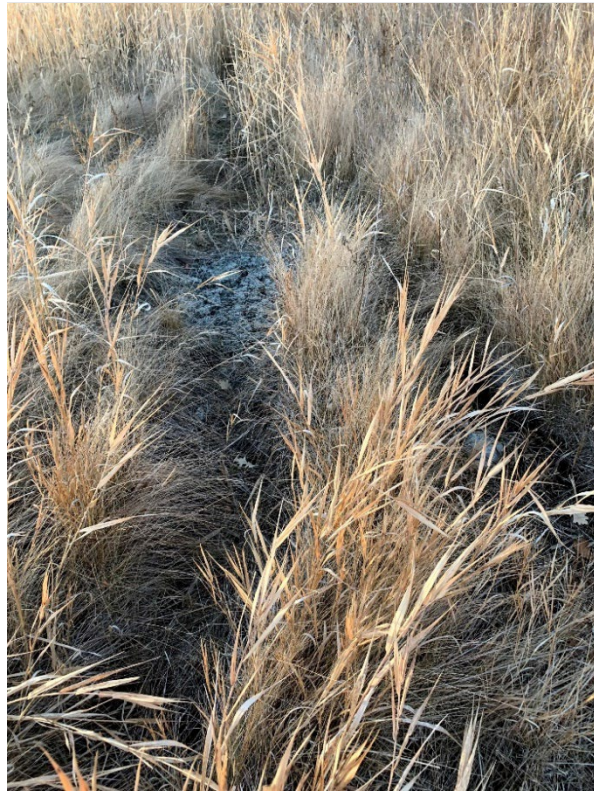
**Photo 16: Rutting on downstream berm.**

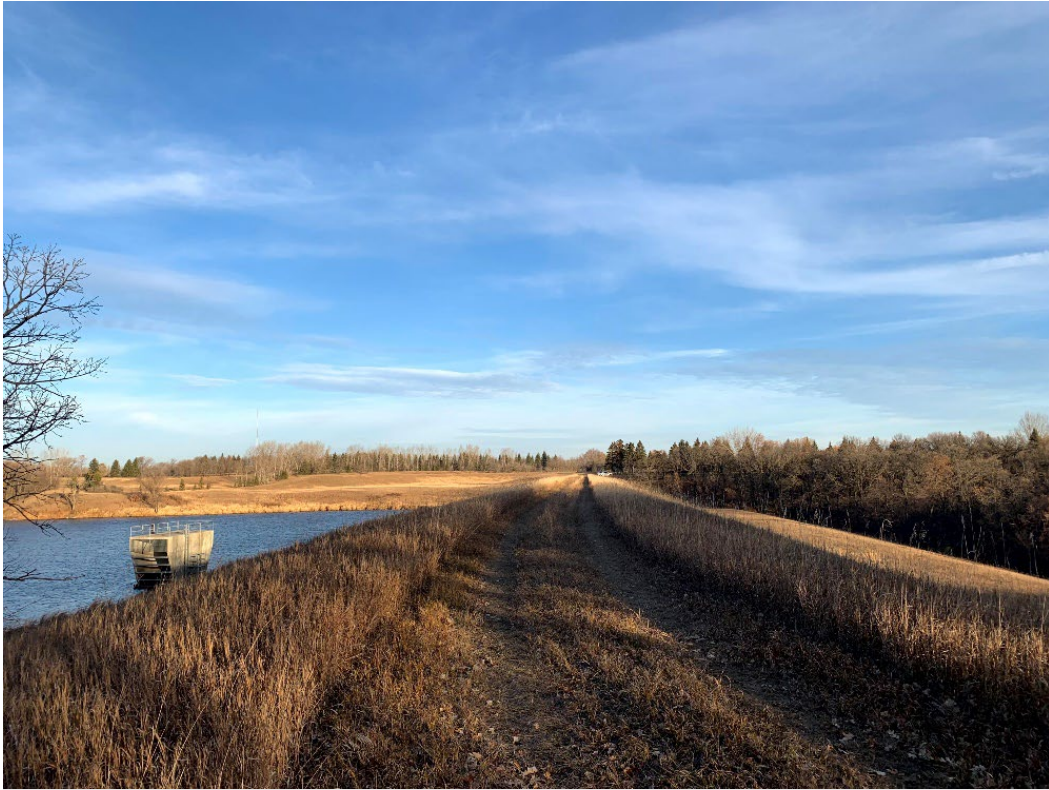
**Photo 17: Crest of dam, looking north.**

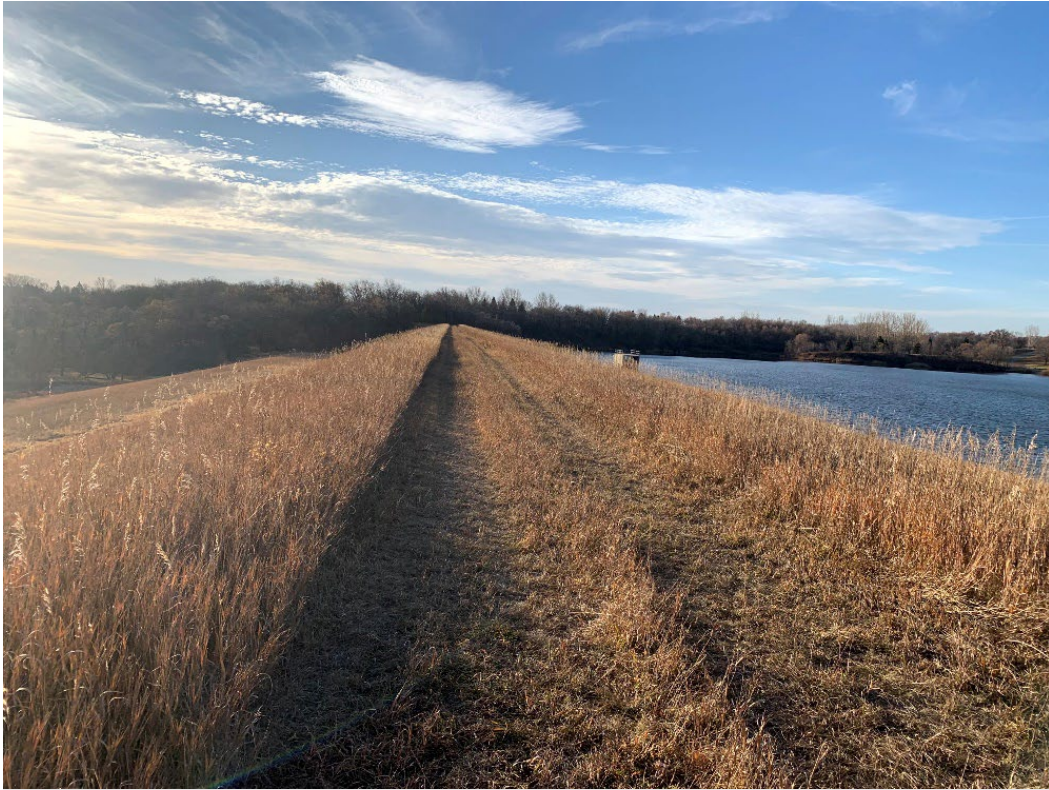
**Photo 18: Crest of dam, looking south.**

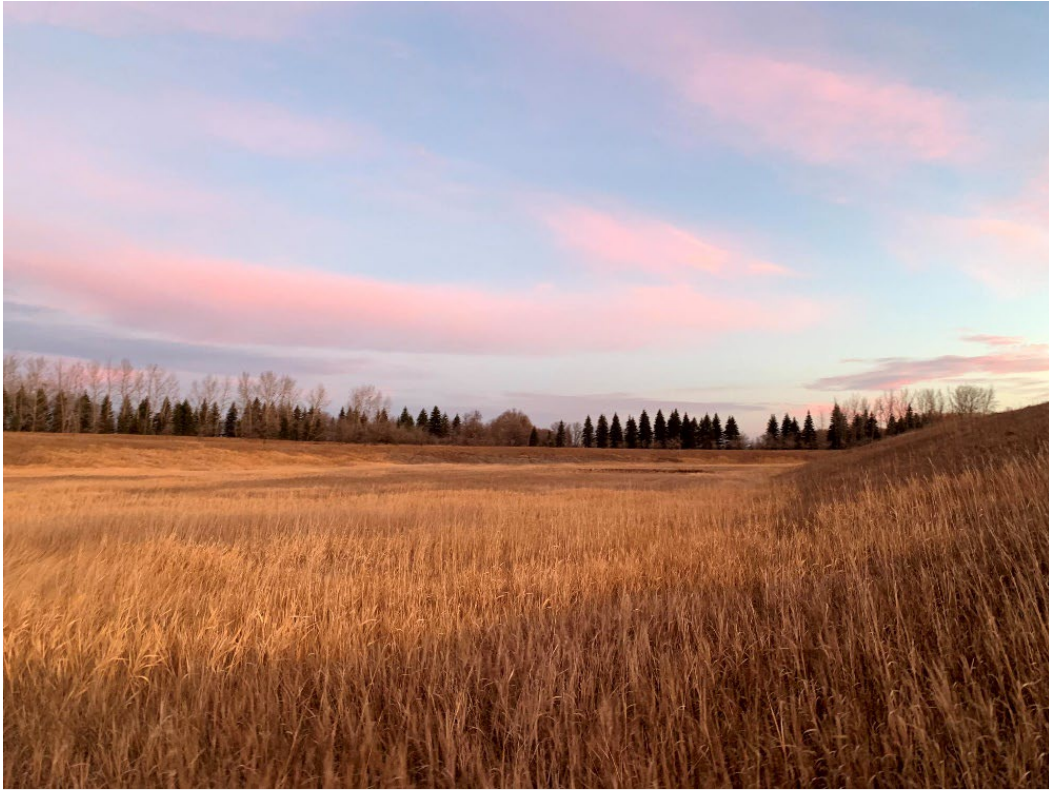
**Photo 19: Auxiliary spillway, looking north.**

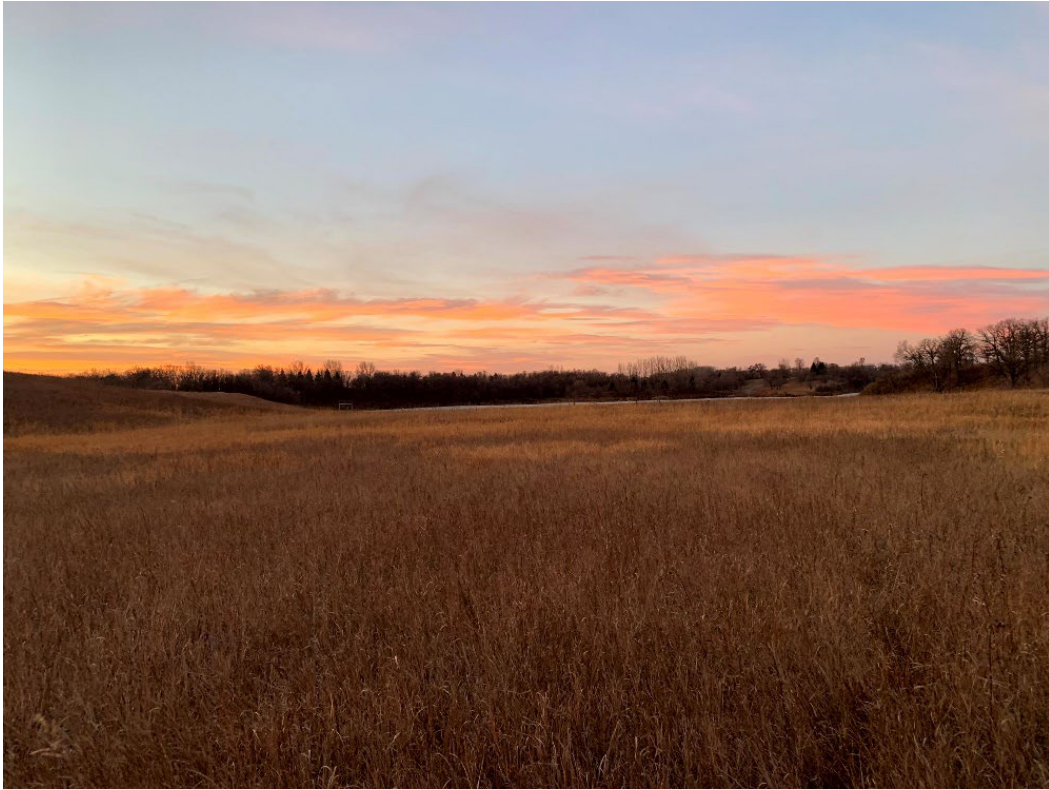
**Photo 20: Auxiliary spillway, looking south towards inlet.**

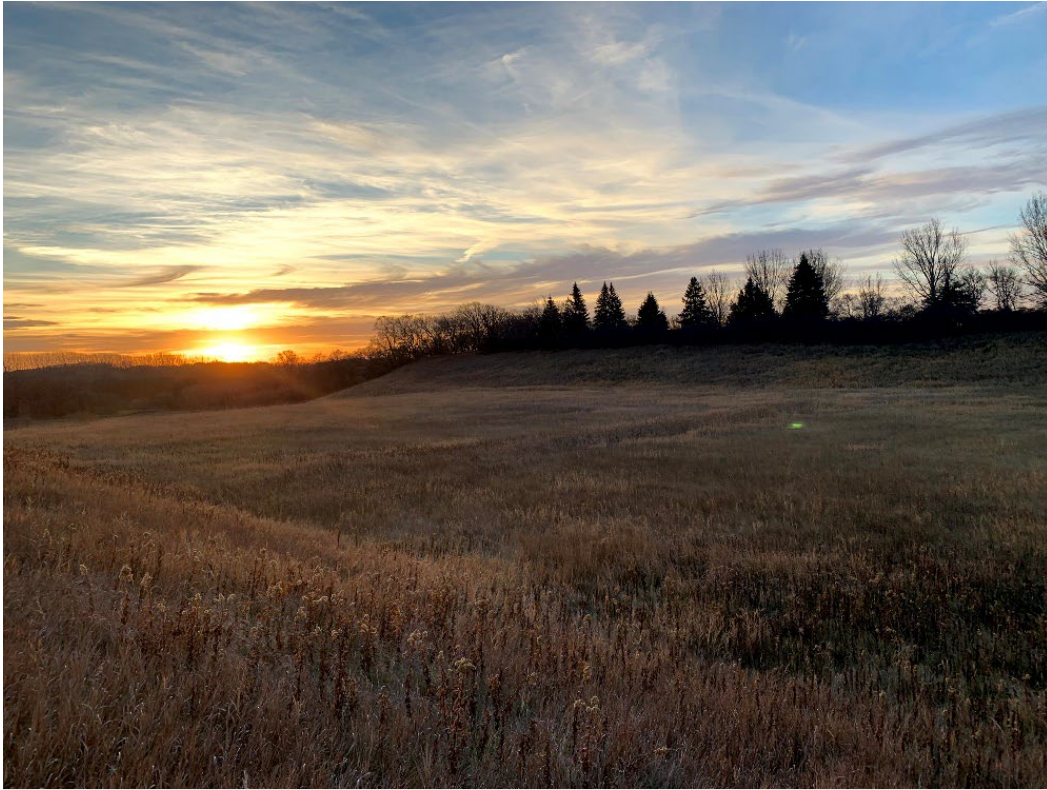
**Photo 21: Auxiliary spillway, looking southeast.**

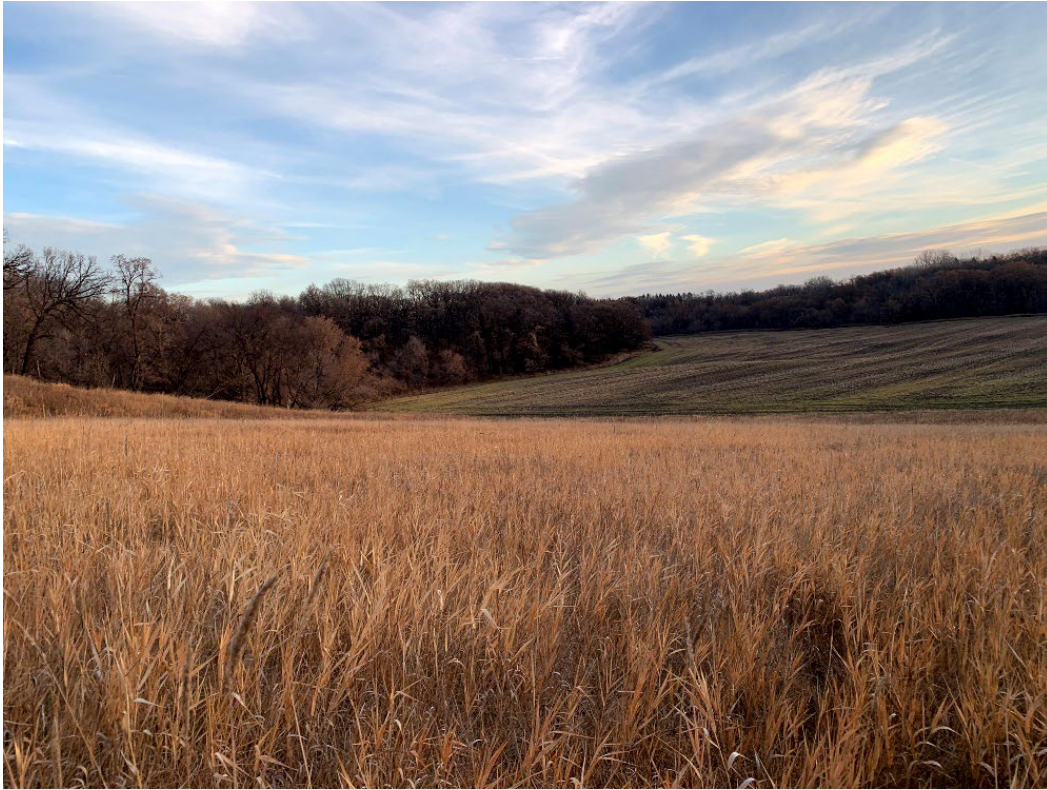
**Photo 22: Exit section of auxiliary spillway, looking east.**

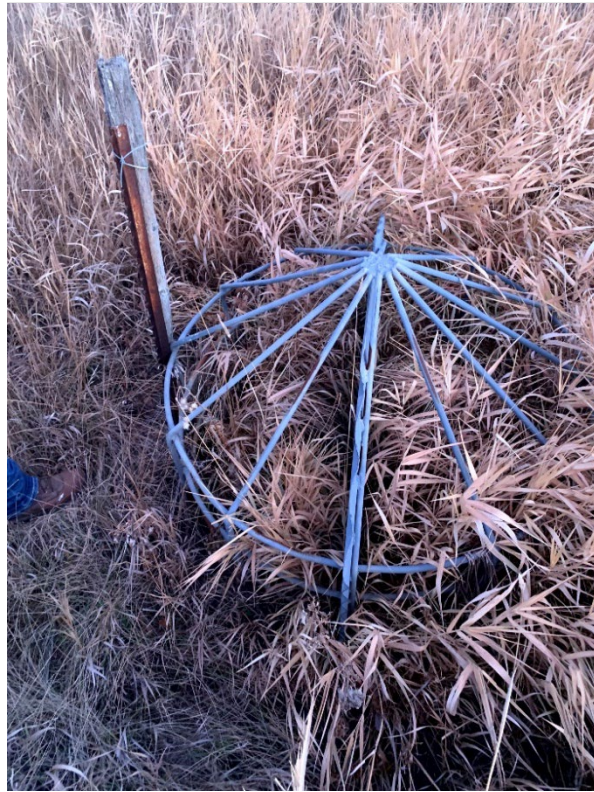
**Photo 23: Structure in inlet section of auxiliary spillway.**

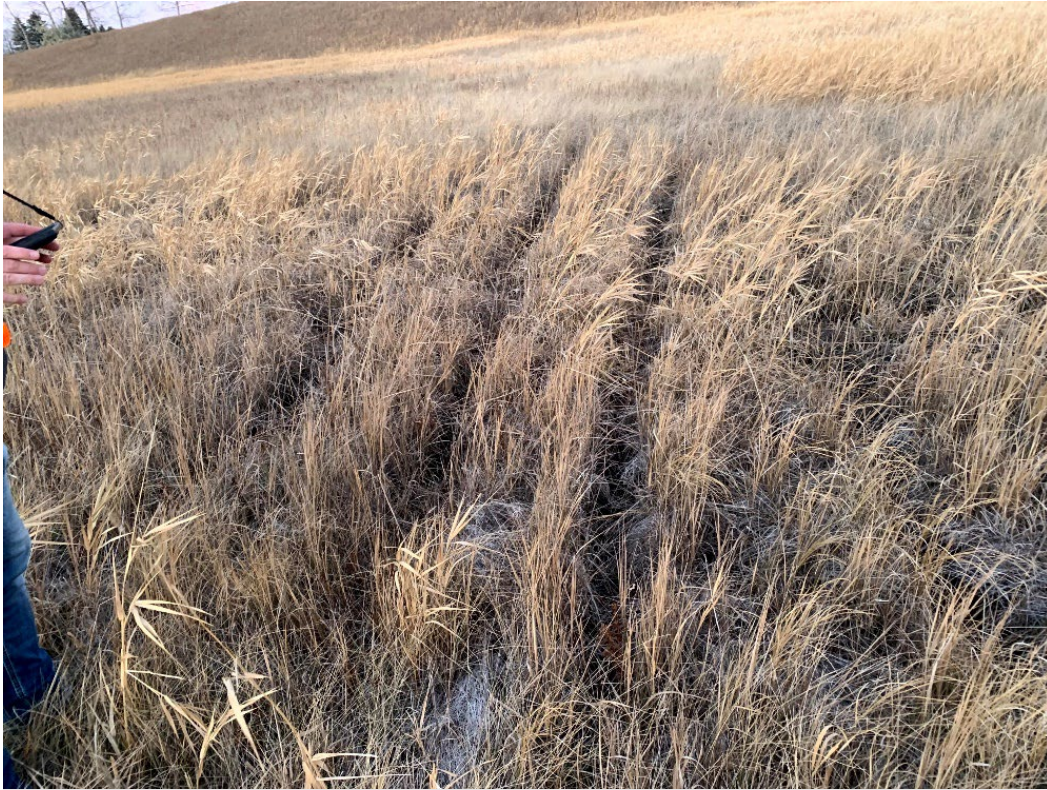
**Photo 24: Rutting from ATVs, auxiliary spillway.**

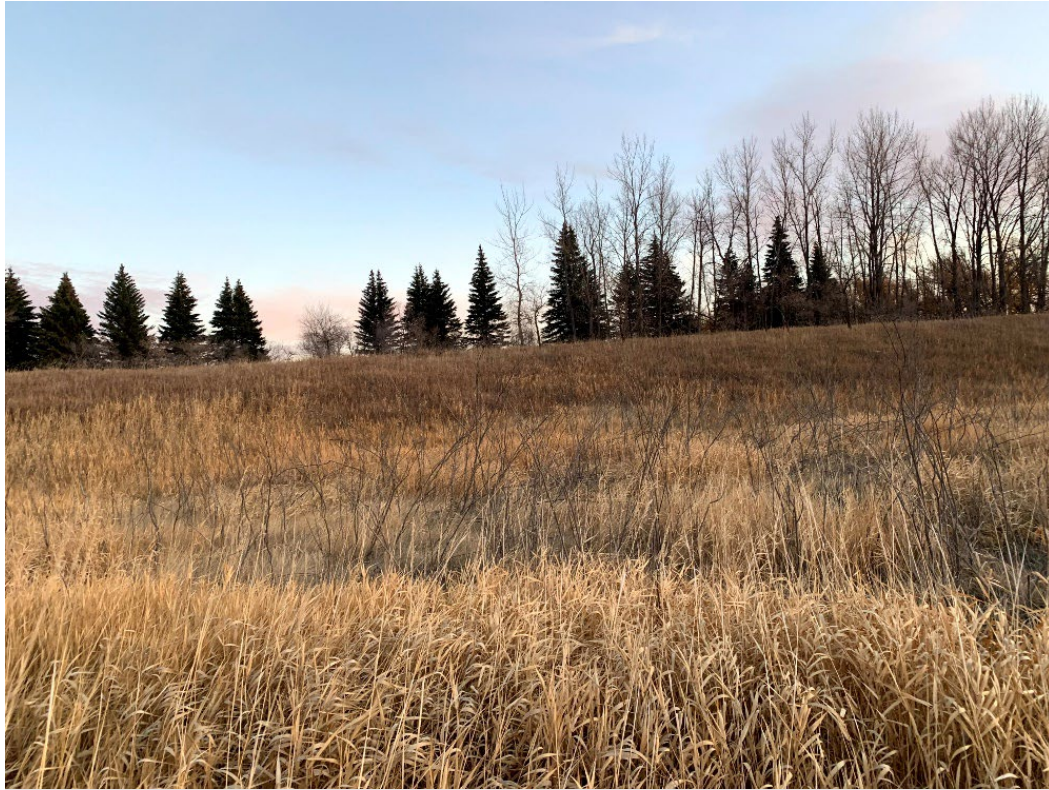
**Photo 25: Woody vegetation, auxiliary spillway.**

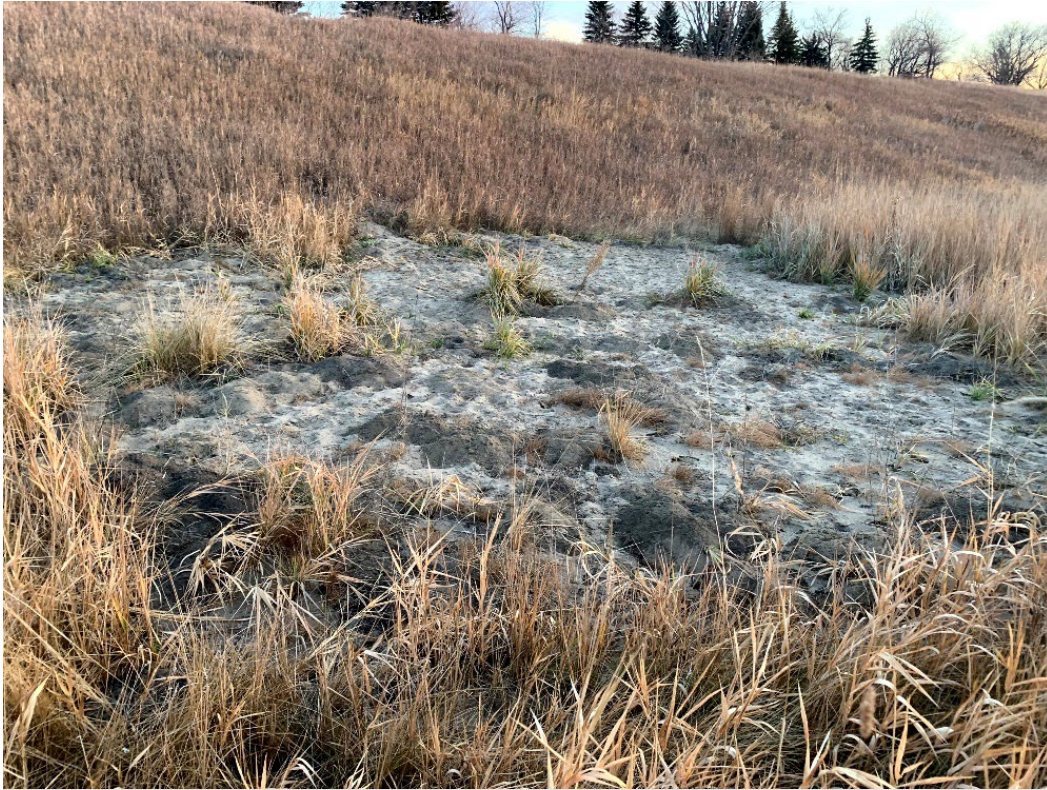
**Photo 26: Gopher mounds, auxiliary spillway.**

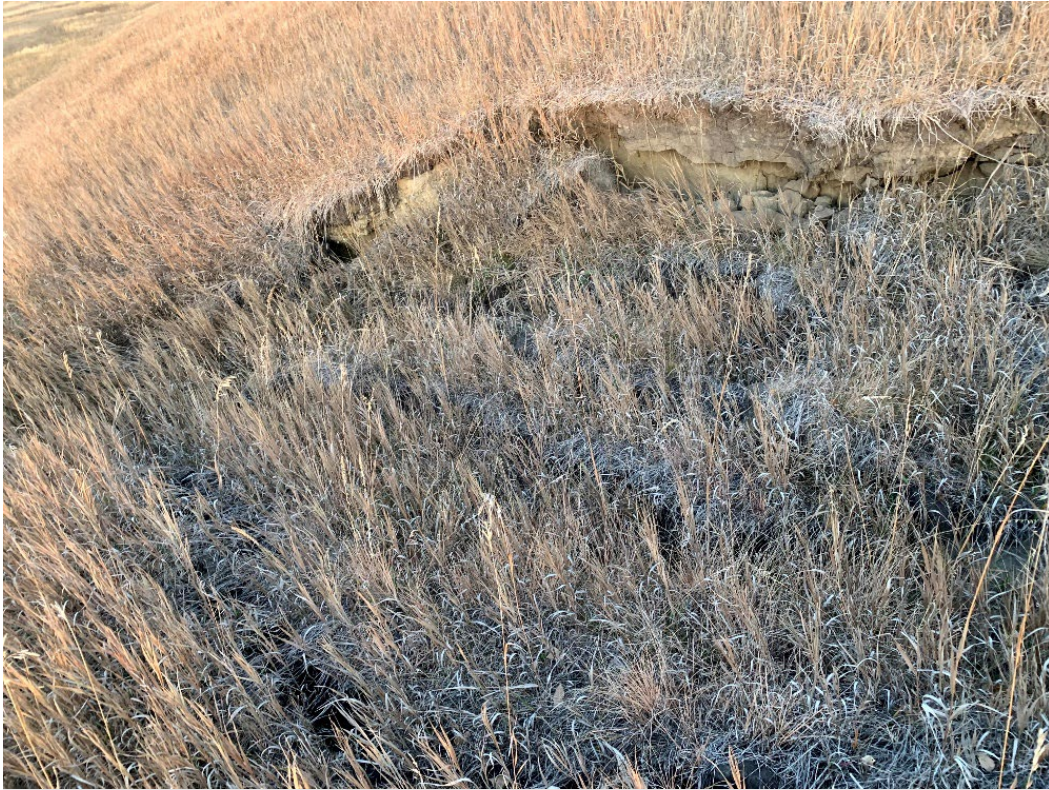
**Photo 27: Erosion/slough in left side slope of auxiliary spillway.**

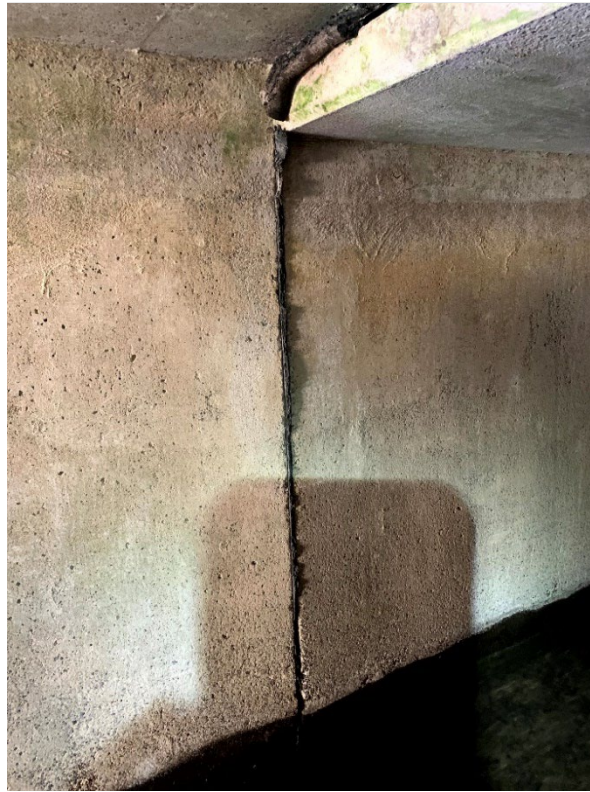
**Photo 30: Joint filler, Joint #3.**

| Date Inspected | Reservoir Elevation | Joint Number | Top Joint Gap | Bottom Joint Gap | Comments |
|---|---|---|---|---|---|
| 11/2/2022 | | 3 | | | Start of straight section, seal in good condition |

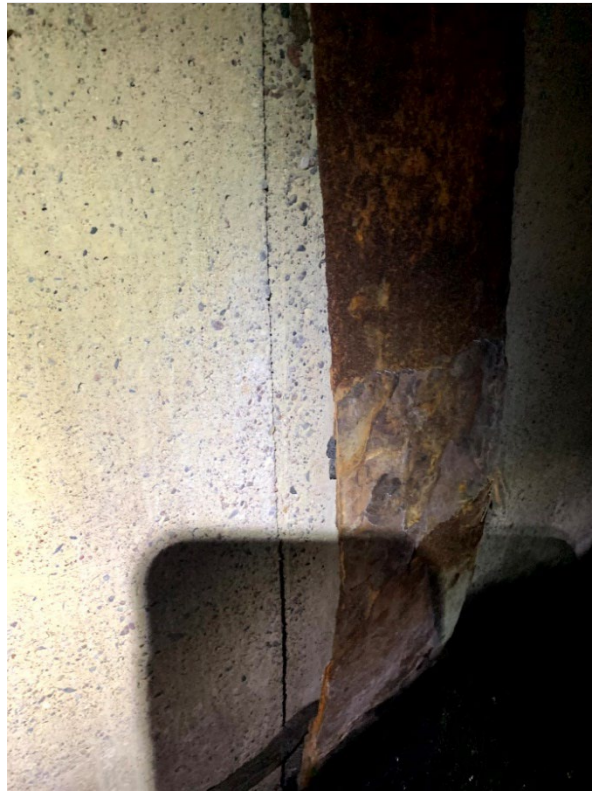
**Photo 35: Separated steel plate, Joint #8.**

| Date Inspected | Reservoir Elevation | Joint Number | Top Joint Gap | Bottom Joint Gap | Comments |
|---|---|---|---|---|---|
| 11/2/2022 | | 8 | | | Steel joint corrosion, plate on left side is separated near the bottom |
