### Public Information Meeting

*Review of Rehabilitation Alternatives*

*Middle Creek Watershed*

PA-637 (Walker Lake Dam)

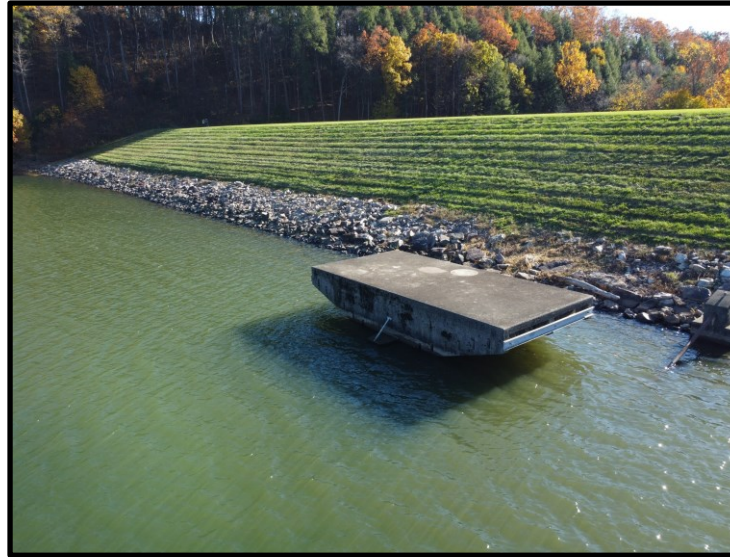
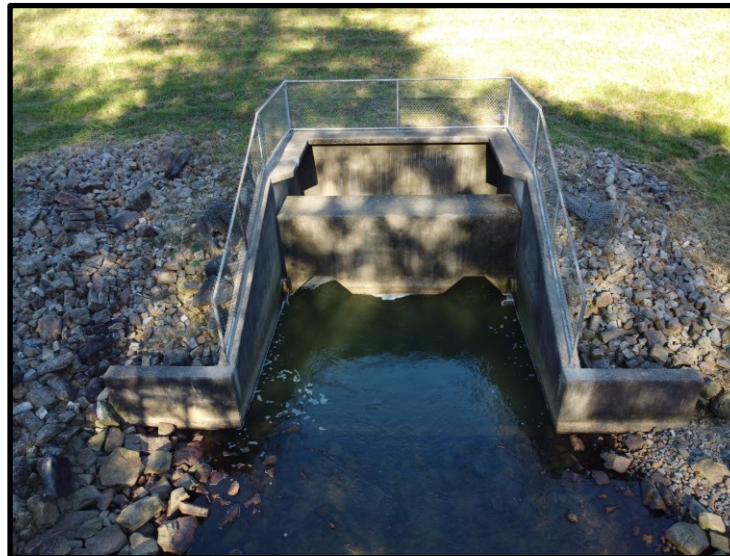
## Principal Spillway (PSW) Infrastructure

- Concrete Riser Structure with Trash Rack
- Reinforced Concrete Pipe (i.e., outlet pipe)
- Concrete Impact Basin

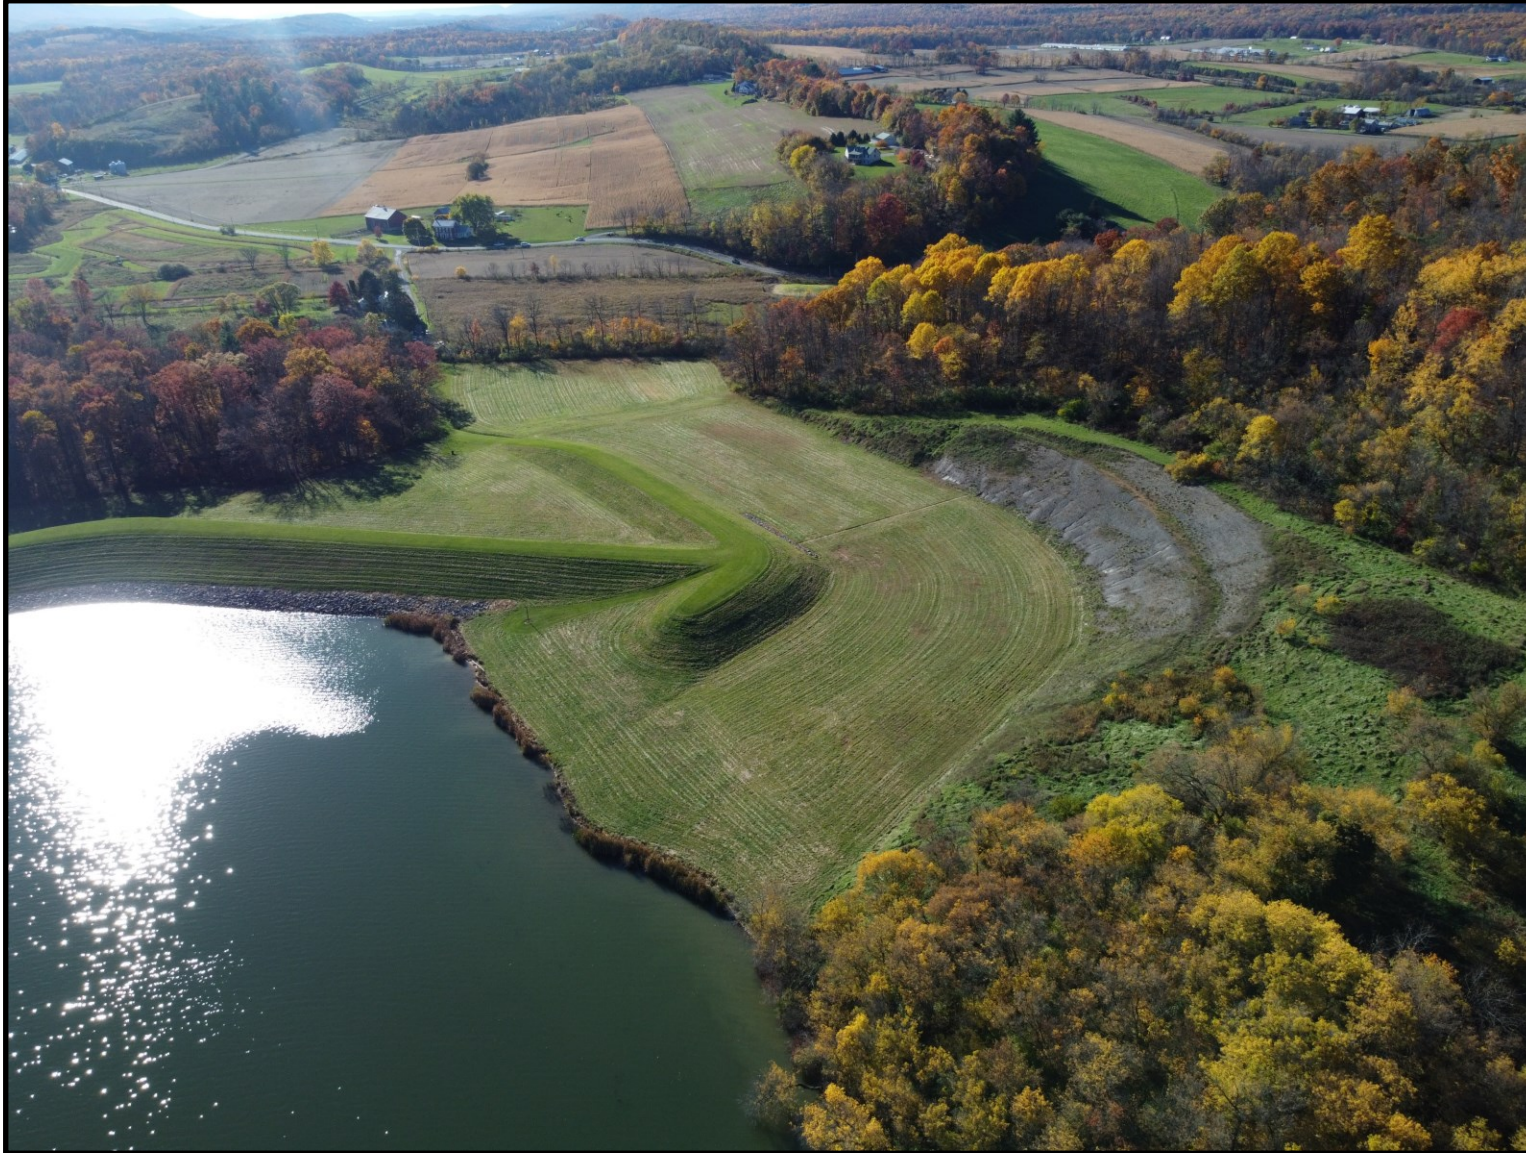
## Auxiliary Spillway (ASW)

- Founded on shale
- Vegetated with concrete sill or ridge
- 170 feet in width
- 12.5 feet in height
- 680 feet in length

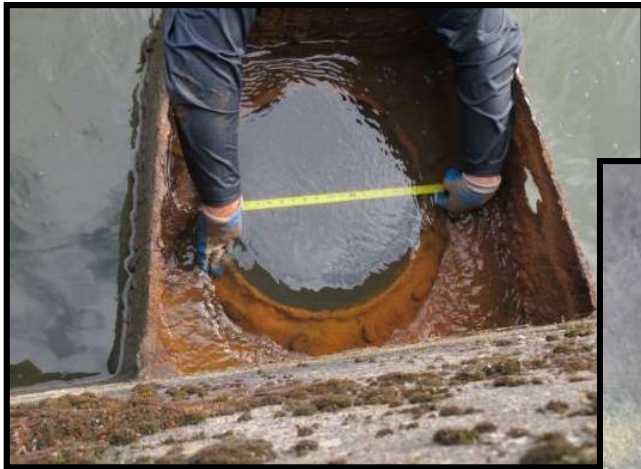
Cold Water Release

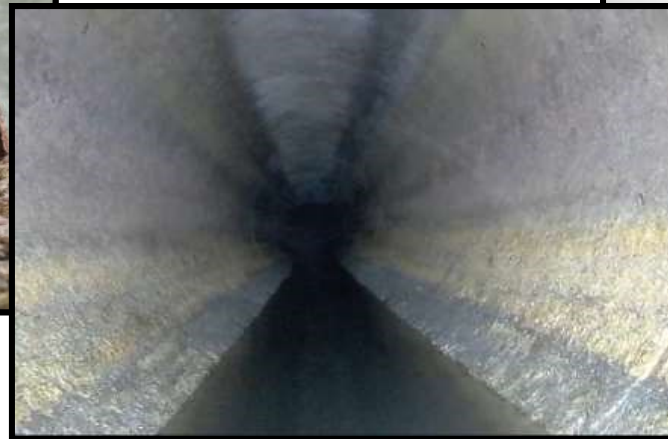
48" Conduit Pipe

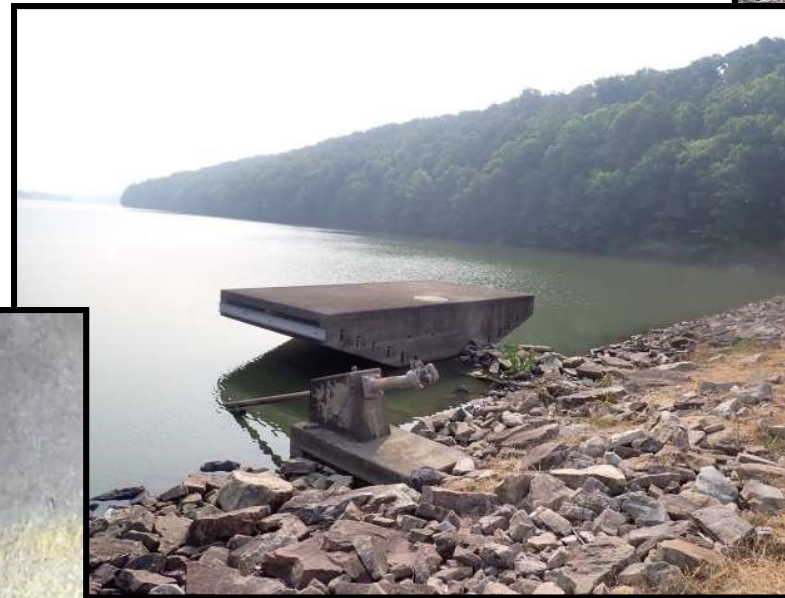
PSW Riser & Pond Drain

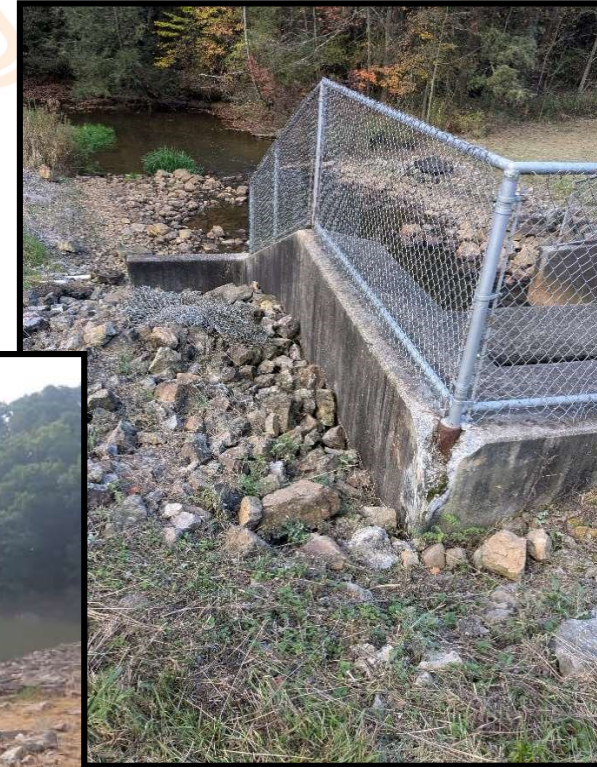
Impact Basin

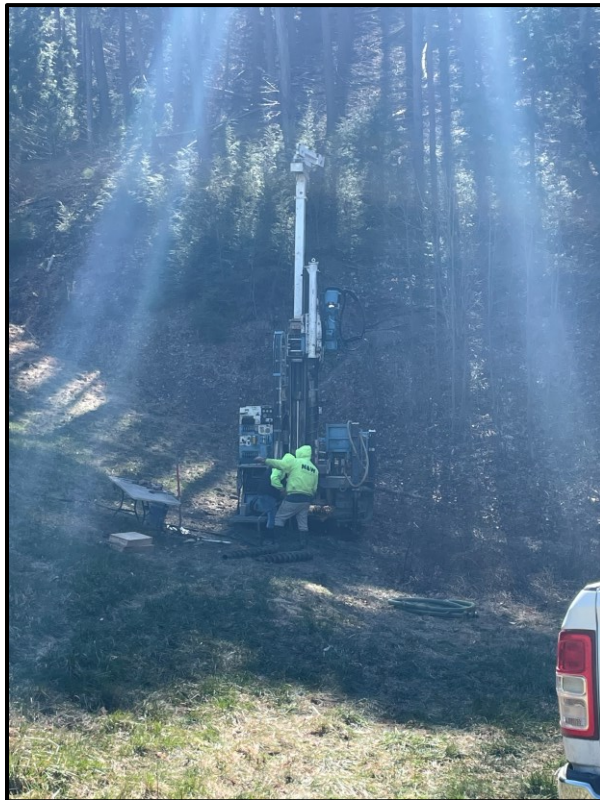
## Geotechnical Investigation

- 10 borings completed

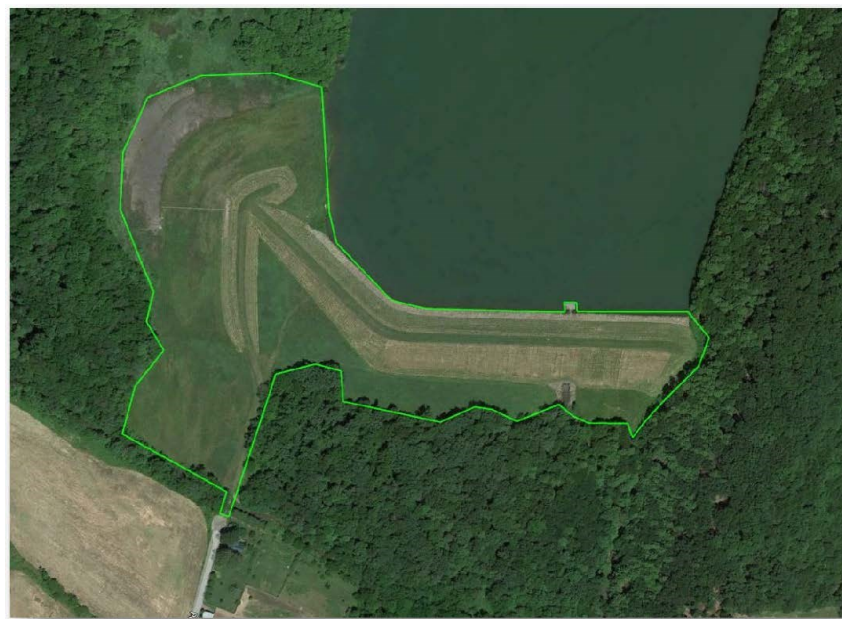
Figure 1. Topographic Survey Limits

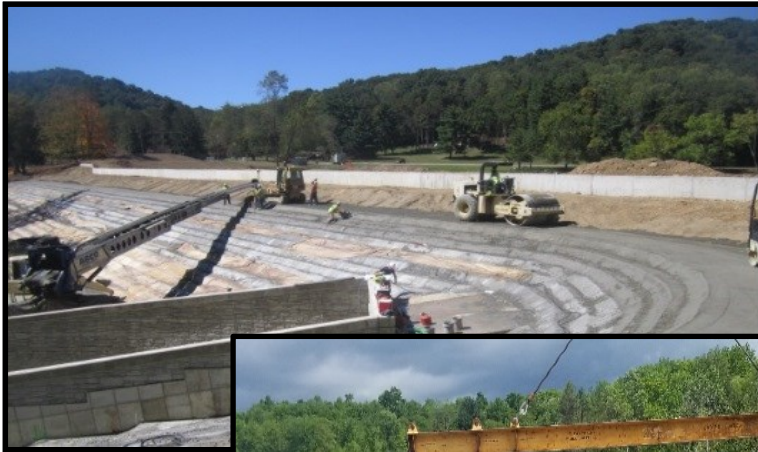
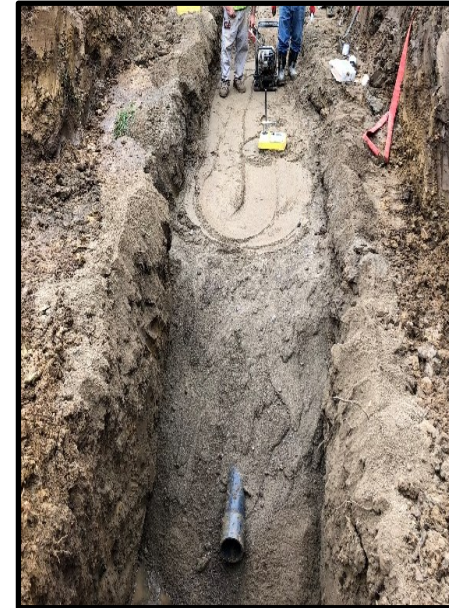
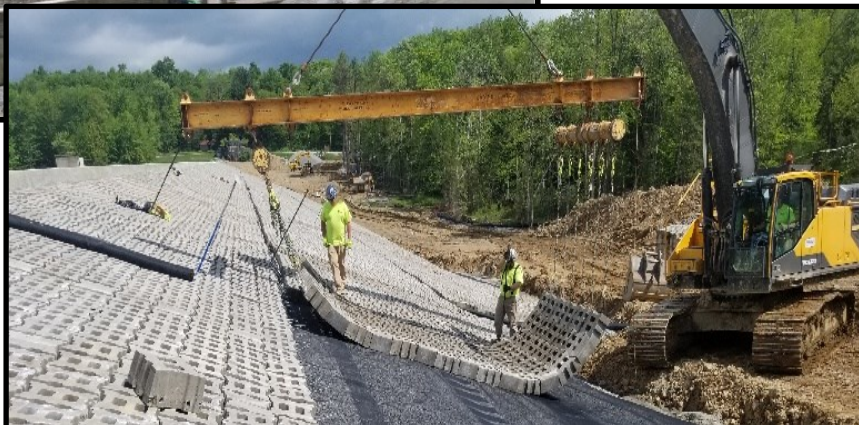
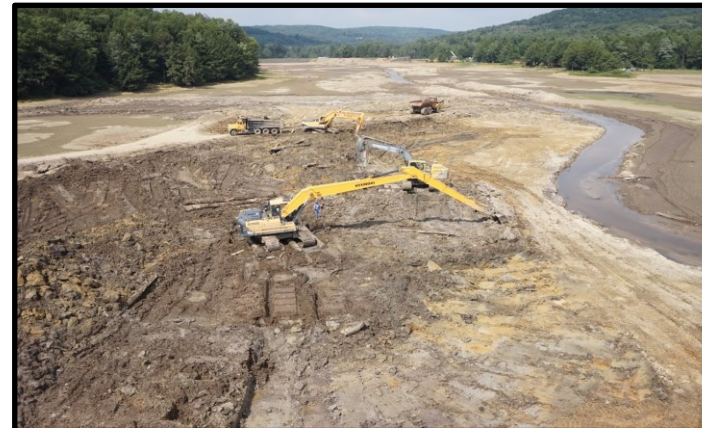
## Potential Solutions

- Widen the ASW
- Raise the crest of Dam
- Provide Embankment Overtopping Protection
- Seepage Collection System (e.g., toe drain)
- Slope flattening / buttressing (for embankment stability)

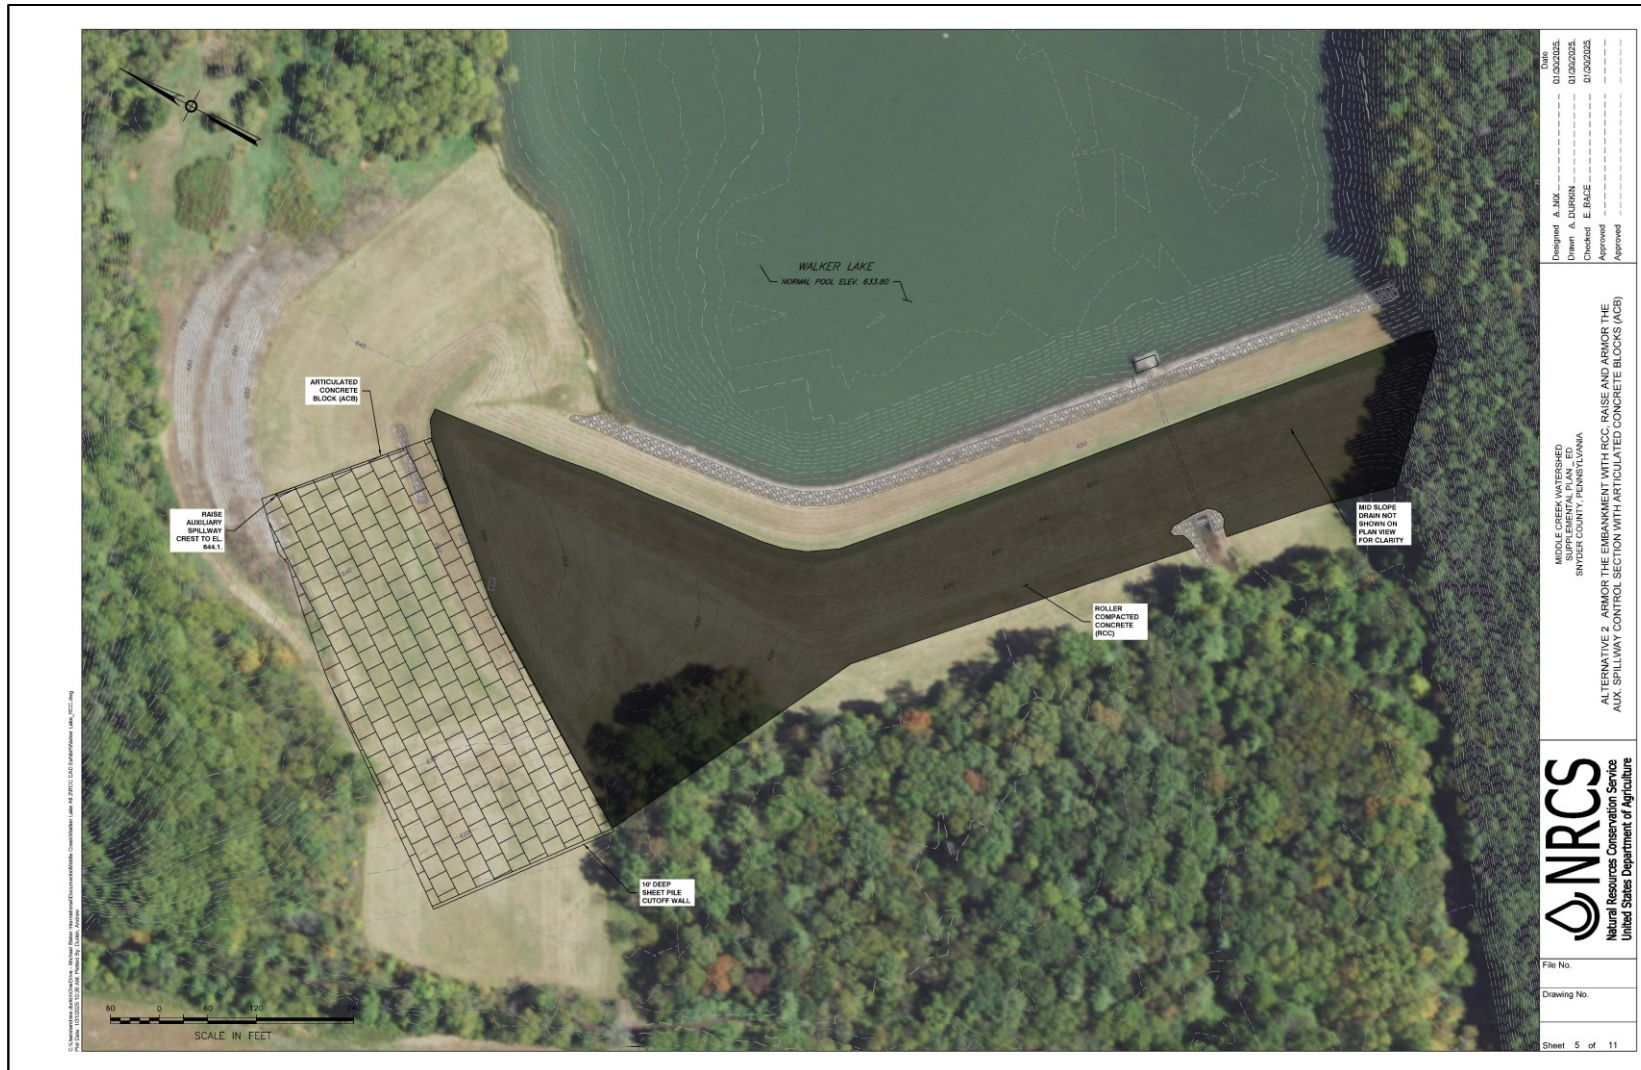
# DESIGN OPTION 2 – ARMOR THE EMBANKMENT WITH ROLLER COMPACTED CONCRETE (RCC), RAISE AND ARMOR THE AUXILIARY SPILLWAY CONTROL SECTION WITH ACBs

- Armor the existing embankment with RCC
- Raise auxiliary (emergency) spillway and armor with ACBs (same as Design Option 1)
- Seepage collection addressed with filter under RCC
- Concrete repairs in select areas
- **Estimated Cost – \$ 16,311,000**
