# Upper Turtle River Watershed Dam #9, Larimore Dam

## Appendix D-8: Stream Classification and Riparian Area Assessment

**Grand Forks County Water Resource District  
USDA - NRCS**

*Submitted by:  
HDR Engineering, Inc.  
3231 Greensboro Drive, Suite 200  
Bismarck, ND 58503*

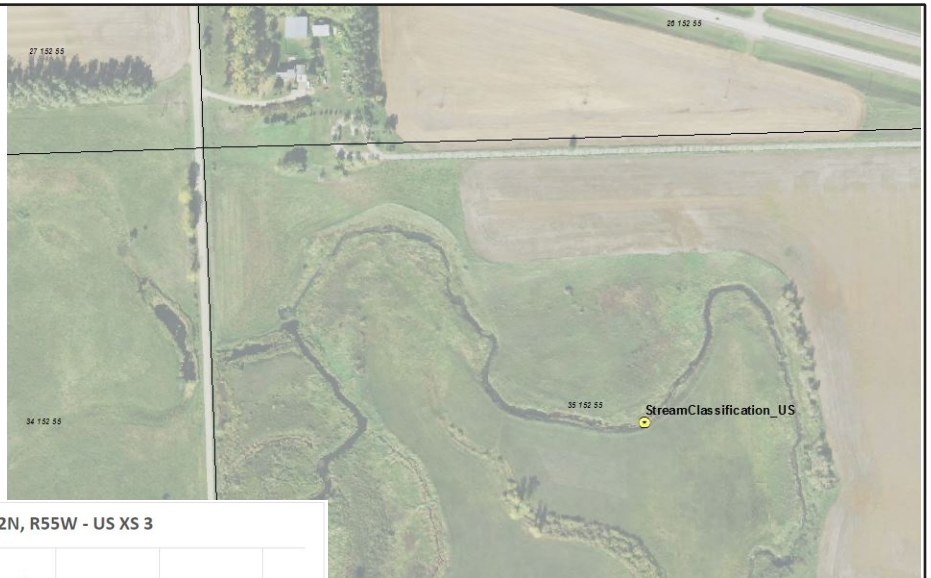
Turtle River - NW, Sect 35, T152N, R55W - US XS 3

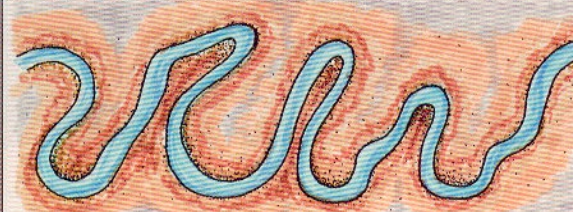
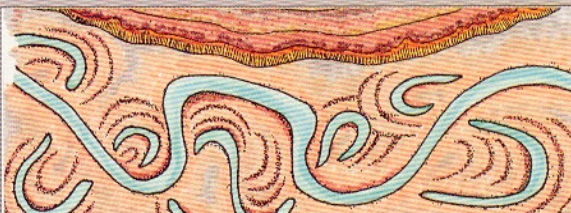
| <b>Meander Patterns</b> | | | | | |
|---|---|---|---|--|--|
| List ALL CATEGORIES that APPLY ➡ | | M3 | M7 | | |
| <p><b>M1      REGULAR MEANDERS</b></p> <p><b>M2      TORTUOUS MEANDERS</b></p> <p><b>M3      IRREGULAR MEANDERS</b></p> <p><b>M4      TRUNCATED MEANDERS</b></p> | | | <p><b>M5      UNCONFINED MEANDER SCROLLS</b></p> <p><b>M6      CONFINED MEANDER SCROLLS</b></p> <p><b>M7      DISTORTED MEANDER LOOPS</b></p> <p><b>M8      IRREGULAR MEANDERS with oxbows and oxbow cutoffs</b></p> | | |

The observation location downstream of the dam has irregular meanders, and the same can be said for the upstream observation location. The downstream observation location appeared to have a few additional mid-channel bars compared to the upstream location. A higher amount of channel blockages was noted at the downstream observation location when compared to the upstream location due to a greater availability of larger tree branches in the reach to fall into channel.

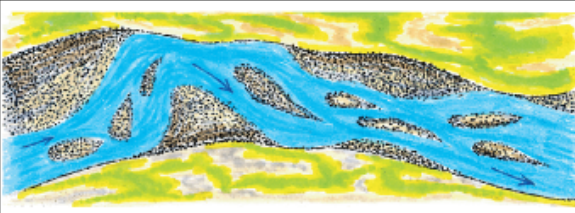
**Worksheet 3-5.** Depositional patterns used for stability assessments.

| Depositional Patterns | | | | | |
|---|---|---|---|--|--|
| List ALL CATEGORIES that APPLY ➞ | | B1 | | | |
| <p><i>Various Depositional Features modified from Galay et al. (1973)</i></p> <div style="display: flex; flex-wrap: wrap;"> <div style="width: 50%; text-align: center;"> <p><b>B1</b>      POINT BARS</p> </div> <div style="width: 50%; text-align: center;"> <p><b>B5</b>      DIAGONAL BARS</p> </div> <div style="width: 50%; text-align: center;"> <p><b>B2</b>      POINT BARS with Few MID-CHANNEL BARS</p> </div> <div style="width: 50%; text-align: center;"> <p><b>B6</b>      Main Channel Branching with Numerous MID-CHANNEL BARS and Islands</p> </div> <div style="width: 50%; text-align: center;"> <p><b>B3</b>      NUMEROUS MID-CHANNEL BARS</p> </div> <div style="width: 50%; text-align: center;"> <p><b>B7</b>      SIDE BARS AND MID-CHANNEL BARS with Length Exceeding 2 to 3 Channel Widths</p> </div> <div style="width: 50%; text-align: center;"> <p><b>B4</b>      SIDE BARS</p> </div> <div style="width: 50%; text-align: center;"> <p><b>B8</b>      DELTA BARS</p> </div> </div> | | | | | |

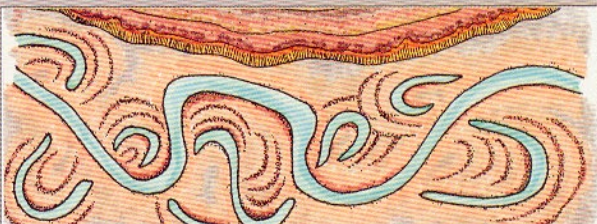
| <b>Meander Patterns</b> | | | | | |
|---|---|---|---|--|--|
| <i>Various Meander Pattern Variables modified from Galay et al. (1973)</i> | | | | | |
| <p><b>M1 REGULAR MEANDERS</b></p> <p><b>M2 TORTUOUS MEANDERS</b></p> <p><b>M3 IRREGULAR MEANDERS</b></p> <p><b>M4 TRUNCATED MEANDERS</b></p> | | | <p><b>M5 UNCONFINED MEANDER SCROLLS</b></p> <p><b>M6 CONFINED MEANDER SCROLLS</b></p> <p><b>M7 DISTORTED MEANDER LOOPS</b></p> <p><b>M8 IRREGULAR MEANDERS with oxbows and oxbow cutoffs</b></p> | | |

| <b>Meander Patterns</b> | | | | | |
|---|---|---|---|--|--|
| List ALL CATEGORIES that APPLY ➡ | | M3 | M7 | | |
