# Dam Rehabilitation Fact Sheet

## Mountain Run Lake, Mountain Run Watershed

The auxiliary spillway of Mountain Run Lake does not have the capacity to pass the water volume required by Virginia dam safety regulations and needs rehabilitation.

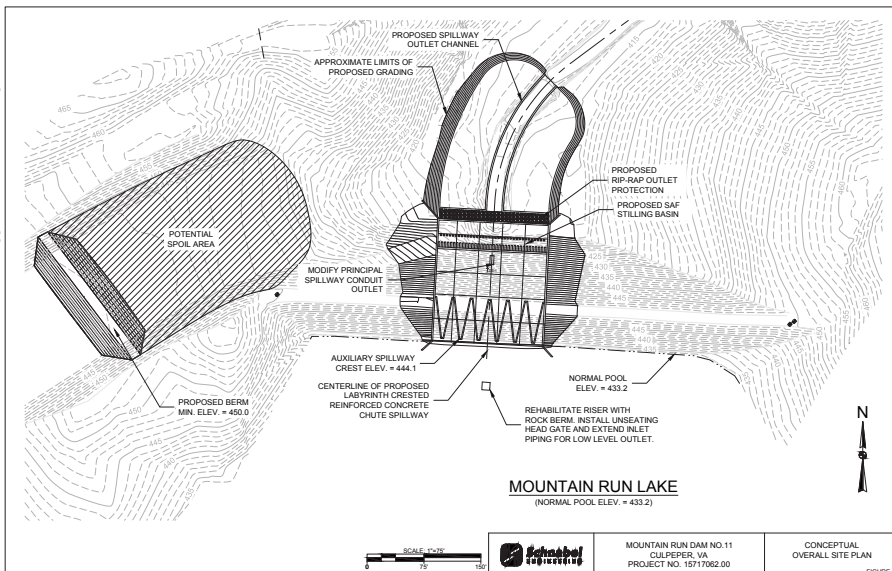
The plan view drawing below outlines the proposed solution to the auxiliary spillway problem.

The plan includes the following rehabilitation activities:

- Installing a 144-foot wide, 6-cycle structural concrete labyrinth weir auxiliary spillway over the embankment
- Installing an earthen berm across the existing auxiliary spillway
- Installing a stilling basin and rip-rap outlet protection below the dam
- Upgrading the principal spillway riser to meet seismic criteria through the installation of about 5.5 feet of granular rock fill placed above and around the periphery of the existing riser footer

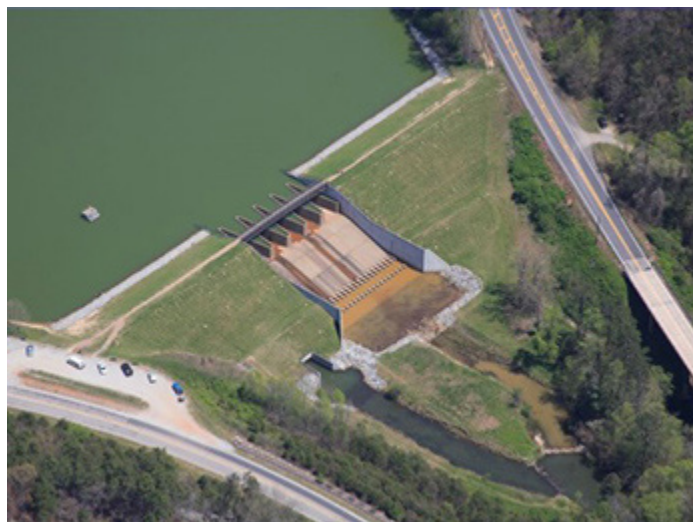
The photo above is an aerial view of a typical labyrinth weir. The graphic below provides a closer look at how this enhancement to a spillway helps to control rising flood waters.
