# **Investigations and Analysis Report for the Corn Creek Watershed Plan and Environmental Assessment**

**Corn Creek Watershed, Millard County, Utah**

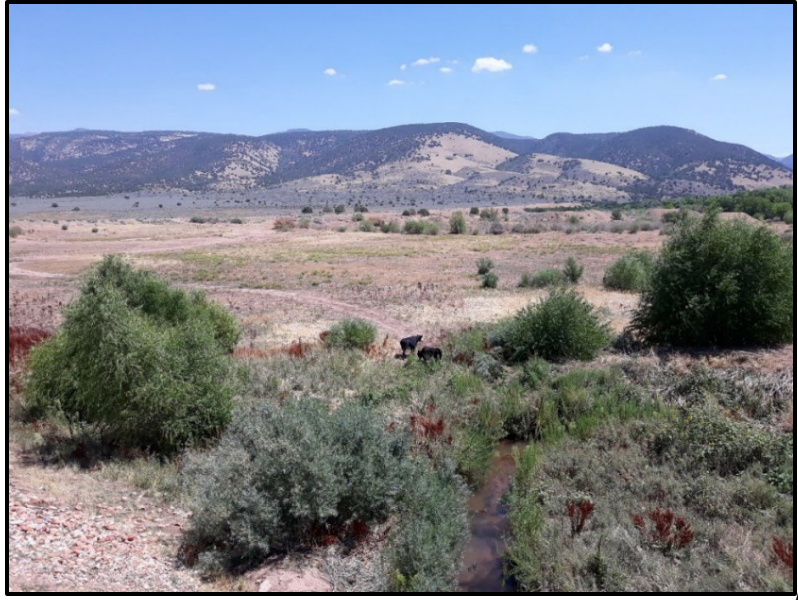
**Figure 1: Debris Basin and Corn Creek from Above the Outlet Works, July 2021**

The Corn Creek debris basin, located upstream of Kanosh, was originally constructed in 1955 and reconstructed in 1985 after failing during the 1984 floods. The reconstruction included various enhancements to improve floodwater management and prevent flooding in Kanosh, such as new outlet works, secondary and emergency spillways, embankment improvements, and erosion prevention measures. The basin's capacity as of 2019 was 200 acre-feet at the secondary spillway crest and 468 acre-feet at the embankment crest. However, Utah Dam Safety has identified significant foundation seepage issues with the embankment, rating the dam as high hazard due to its location. Maintenance issues have persisted, including vegetation growth, breaching, burrowing rodents, riprap sloughing, and extensive foundation seepage.

Utah Dam Safety has expressed concerns about the seepage through the embankment foundation and the inadequacy of the toe drain installed in 1985, requiring remediation to prevent internal erosion. Utah Dam Safety has mandated the control be completely open to prevent storage of flood water. This increases the risk of downstream flooding. The basin stores water only briefly during peak runoff periods and is dry for most of the summer; it's mainly used for animal grazing, ATV recreation, and gravel stockpiling that originates from the debris basin. The gravel stockpiles vary in aggregate size and will likely be used as a source for the proposed debris basin embankment. Without adequate water detention, the peak flows cannot be attenuated, potentially leading to significant flooding in Kanosh.

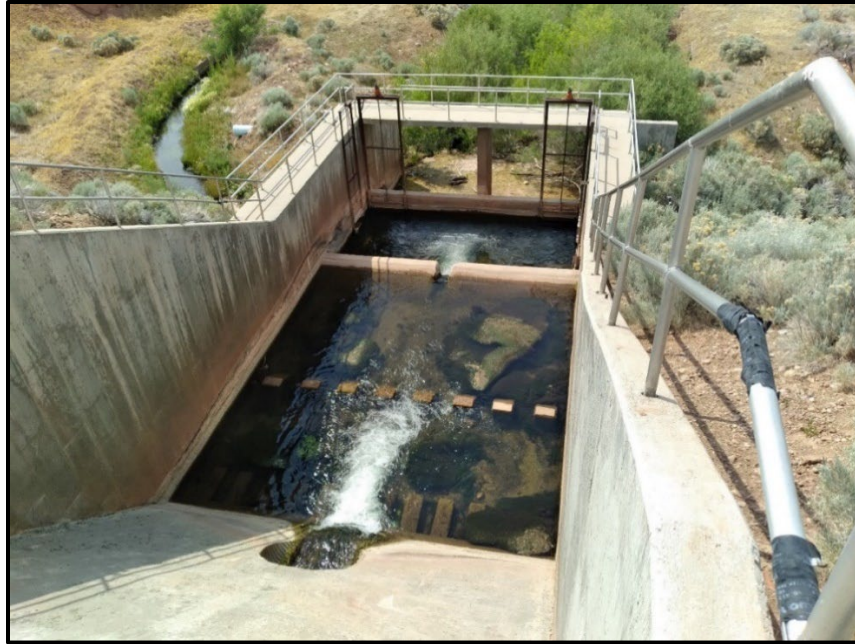
The debris basin's primary outlet and secondary spillway are in good condition. The outlet works' stilling basin shows erosion and algae buildup, with the spillway capable of discharging about 2,300 cfs at the dam crest (5,198 feet). The 60-inch outlet pipe, with capacities of 365 cfs at the secondary spillway crest (5189.62 feet) and 440 cfs at the dam crest, shows corrosion and delaminating tar lining. A conveyance pipeline for Kanosh's secondary irrigation system includes a rarely used 12-inch PVC pipe to the Paiute Tribe, whose leaking headgate allows some water to reach the reservation pond. The Town's secondary system pipeline is also a 12-inch PVC pipe rated at 100 psi. In the past, during high flow events, stop logs have been used in the secondary spillway to get the water level high enough to go out the emergency spillway. Placing stop logs in the secondary spillway increases failure risk during high floods and Utah Dam Safety has prohibited the use of stop logs in the future. The configuration of the existing dam and spillways are listed in Table 6-1: Comparison of Existing Dam Design and Preferred Alternative Design in Chapter 6 Section 2 of the Plan-EA.

**Figure 2: Outlet Works Stilling Basin, June 2021**

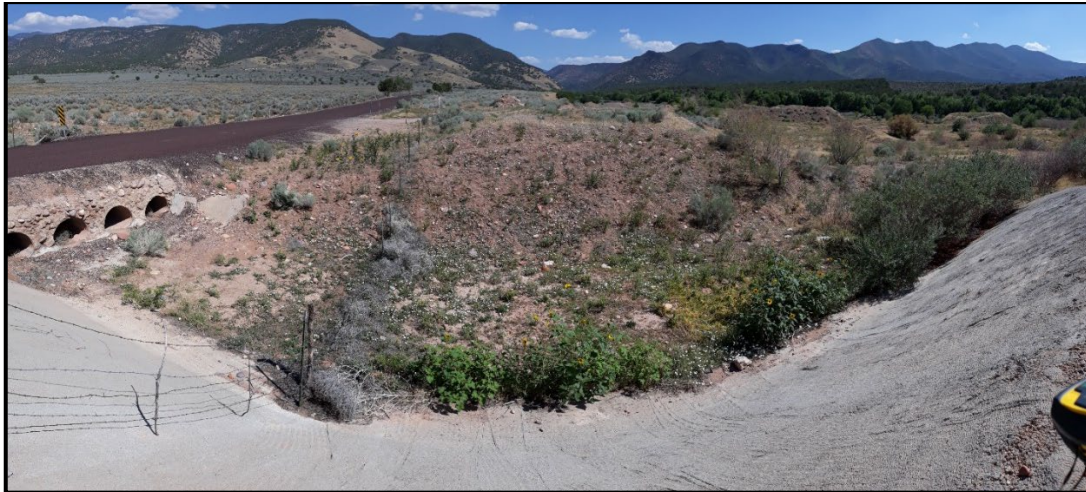
The emergency spillway culverts, designed to release excess water to a flood channel, consist of four partially obstructed 49-inch corrugated metal pipe (CMP) arch culverts, reducing their discharge capacity and increasing the dam's failure risk due to foundation seepage issues. Currently, water must back up in the debris basin before it can flow through the emergency spillway, leading to all flood water passing through the 60-inch primary outlet works until it overflows the secondary and emergency spillway crests (5189.65 feet and 5,189.5 feet). Clearing the culverts could allow a maximum discharge of approximately 427 cfs to the flood channel when water is at the dam crest. The basin's configuration and filling restriction result in nearly all flood water flowing uncontrolled towards Kanosh, risking debris and sediment blockage of channels and culverts. The emergency spillway channel, with a capacity of about 2,000 cfs, discharges to land east of Kanosh, potentially flooding agricultural fields and Highway 133.

**Figure 3: Emergency Spillway and Flood Channel, July 2021**

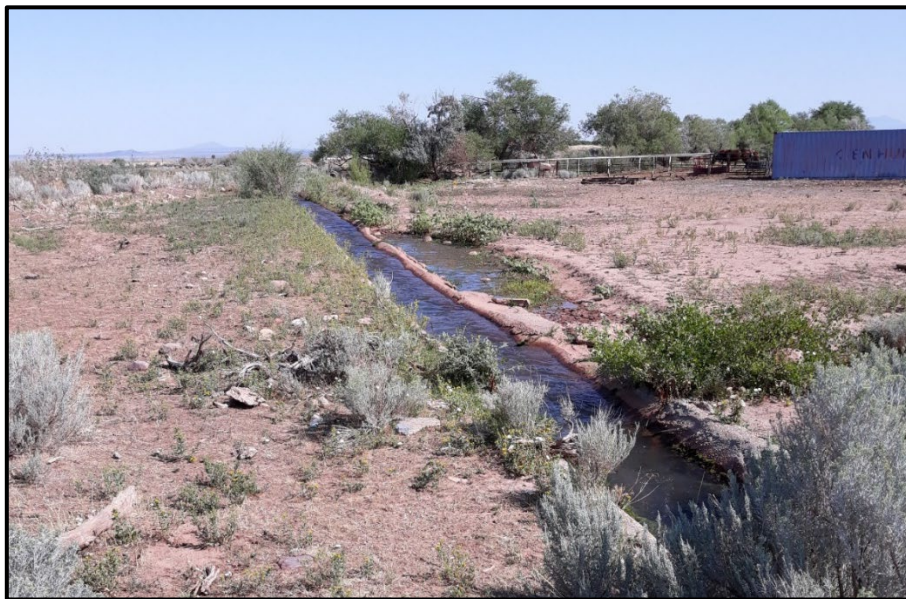
Downstream of the debris basin, Corn Creek is diverted into several channels at two primary locations: the outlet works stilling basin and a splitting structure further downstream. The East Middle Hatton Double Ditch, one of the channels, is concrete-lined but has leakage issues and a design capacity of about 12 cfs, but it can handle no more than 4-5 cfs without overflowing due to settlement of a blockage by failed concrete farther down the channel. The South & West Field Double Ditch transitions to a 24-inch PVC pipe after 100 feet, with a maximum flow rate limited to about 15 cfs due to debris blockage at the pipe inlet.

**Figure 4: Leakage from the East Middle Hatton Ditch, Flow Approx. 3 cfs, July 2021**

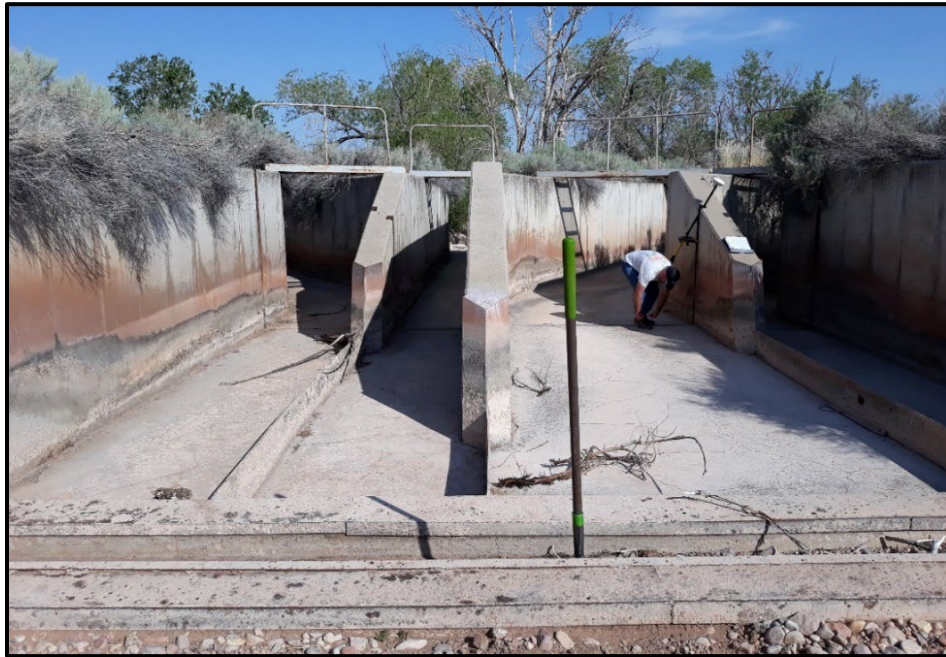
At higher flows, water is discharged to a natural channel from the outlet works stilling basin, with a capacity of approximately 1,300 cfs, though vegetation limits this. The splitting structure, 650 feet downstream from the outlet works, divides the flow into four channels: South Single Ditch,

West Single Ditch (natural channel), Main Hatton Single Ditch, and East Field Single Ditch. Each channel has different capacities and limitations, with debris and sediment buildup significantly impacting their effectiveness.

The East Field Single Ditch has an estimated capacity of about 280 cfs but is limited to 50 cfs at certain culverts. The Main Hatton Single Ditch, the largest of the splitting structures, has a capacity of around 630 cfs when free of debris but is currently limited due to sediment and debris buildup. The West Single Ditch historically passed through Kanosh but is now redirected, with a concrete channel portion capable of handling significant storm events, though the capacity drops to 65 cfs in the dirt channel section at the end due to a smaller culvert.

**Figure 5: Diversion Structure, July 2021**

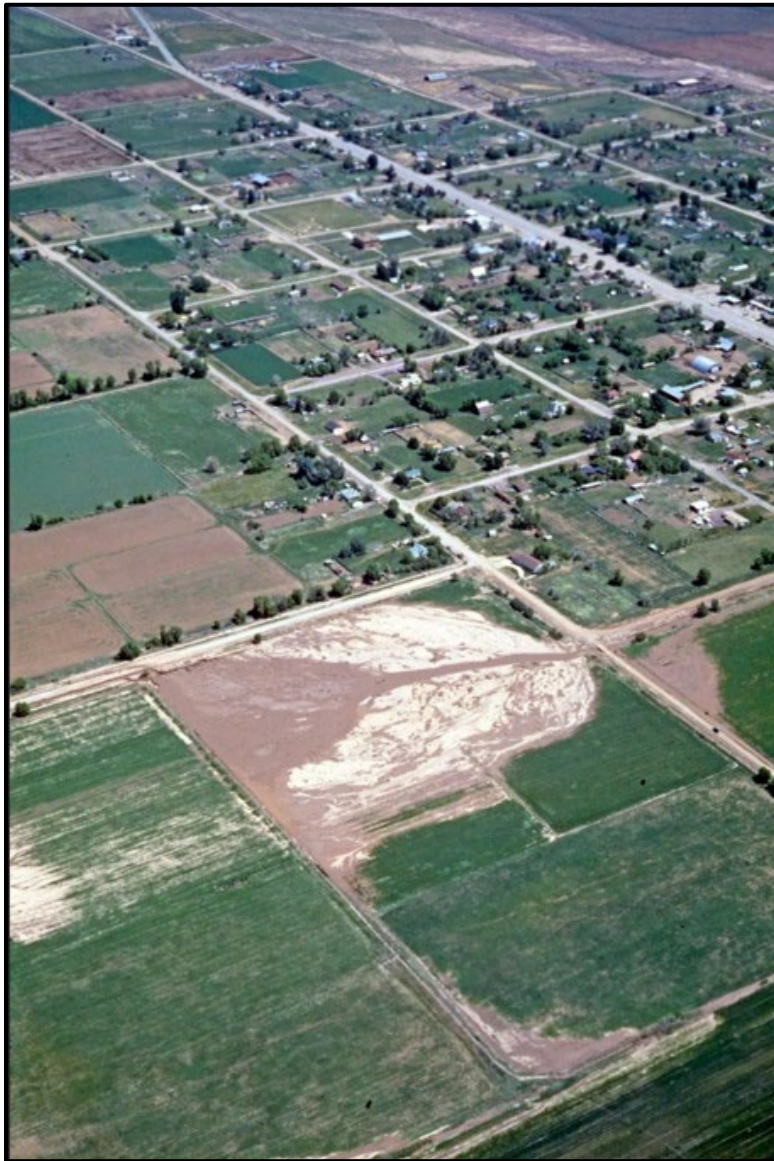
Historical flood events, such as those in July 1997, May/June 1983, May 1984, and May/June 2010, have caused significant damage, with the 1984 event being particularly notable for its breach of the debris basin embankment (see Figure 10). The breach led to extensive erosion and damage to infrastructure, necessitating repairs and modifications to mitigate future flood risks. Culverts, berm constructions, and emergency channels were implemented to manage floodwaters and protect critical infrastructure, highlighting the ongoing efforts to address flood hazards in the area. Despite these measures, the absence of comprehensive flooding maps and FEMA studies underscores the reliance on historical records and recent modeling to understand and mitigate flood risks effectively.

**Figure 10: Aerial Photo of Kanosh 1984 Flooding**
