Natural Resource Conservation Service EAXX-005-53-48-1353880190 August 2026

# Appendix F: Environmental Assessment for the Supplemental Watershed Plan No. 2 Rehabilitation of Olmitos and Garcia Watershed Dam No. 6

**Proposal Name:** Supplemental Watershed Plan No. 2 – for the Rehabilitation of Olmitos and Garcia Watershed Dam No. 6

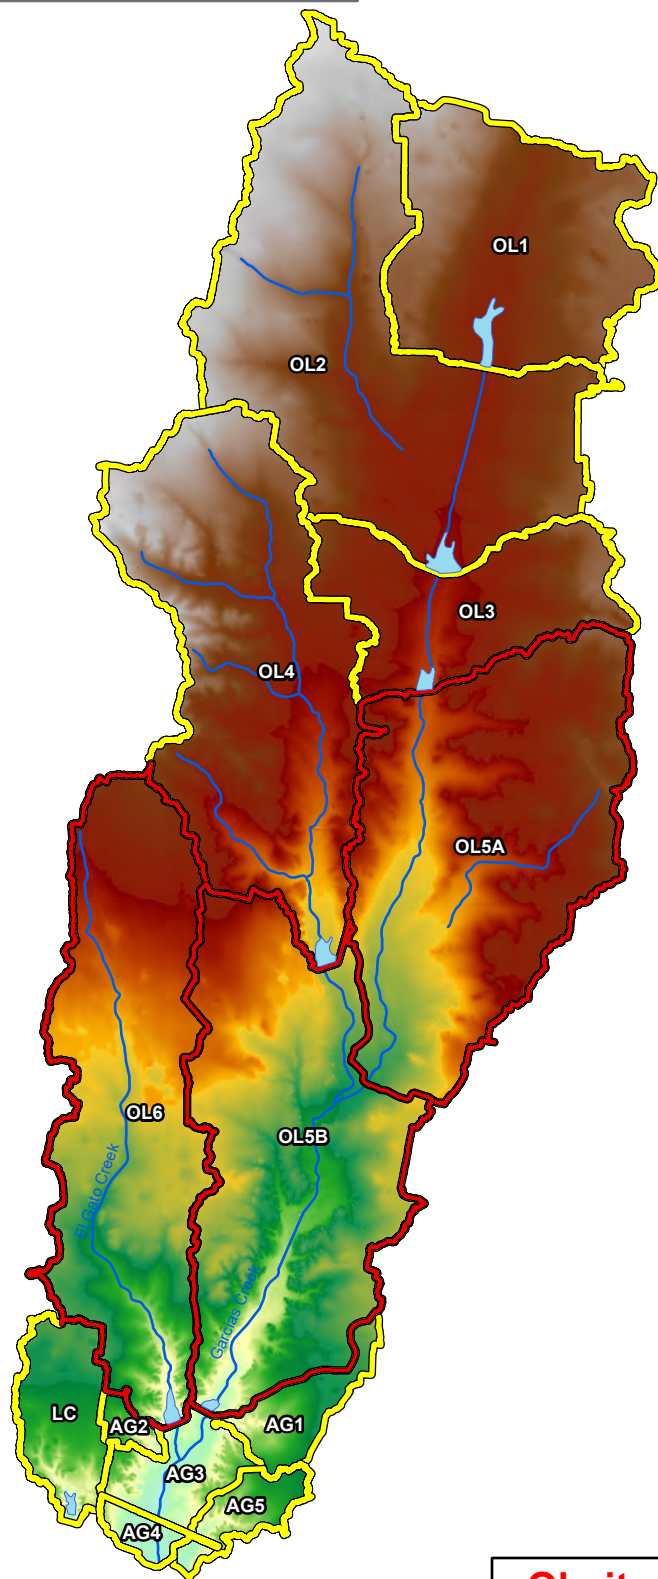
Total Watershed Area = 103.8 square miles

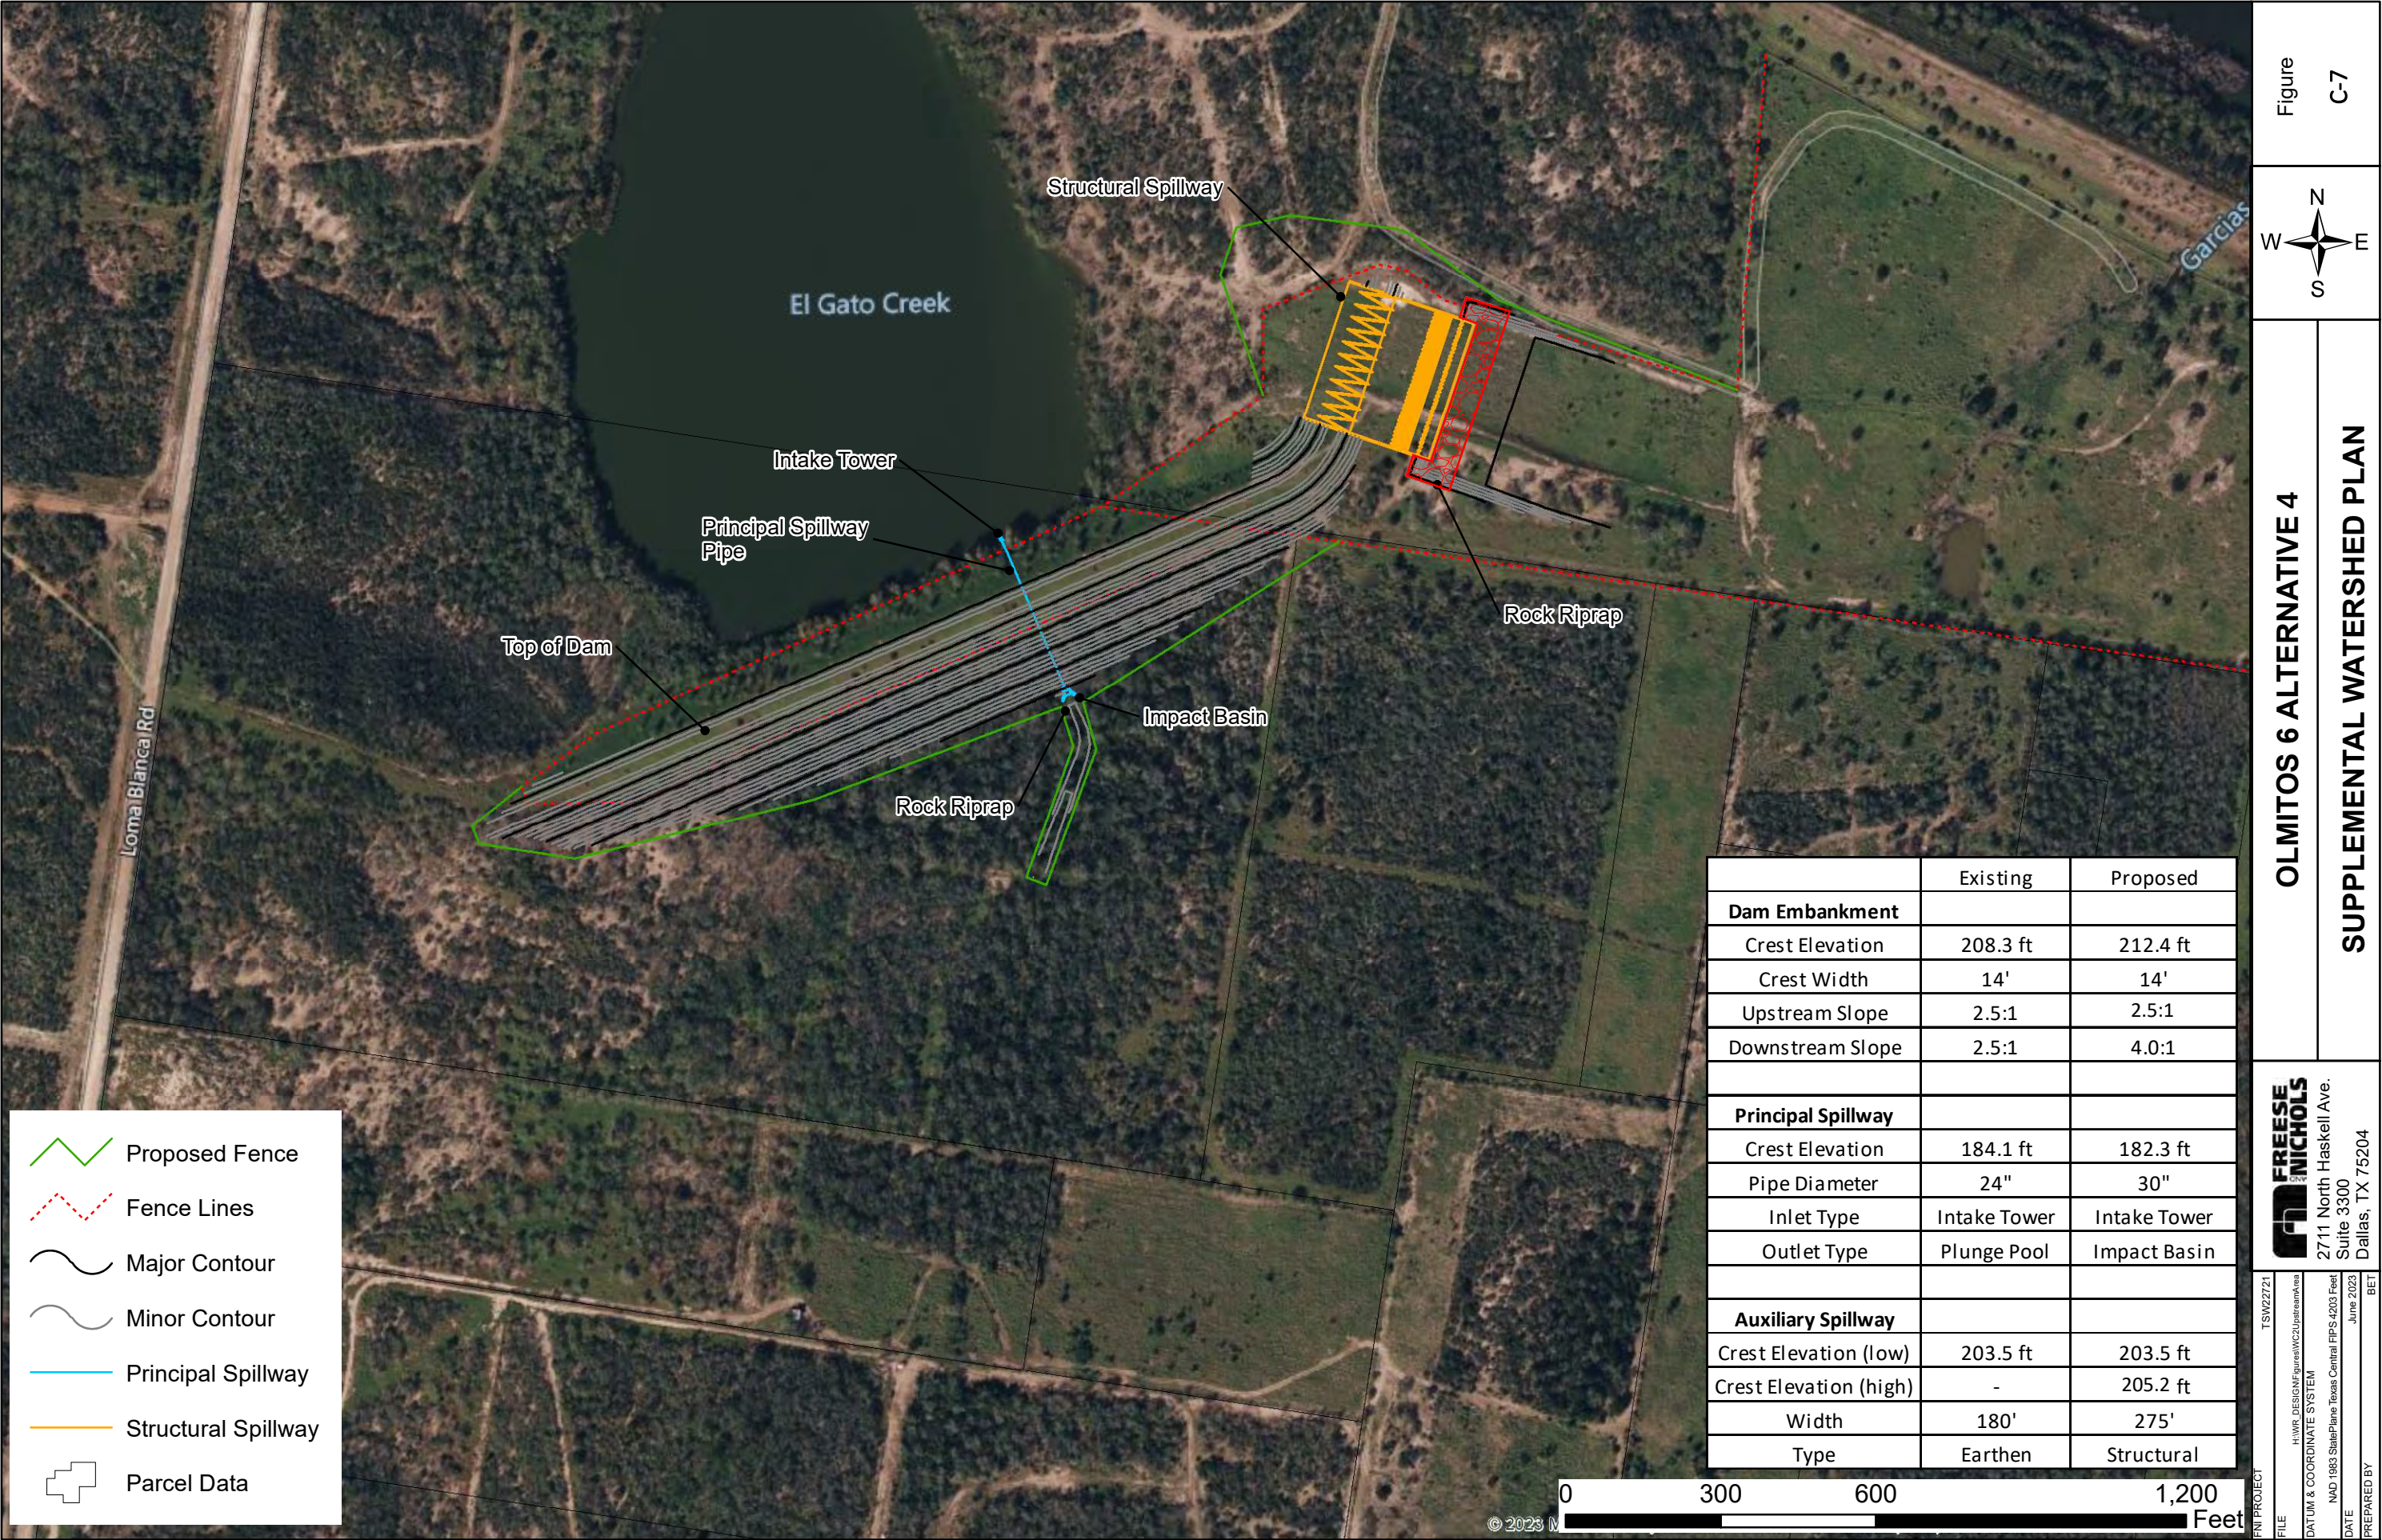
C-7: Alternative 4 - Plan View, Olmitos and Garcias Creek 6

OLMITOS 6 ALTERNATIVE 4

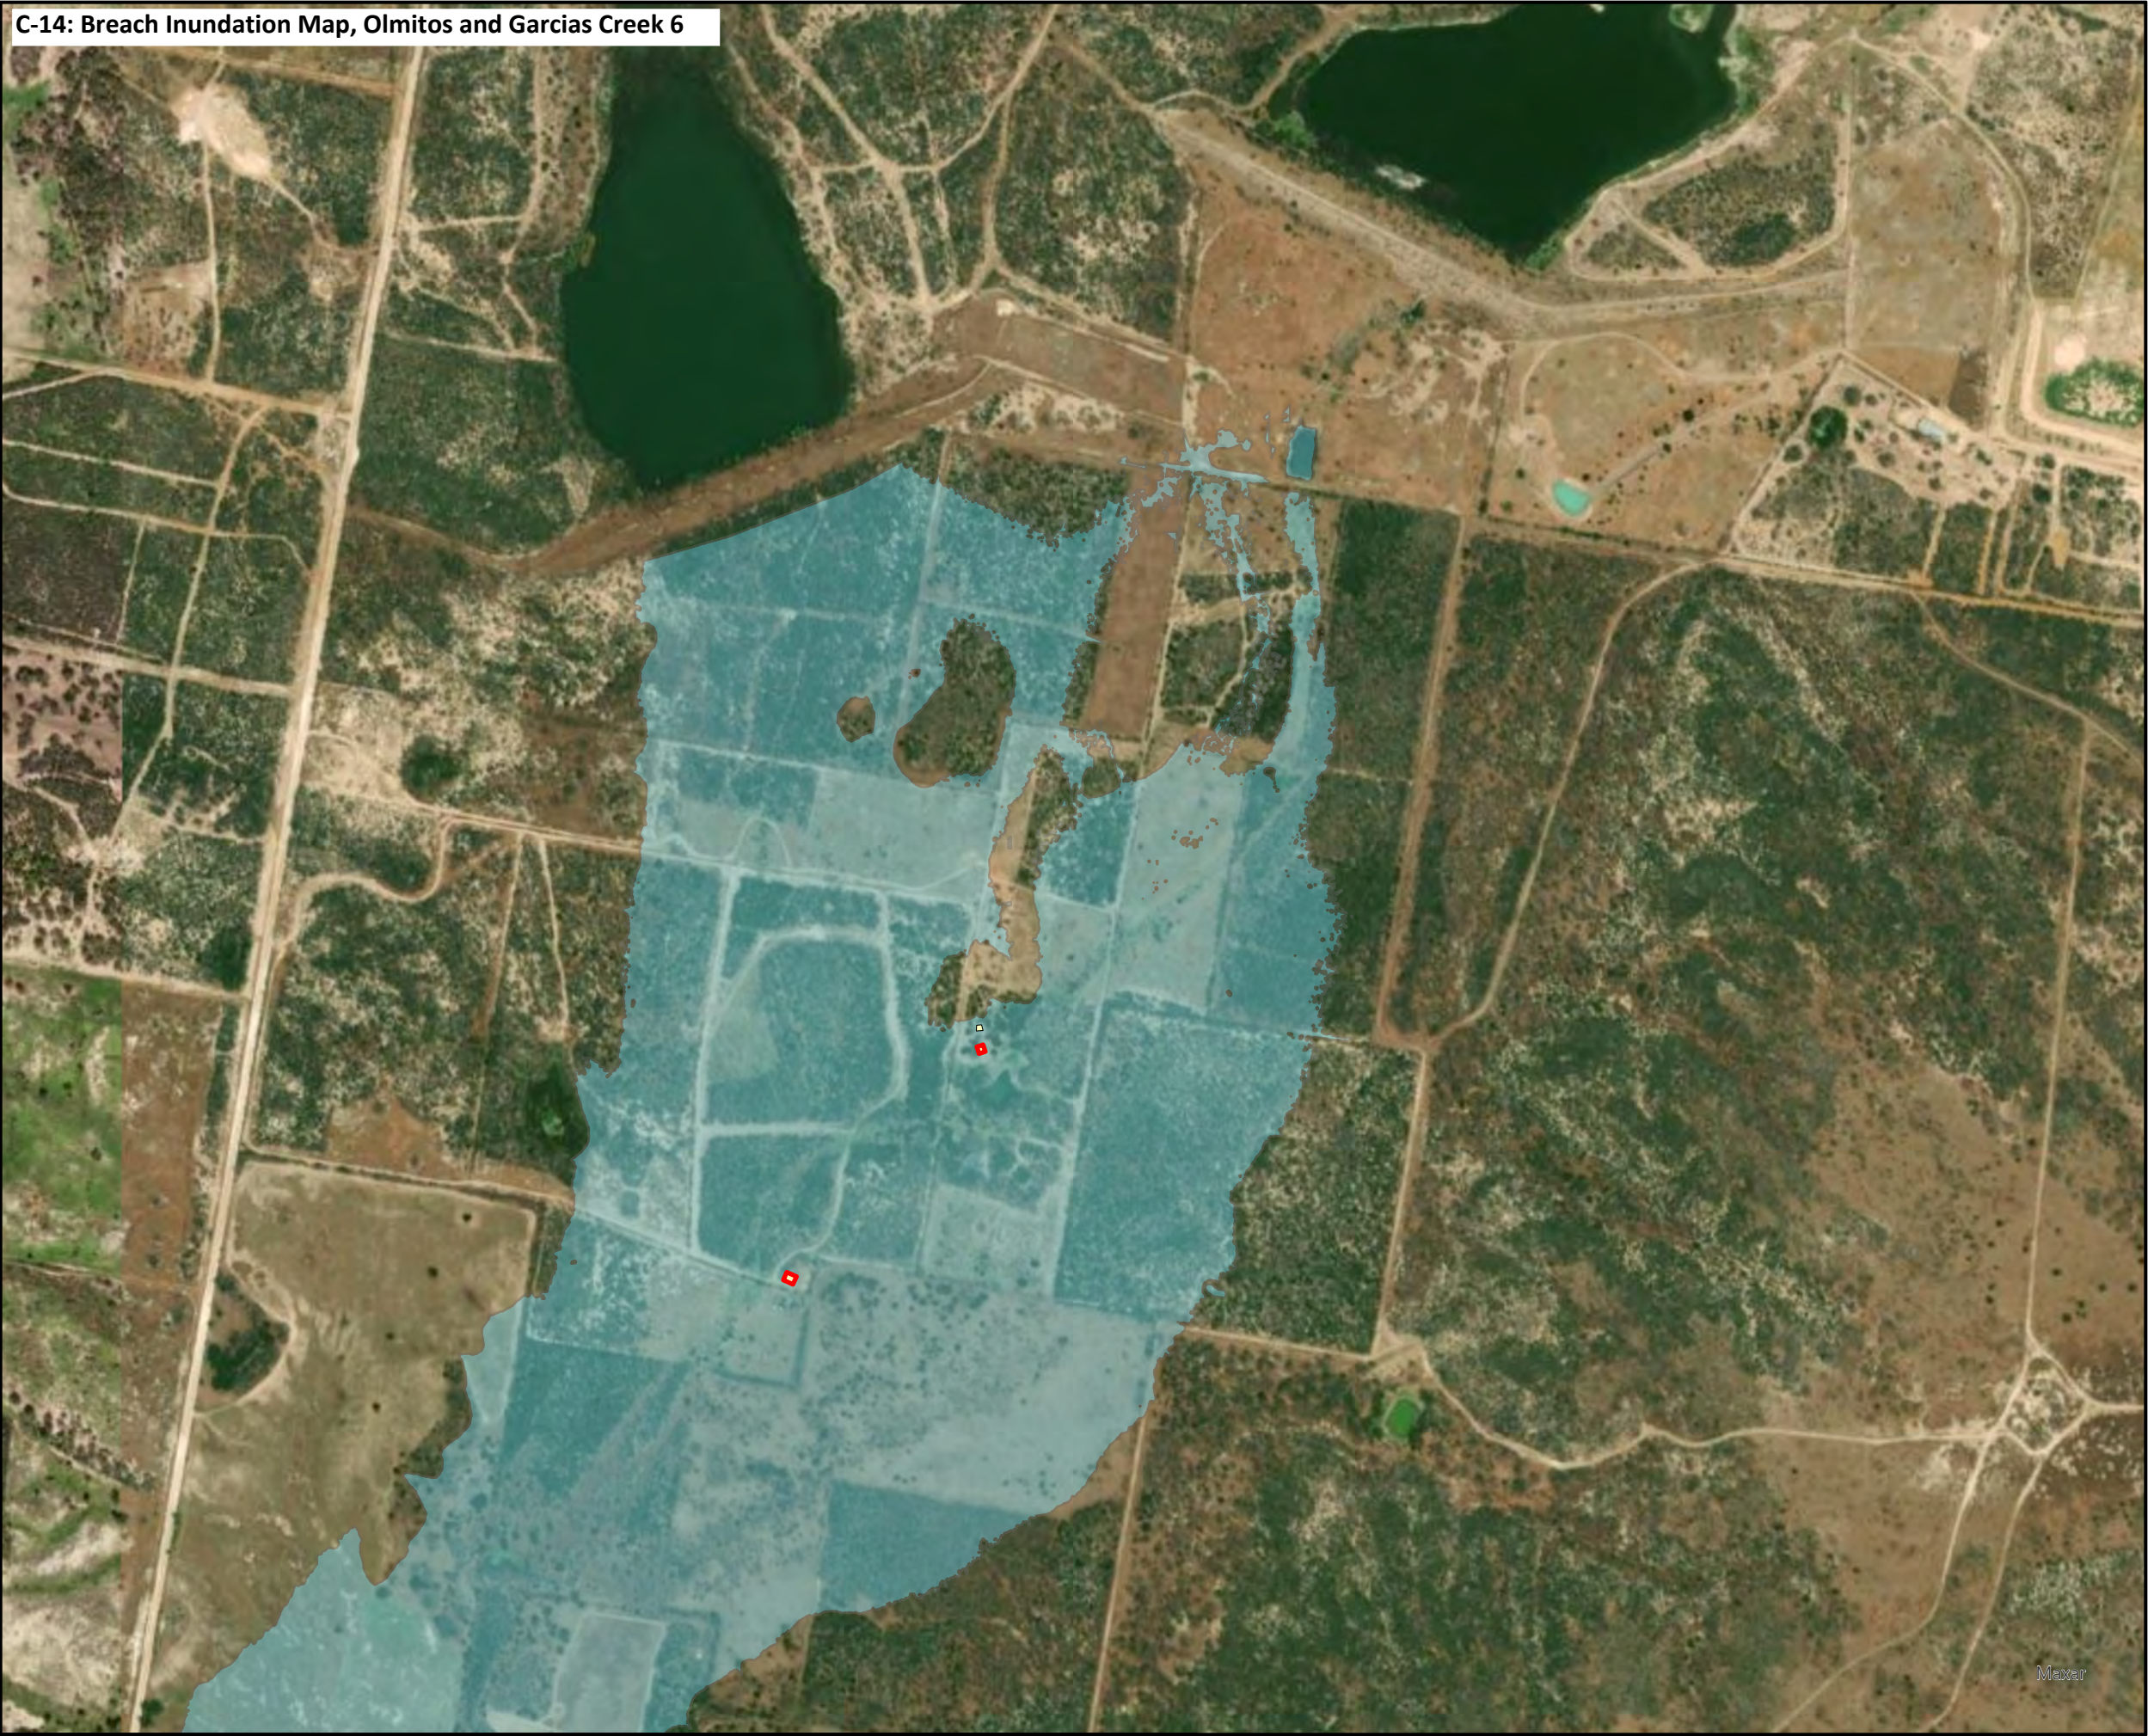
**OLMITOS & GARCIAS CREEK #6  
DAM FAILURE MAPPING**

Panel 1 of 5

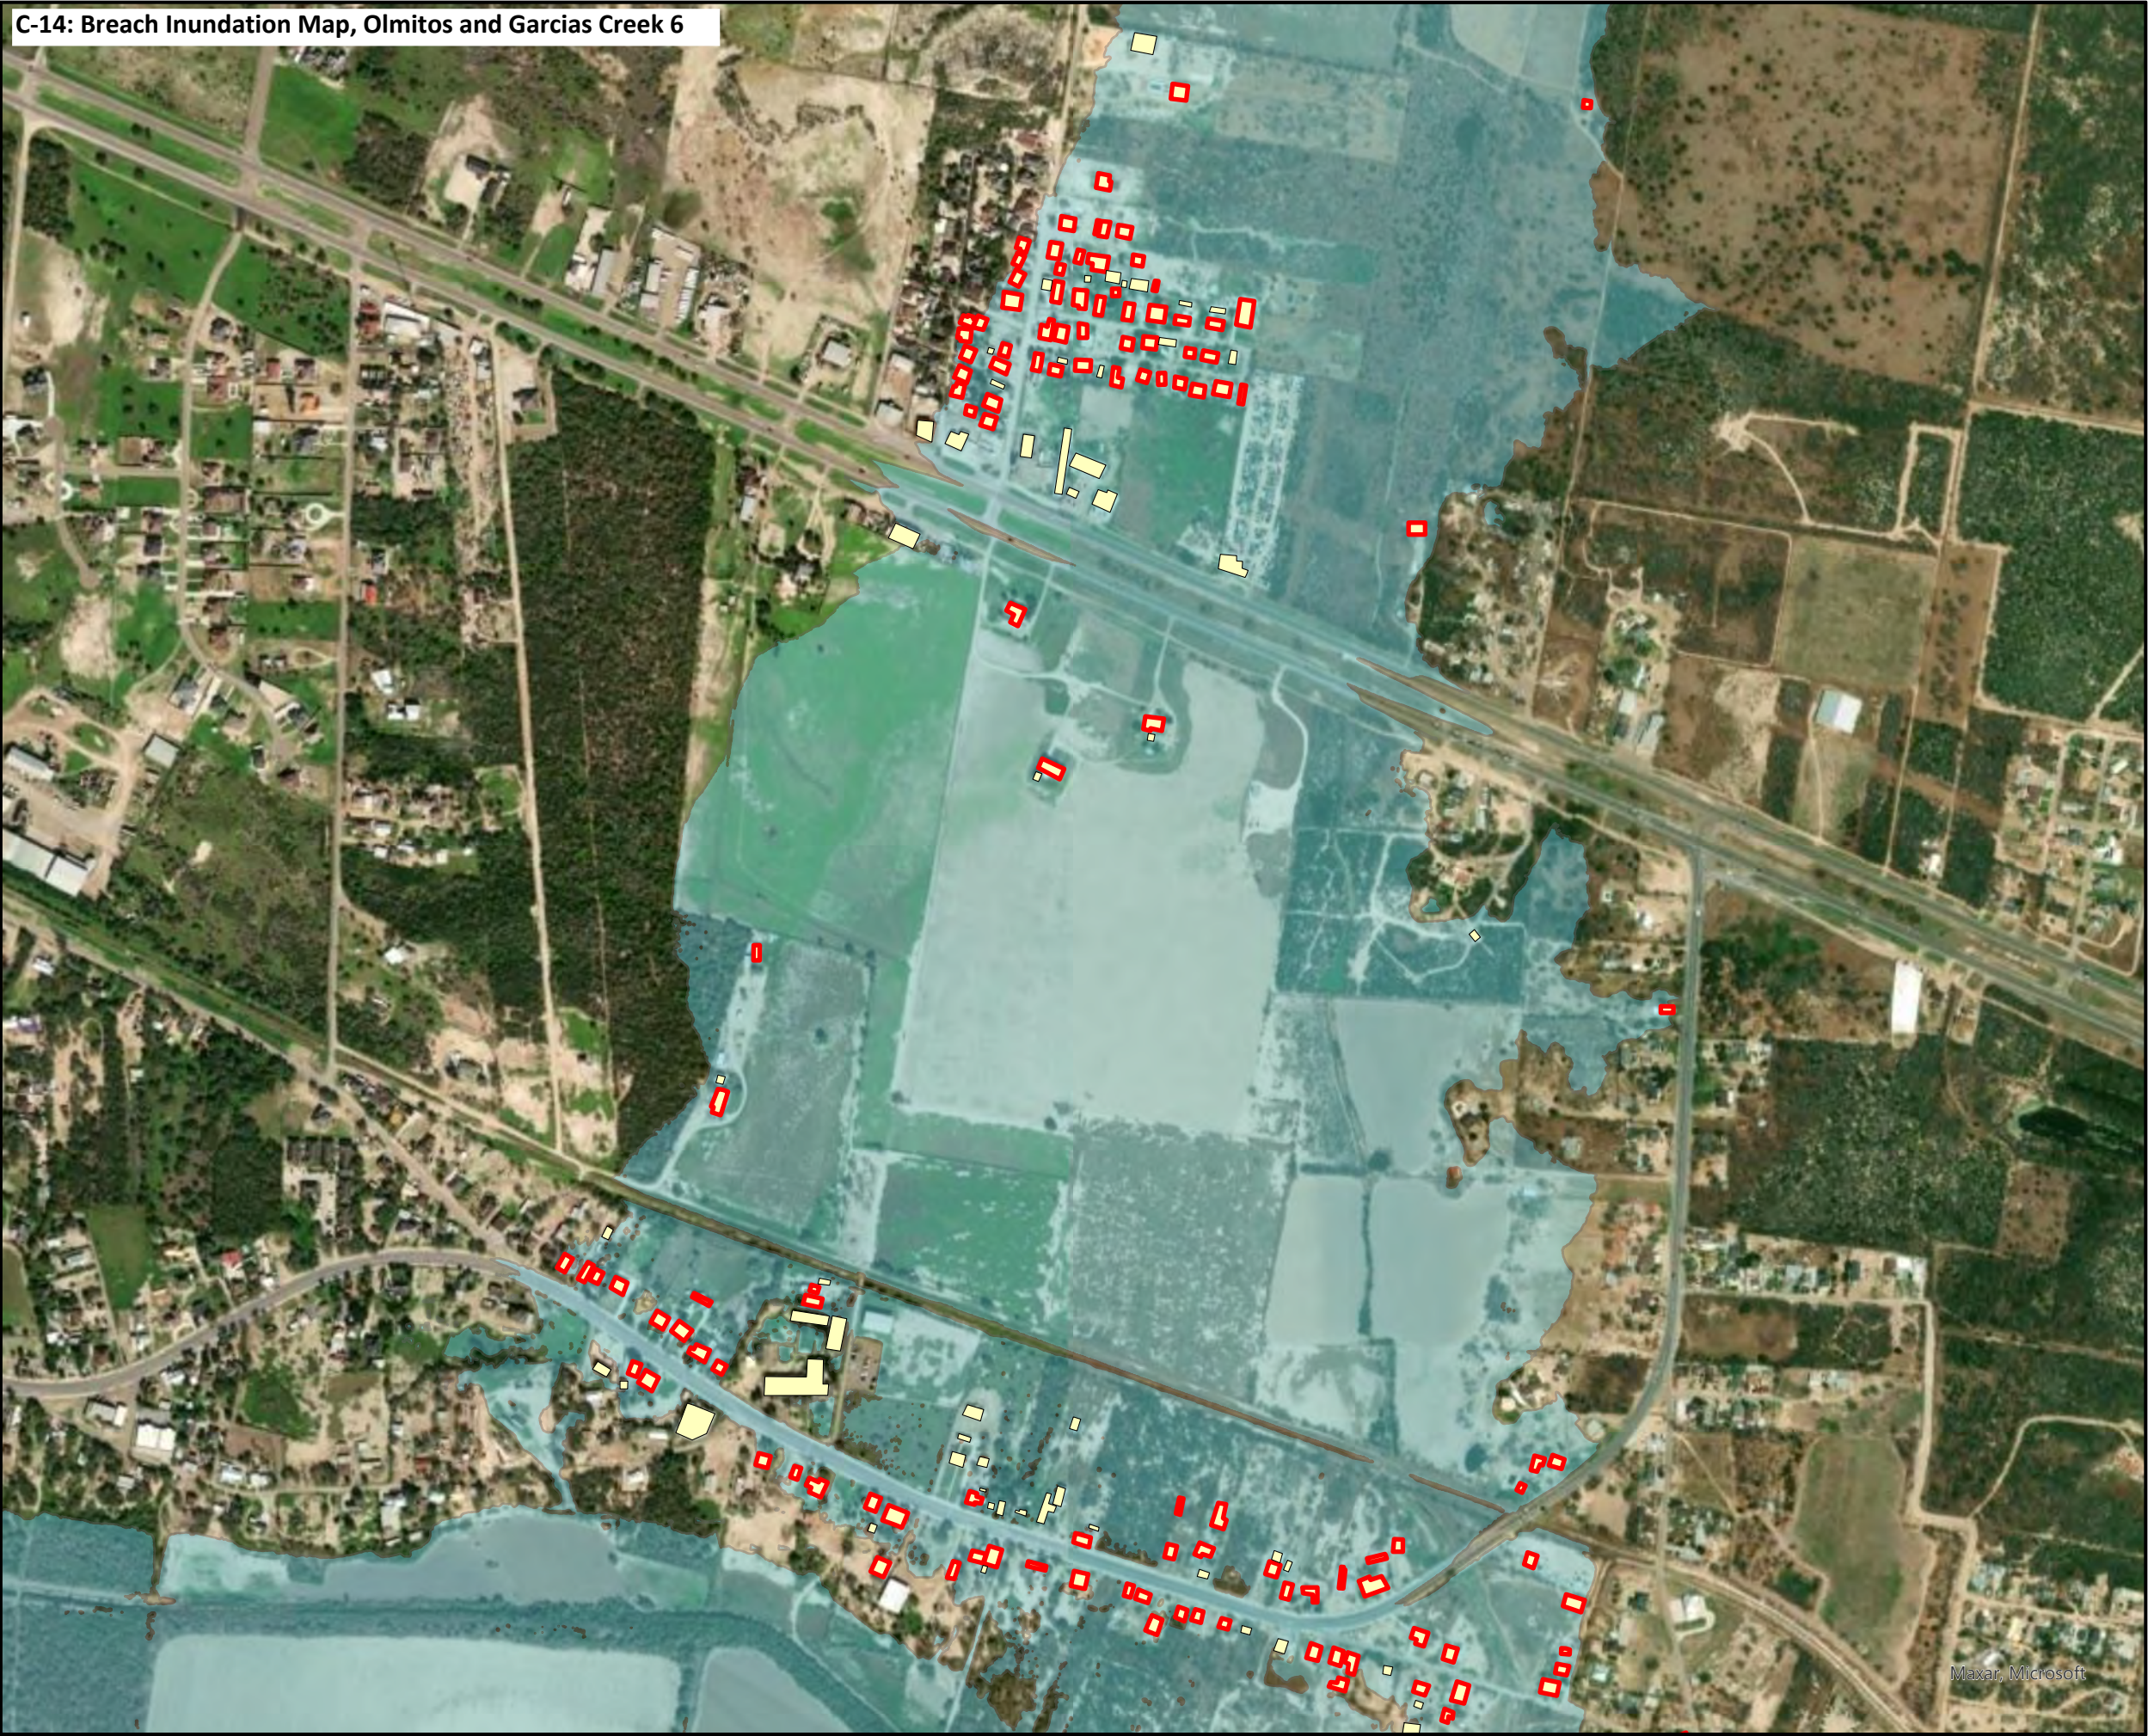
C-14: Breach Inundation Map, Olmitos and Garcias Creek 6

**OLMITOS & GARCIAS CREEK #6  
DAM FAILURE MAPPING**

Panel 2 of 5

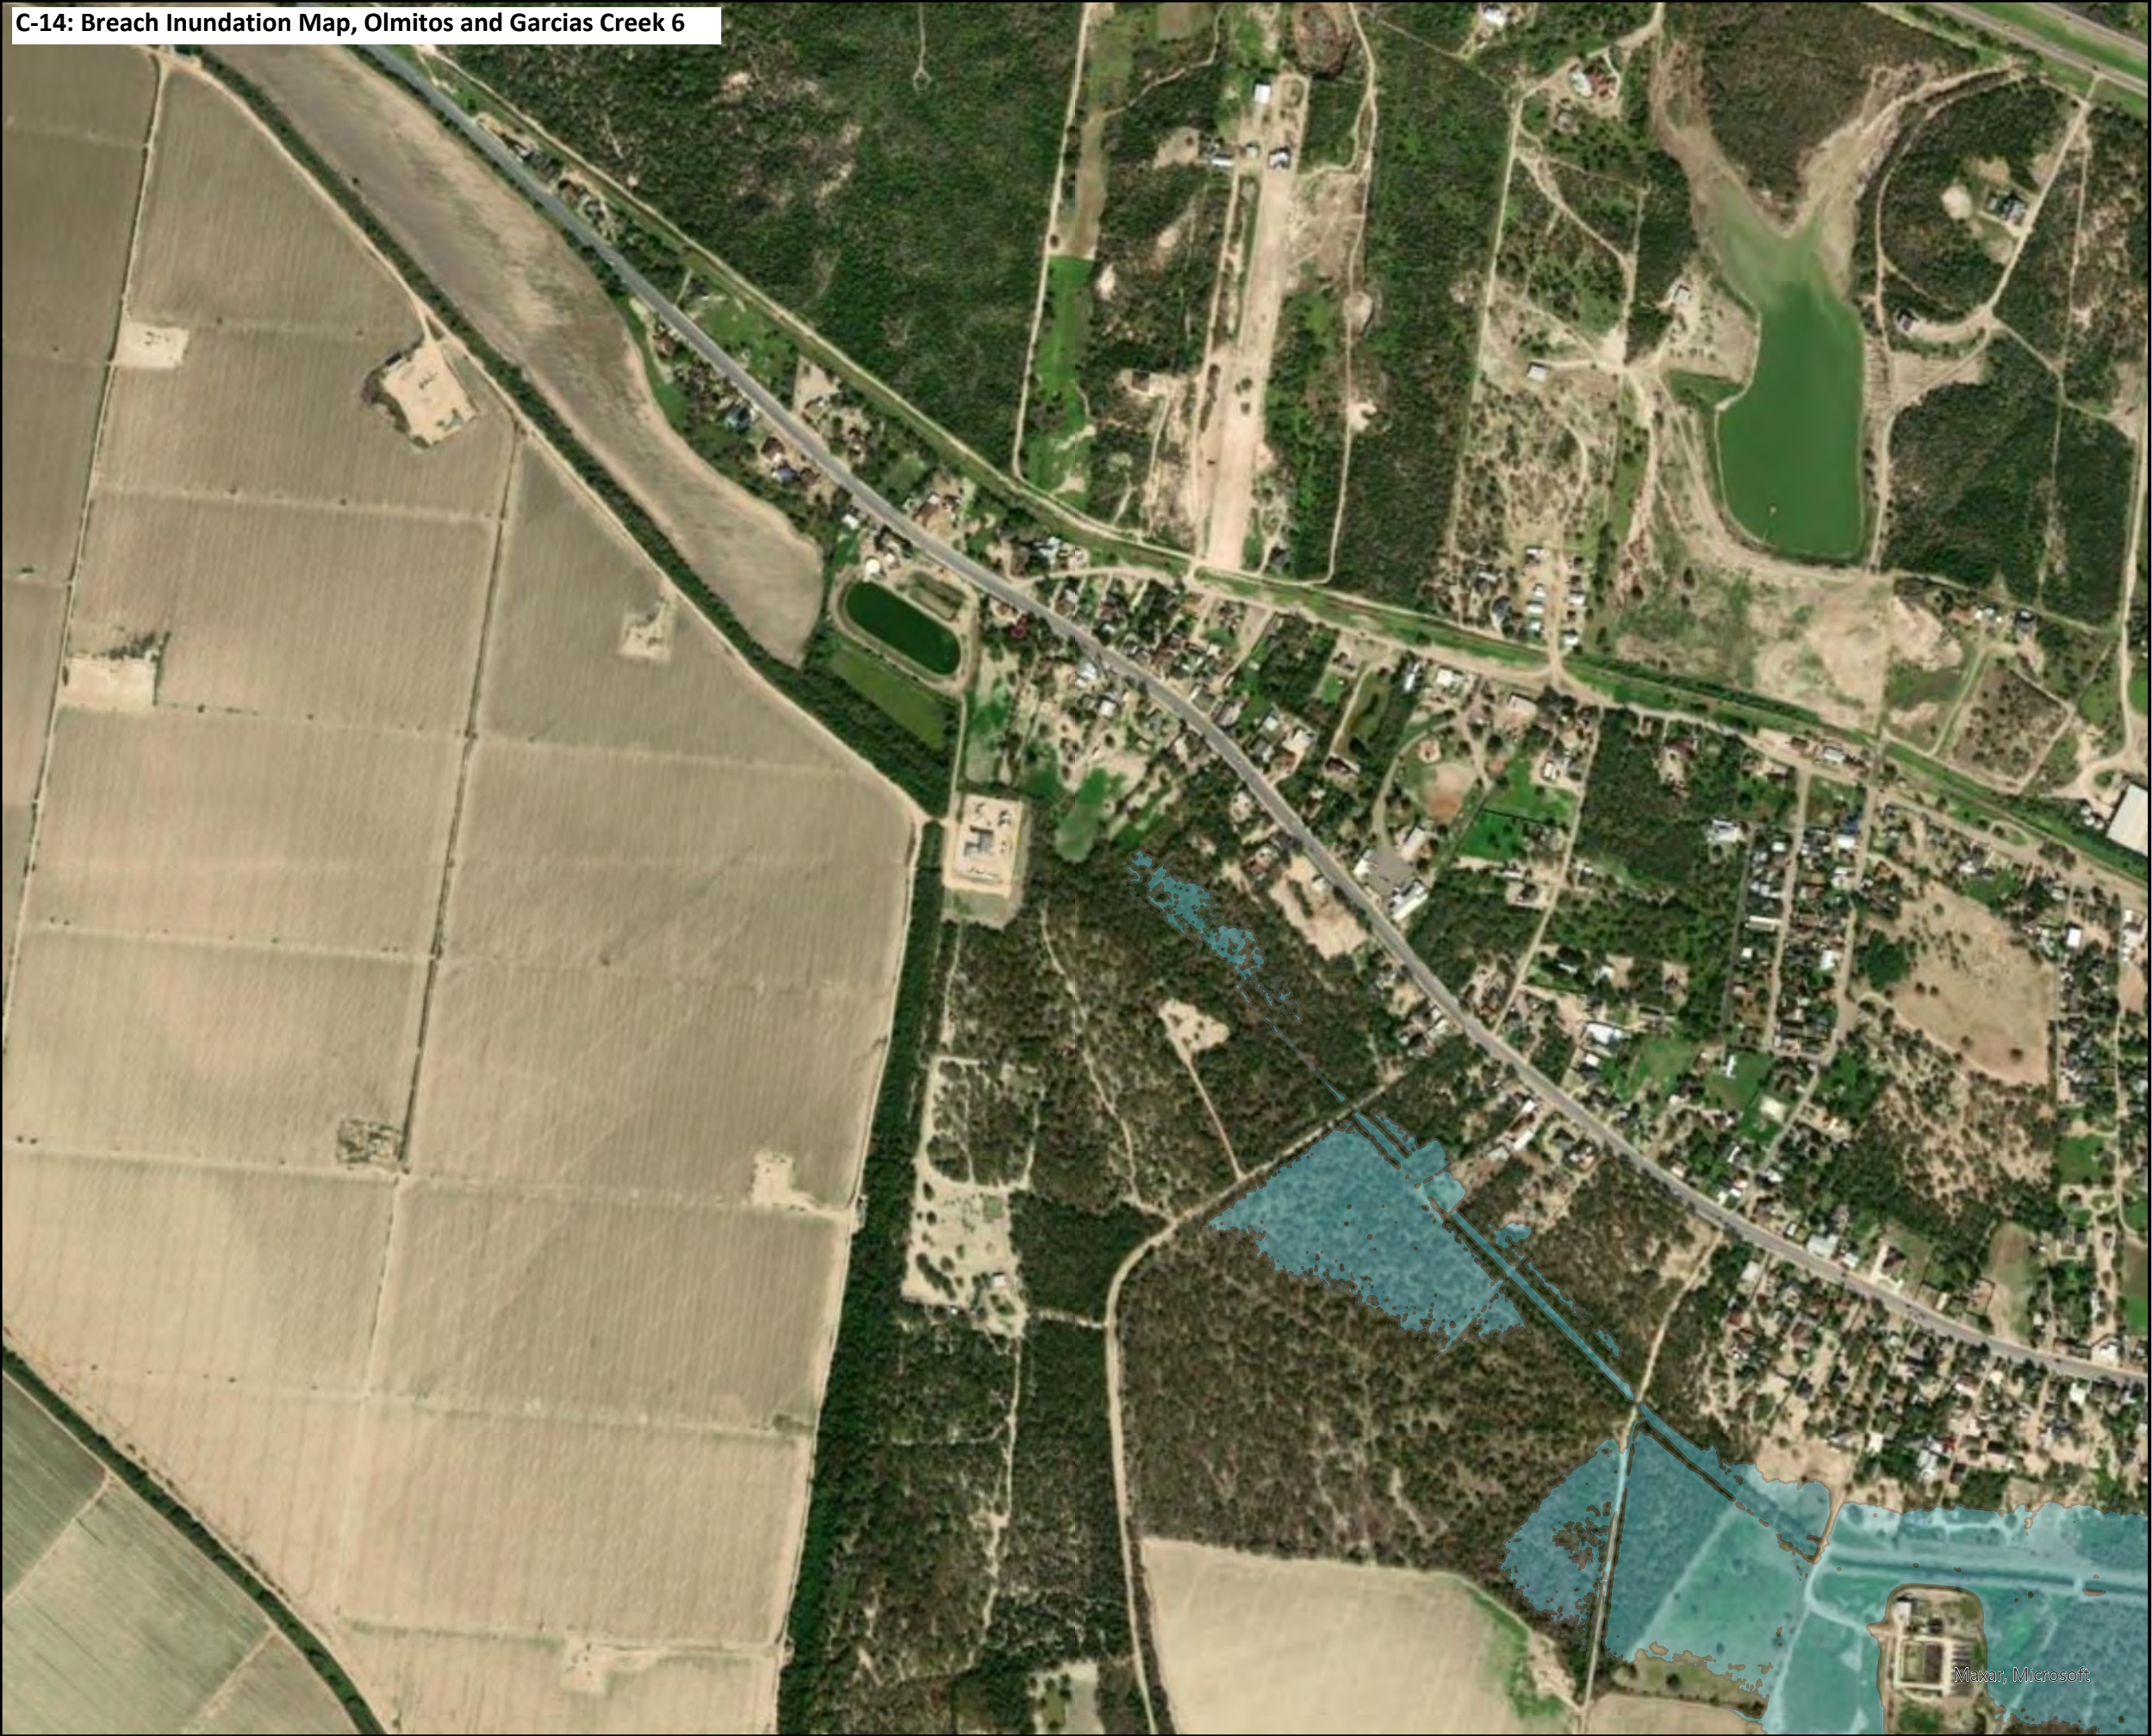
C-14: Breach Inundation Map, Olmitos and Garcias Creek 6

**OLMITOS & GARCIAS CREEK #6  
DAM FAILURE MAPPING**

Panel 3 of 5

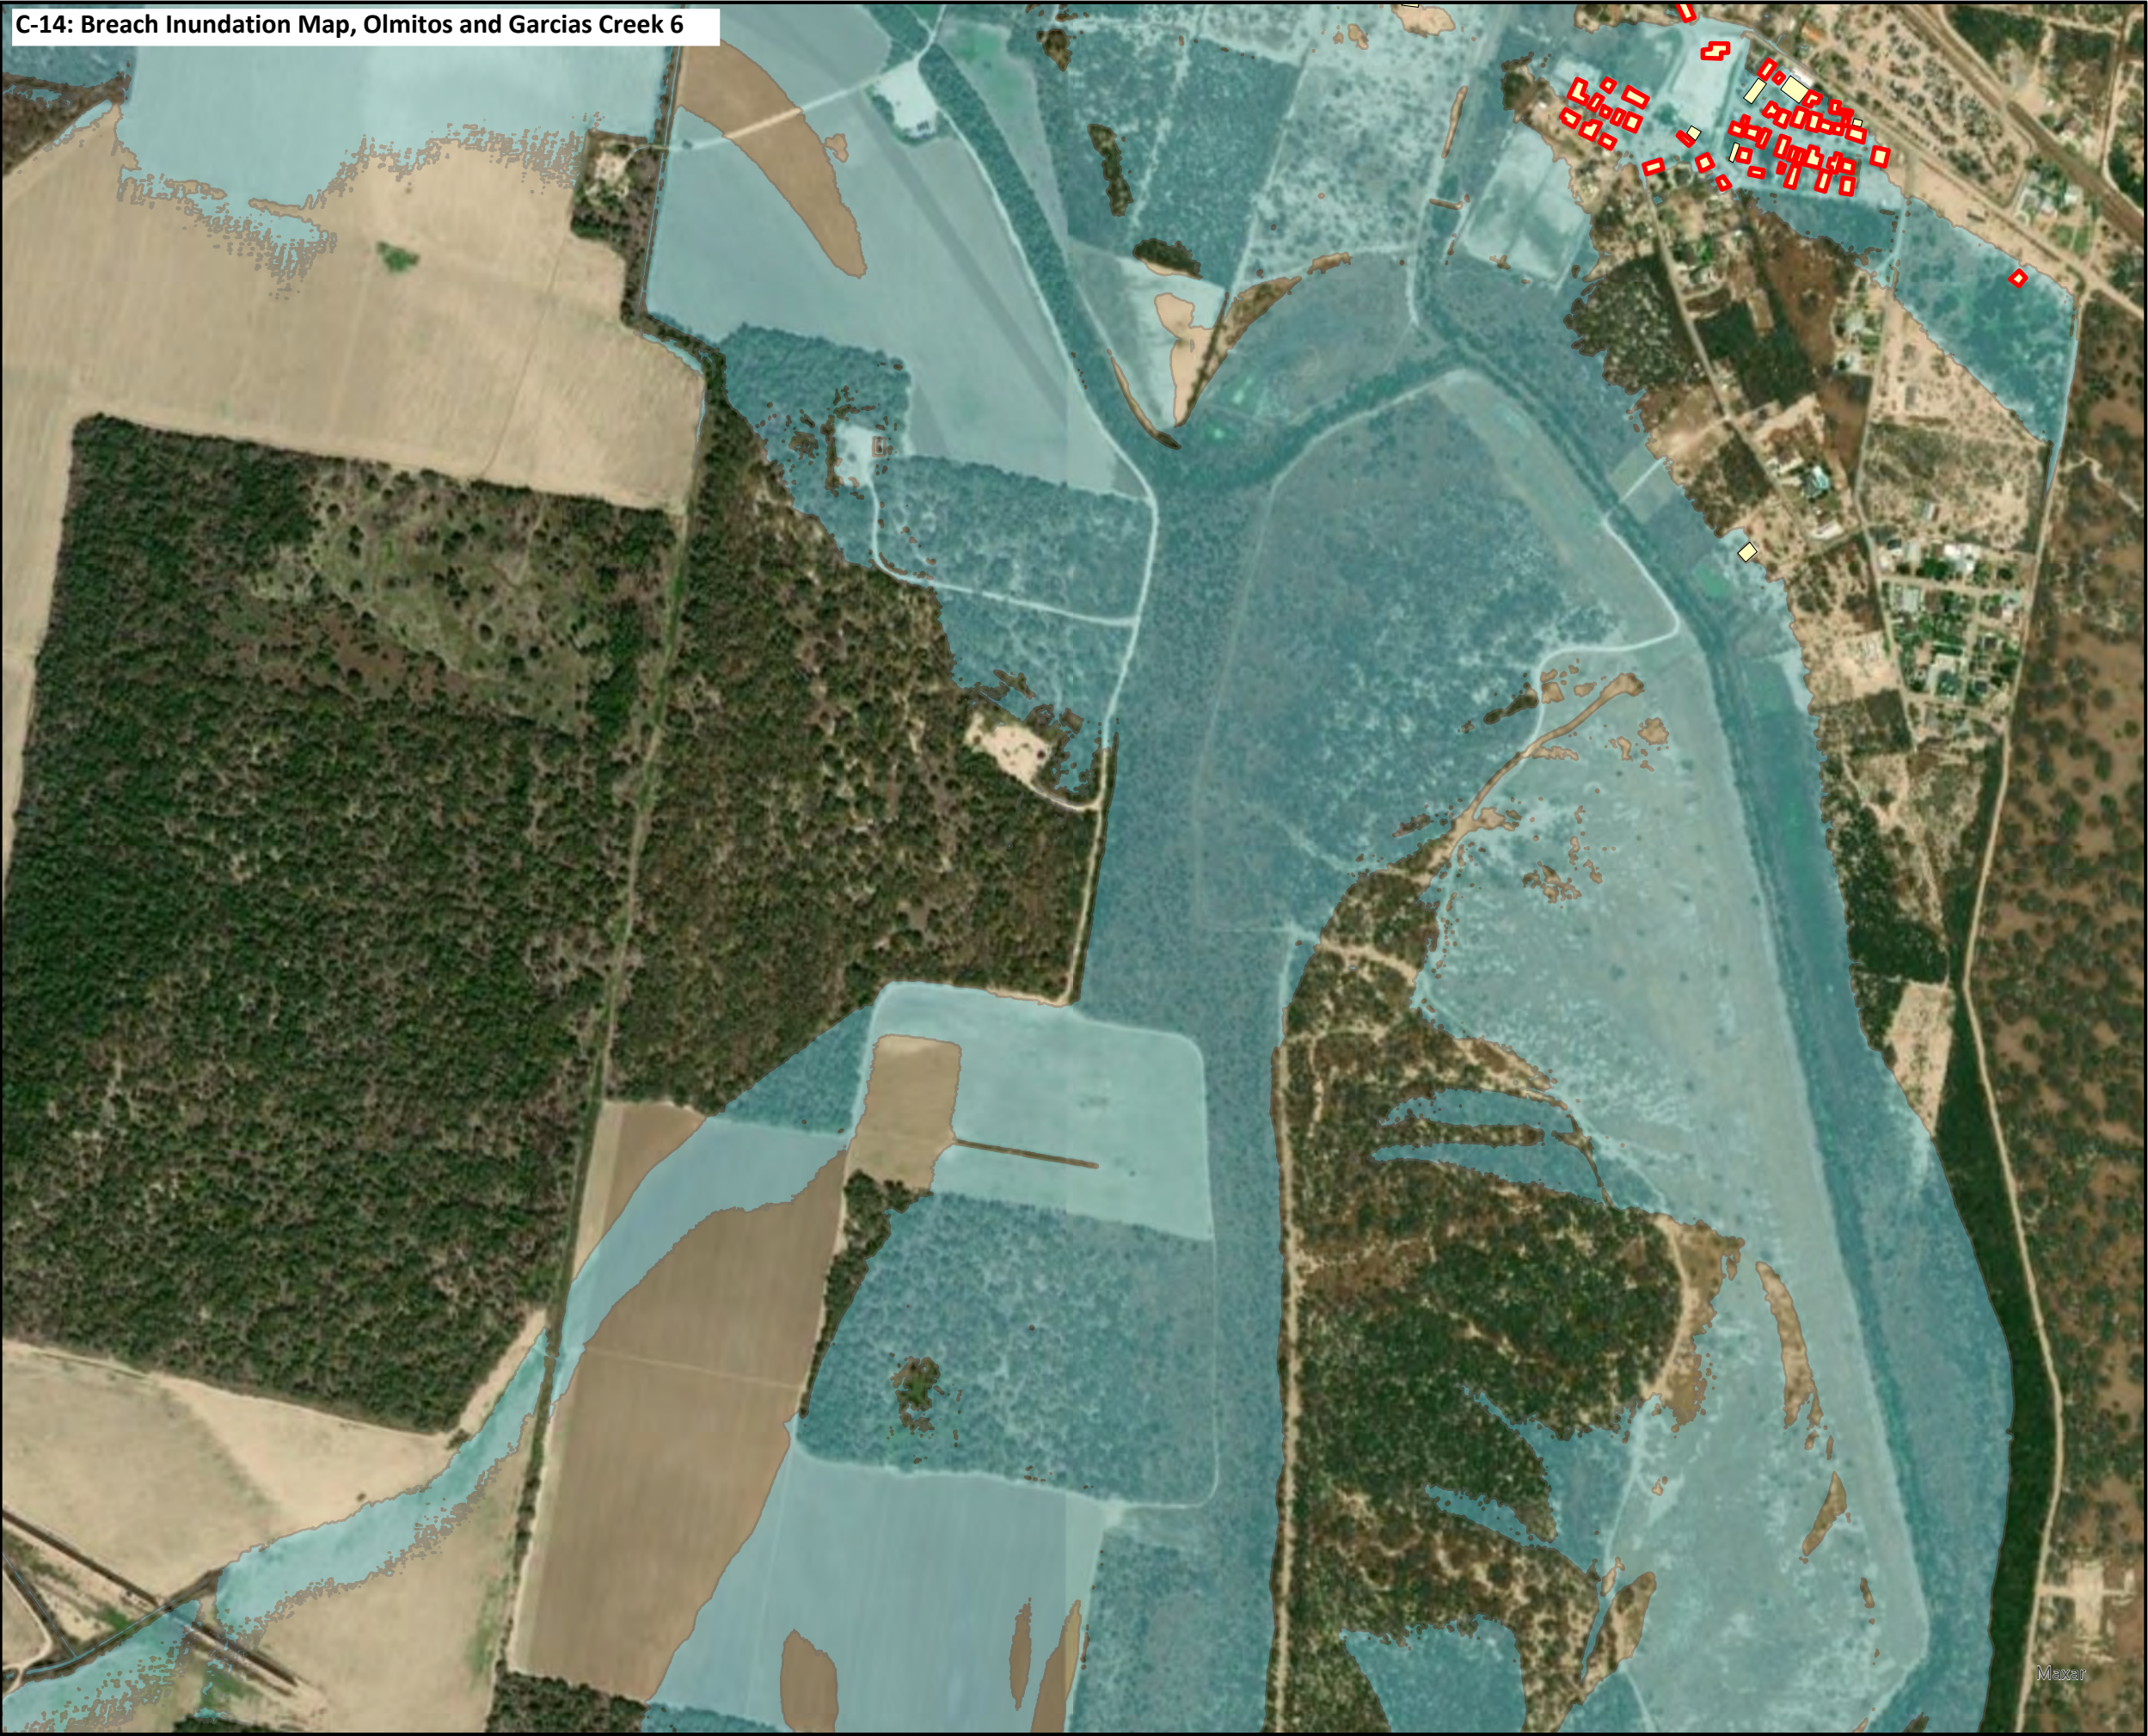
C-14: Breach Inundation Map, Olmitos and Garcias Creek 6

**OLMITOS & GARCIAS CREEK #6  
DAM FAILURE MAPPING**

Panel 4 of 5
