Natural Resource Conservation Service EAXX-005-53-48-1353880190 August 2026

# Appendix F: Environmental Assessment for the Supplemental Watershed Plan No. 2 Rehabilitation of Olmitos and Garcia Watershed Dam No. 6

**Proposal Name:** Supplemental Watershed Plan No. 2 – for the Rehabilitation of Olmitos and Garcia Watershed Dam No. 6

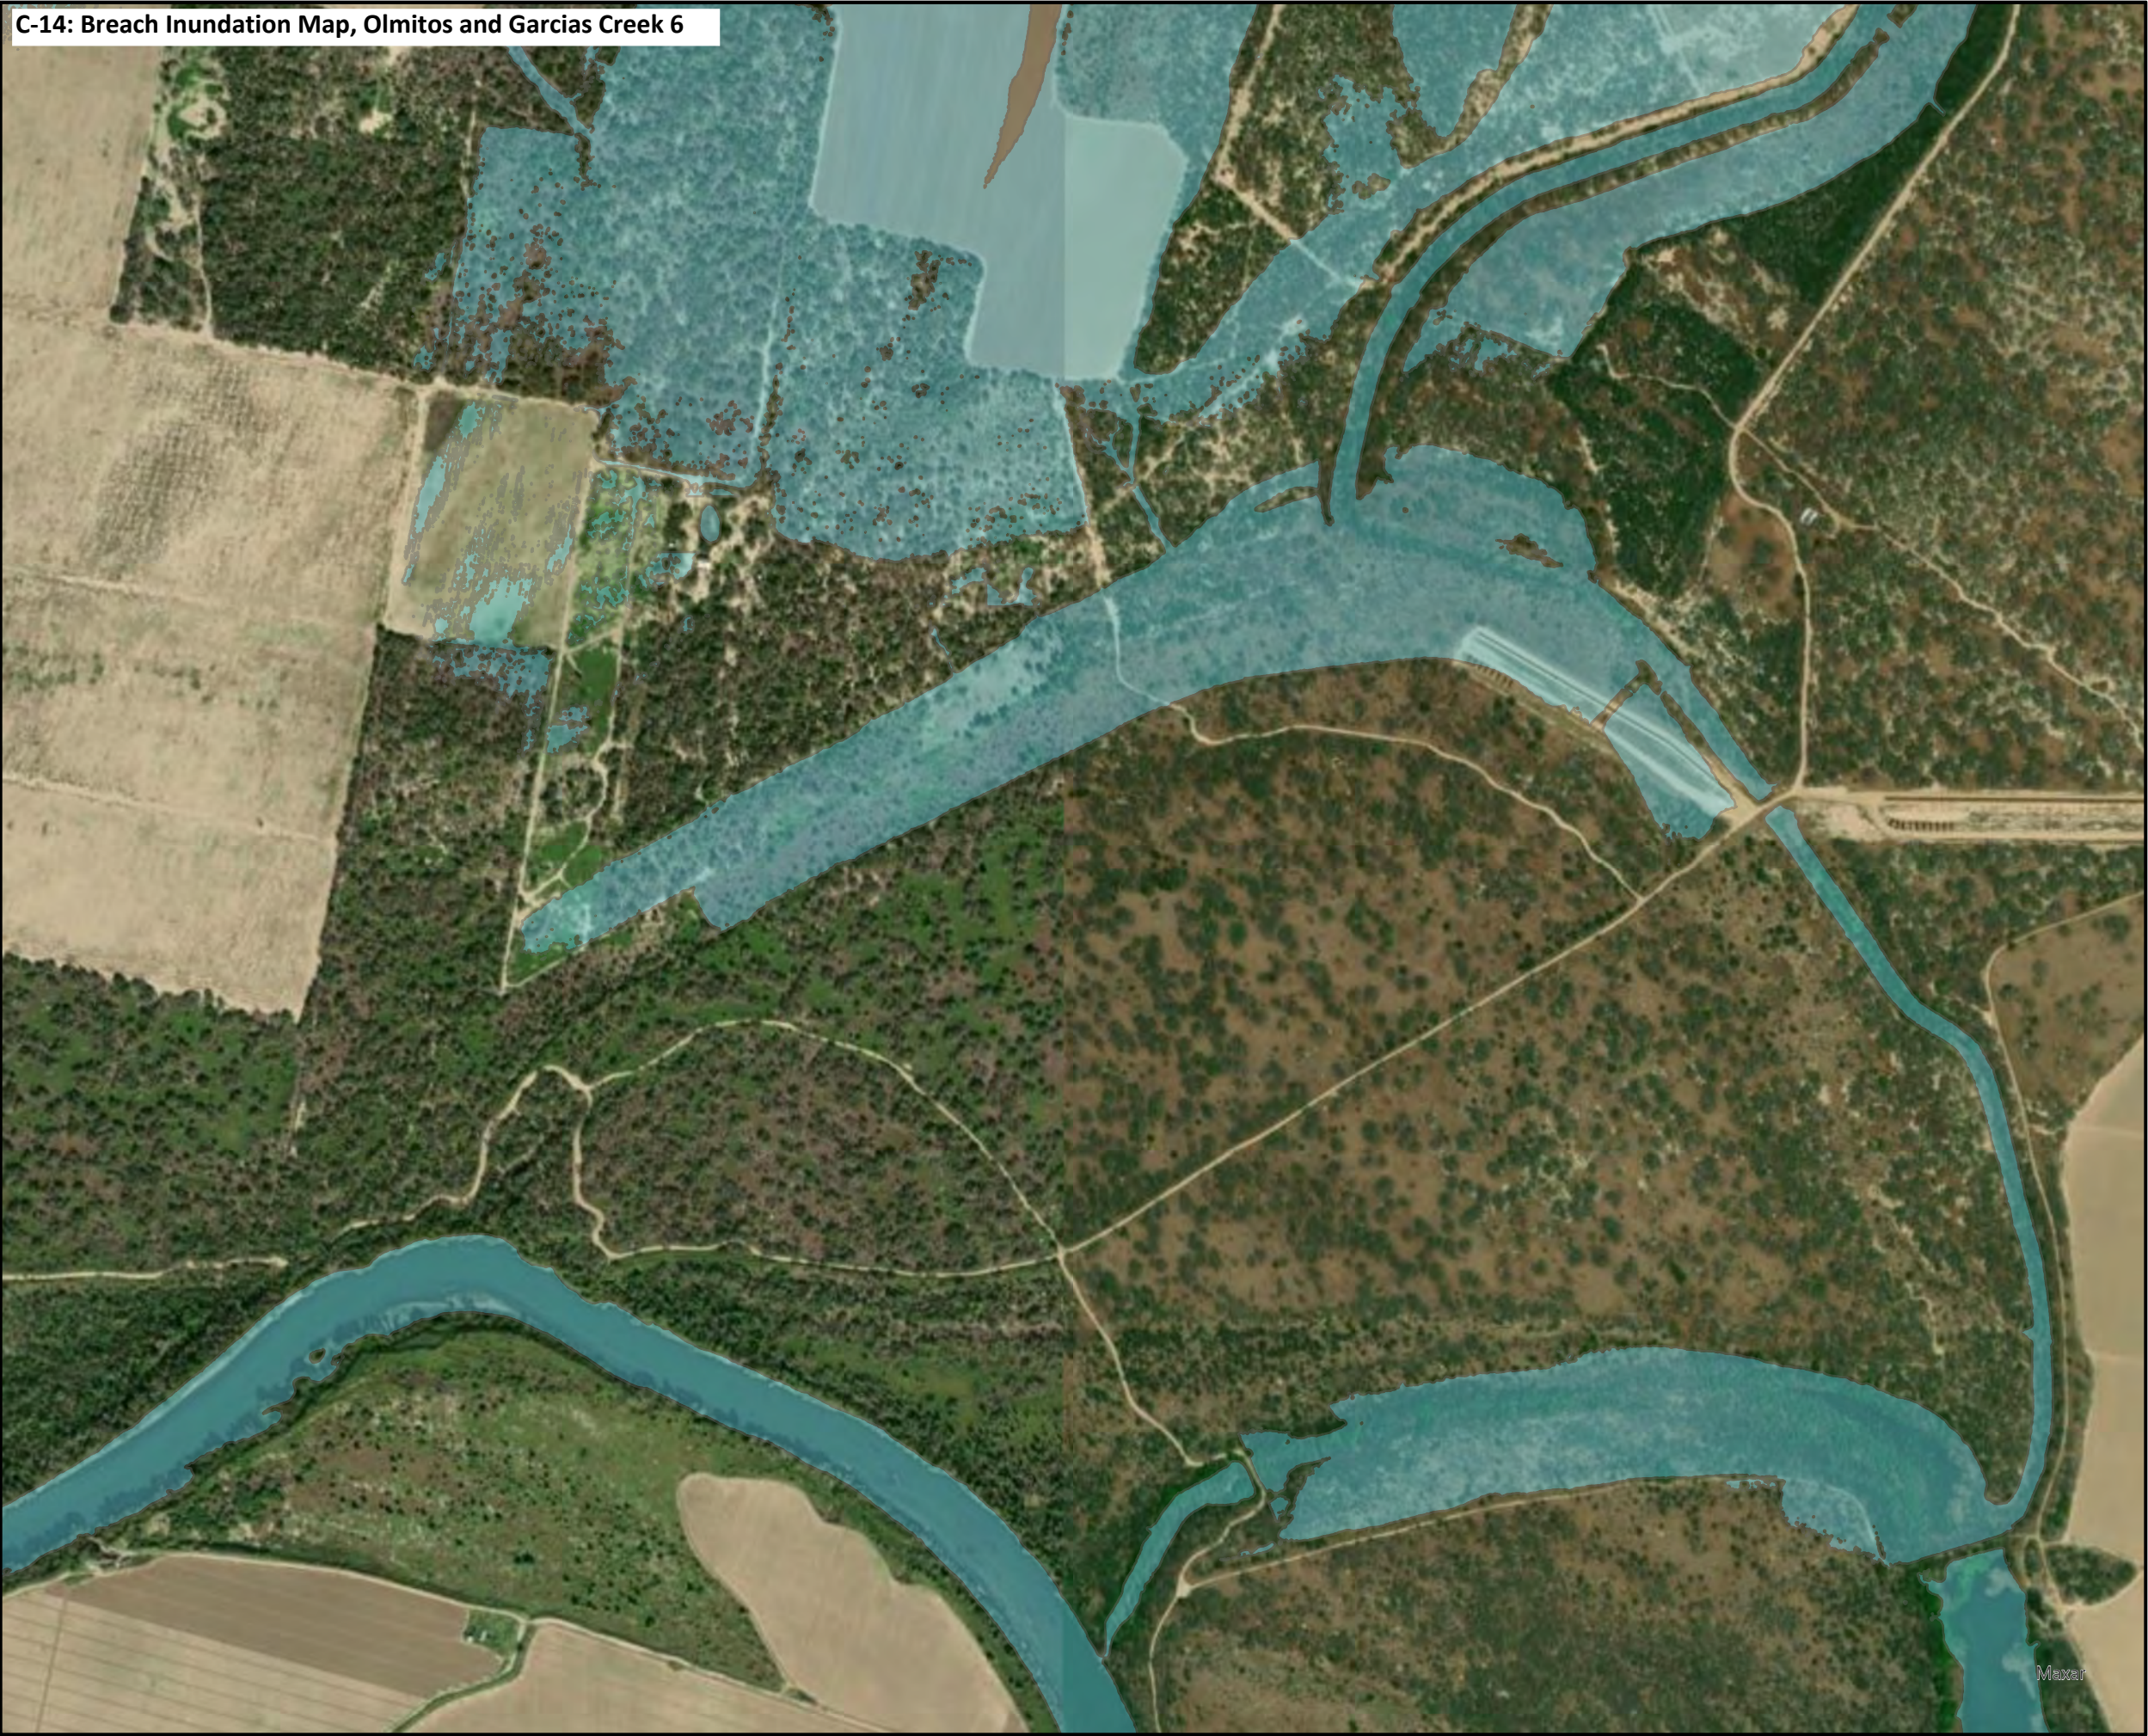
**OLMITOS & GARCIAS CREEK #6  
DAM FAILURE MAPPING**

Panel 5 of 5

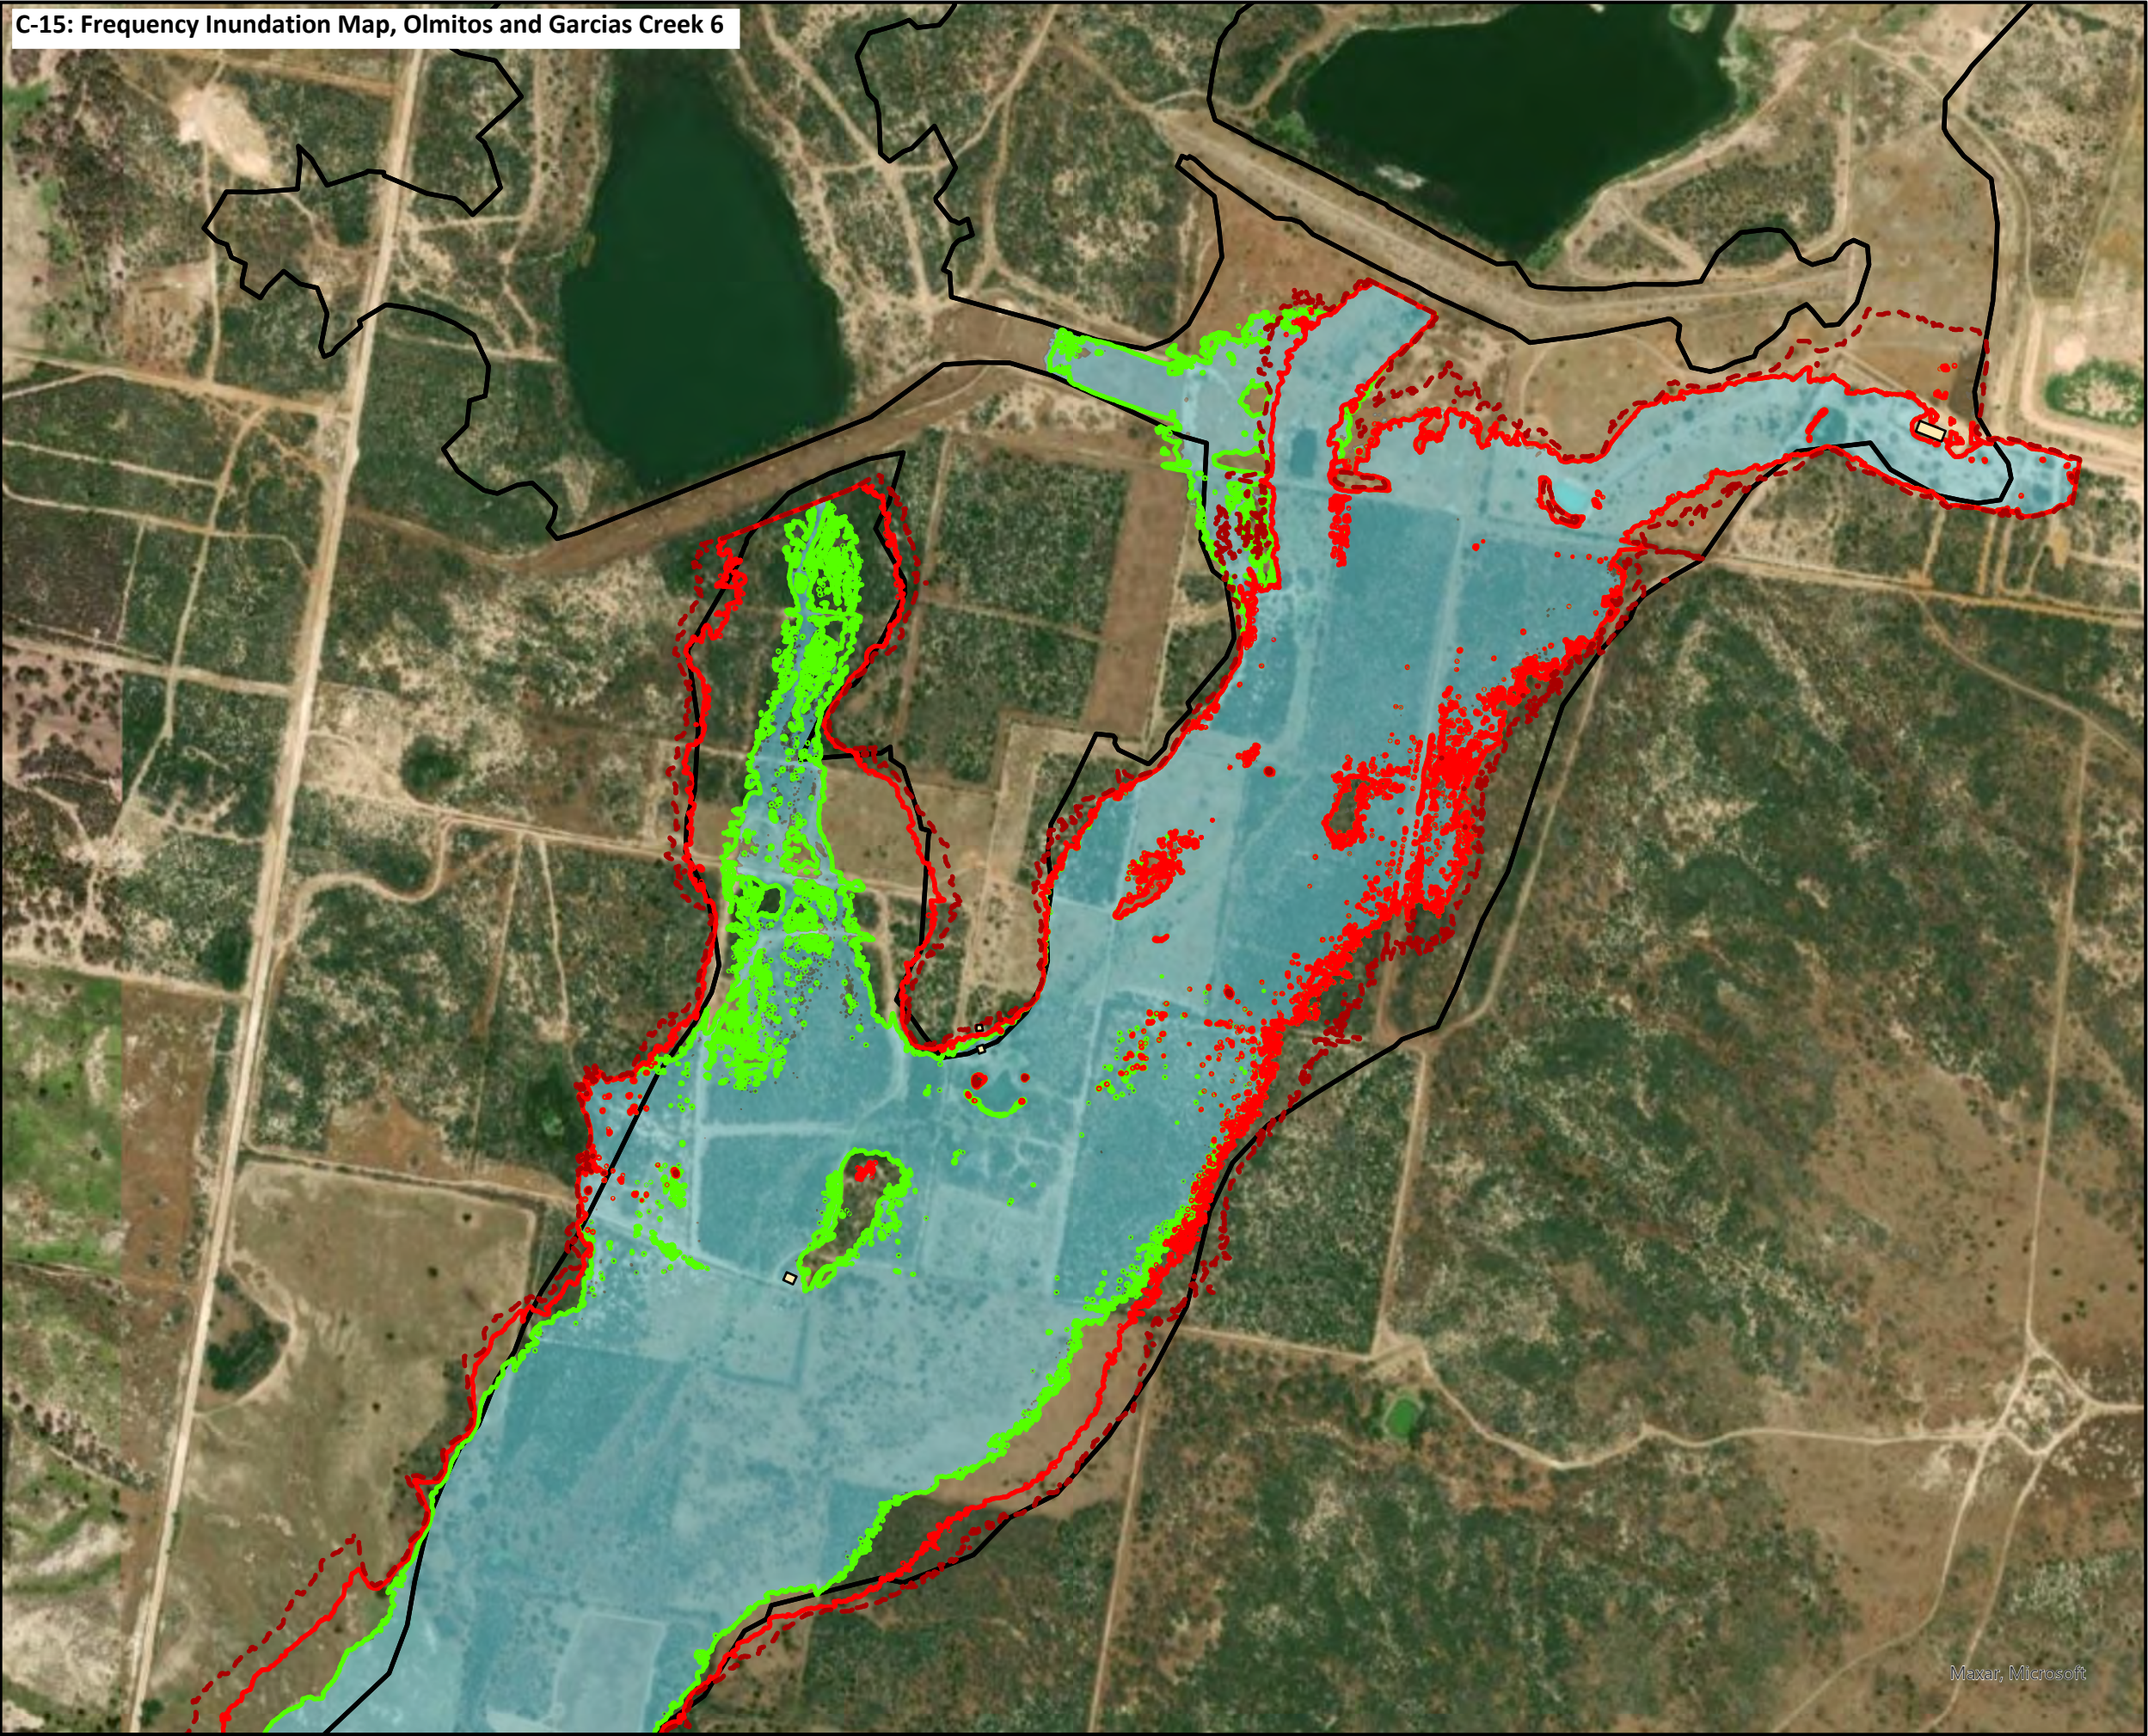
**OLMITOS & GARCIAS CREEK #6**  
**FREQUENCY EVENTS**  
**INUNDATION MAP**  
Panel 1 of 8

- Dam Centerline
- Structure Inventory
- Decom. 1000 Year Inundation
- Decom. 100 Year Inundation
- Preferred Alt. 100 Year Inundation
- Regulatory FEMA Zone A & AE
- Existing 100 yr Floodplain

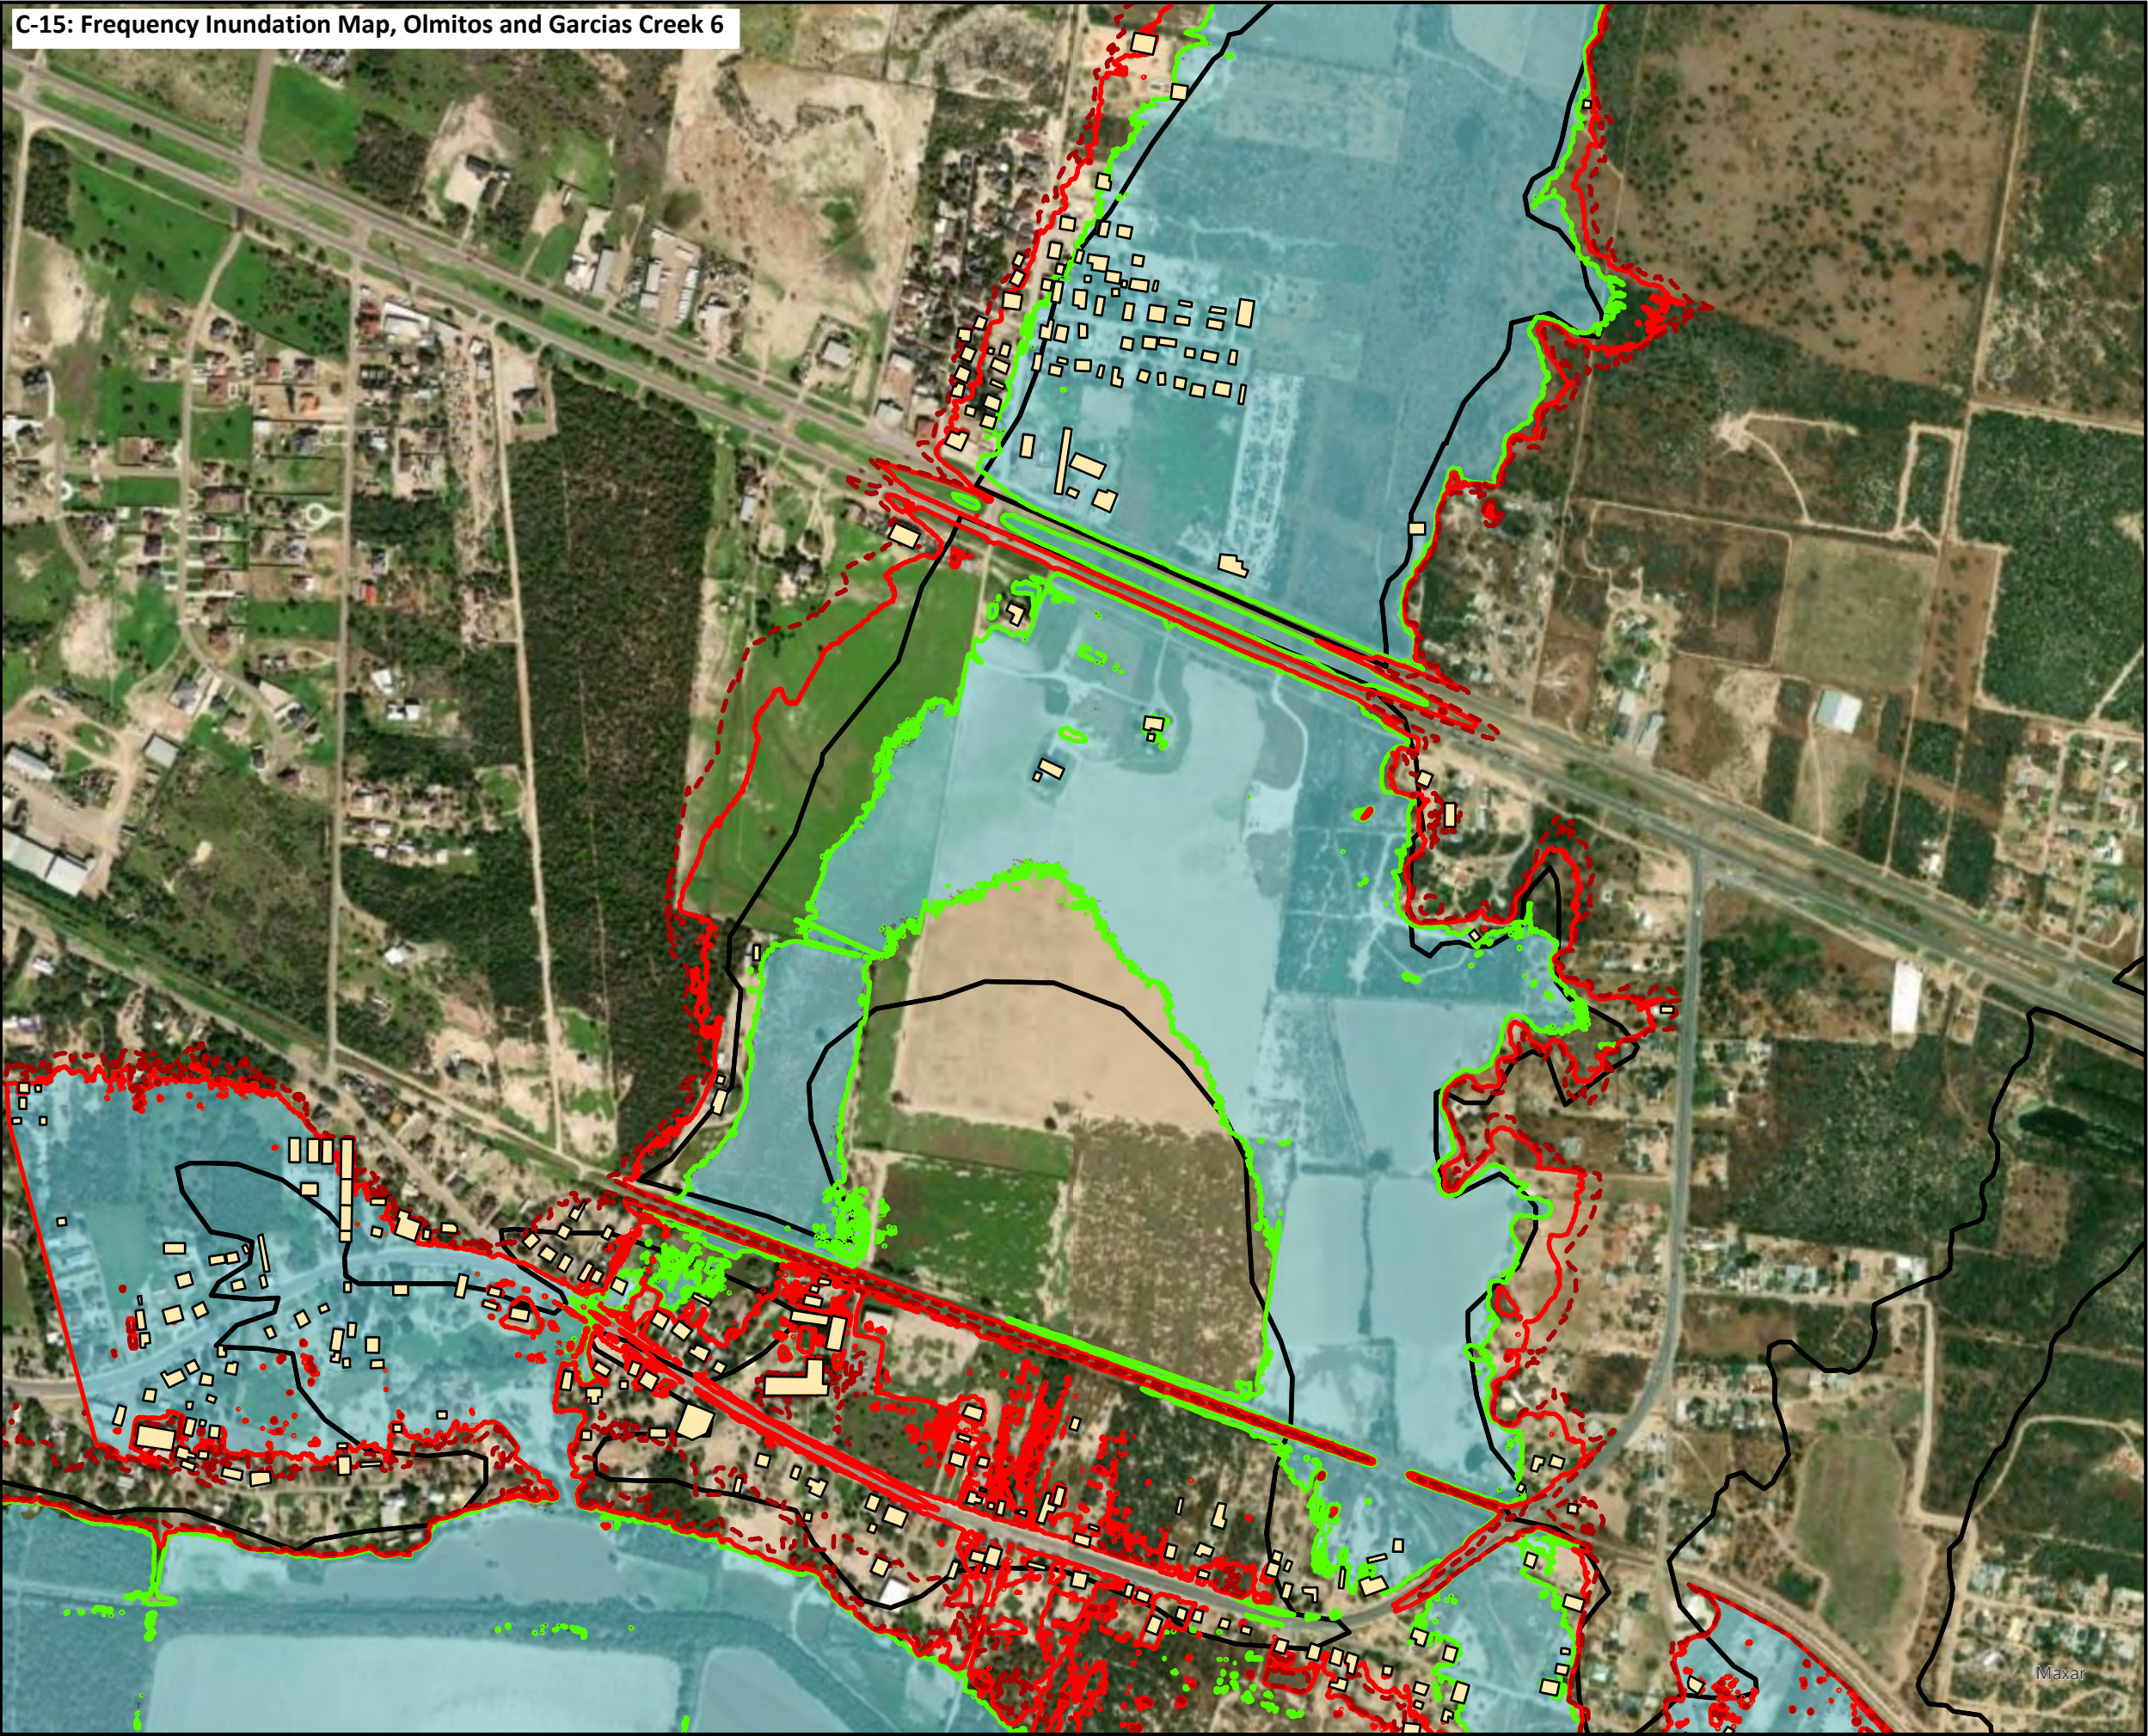
**OLMITOS & GARCIAS CREEK #6**  
**FREQUENCY EVENTS**  
**INUNDATION MAP**  
Panel 2 of 8

- Dam Centerline
- Structure Inventory
- Decom. 1000 Year Inundation
- Decom. 100 Year Inundation
- Preferred Alt. 100 Year Inundation
- Regulatory FEMA Zone A & AE
- Existing 100 yr Floodplain

*The methods used to develop inundation zones and flood wave arrival times are approximate and should only be used as guidance for establishing evacuation zones. Actual areas inundated will depend on actual failure and pre-failure hydrologic conditions and may differ significantly from information shown on maps.*

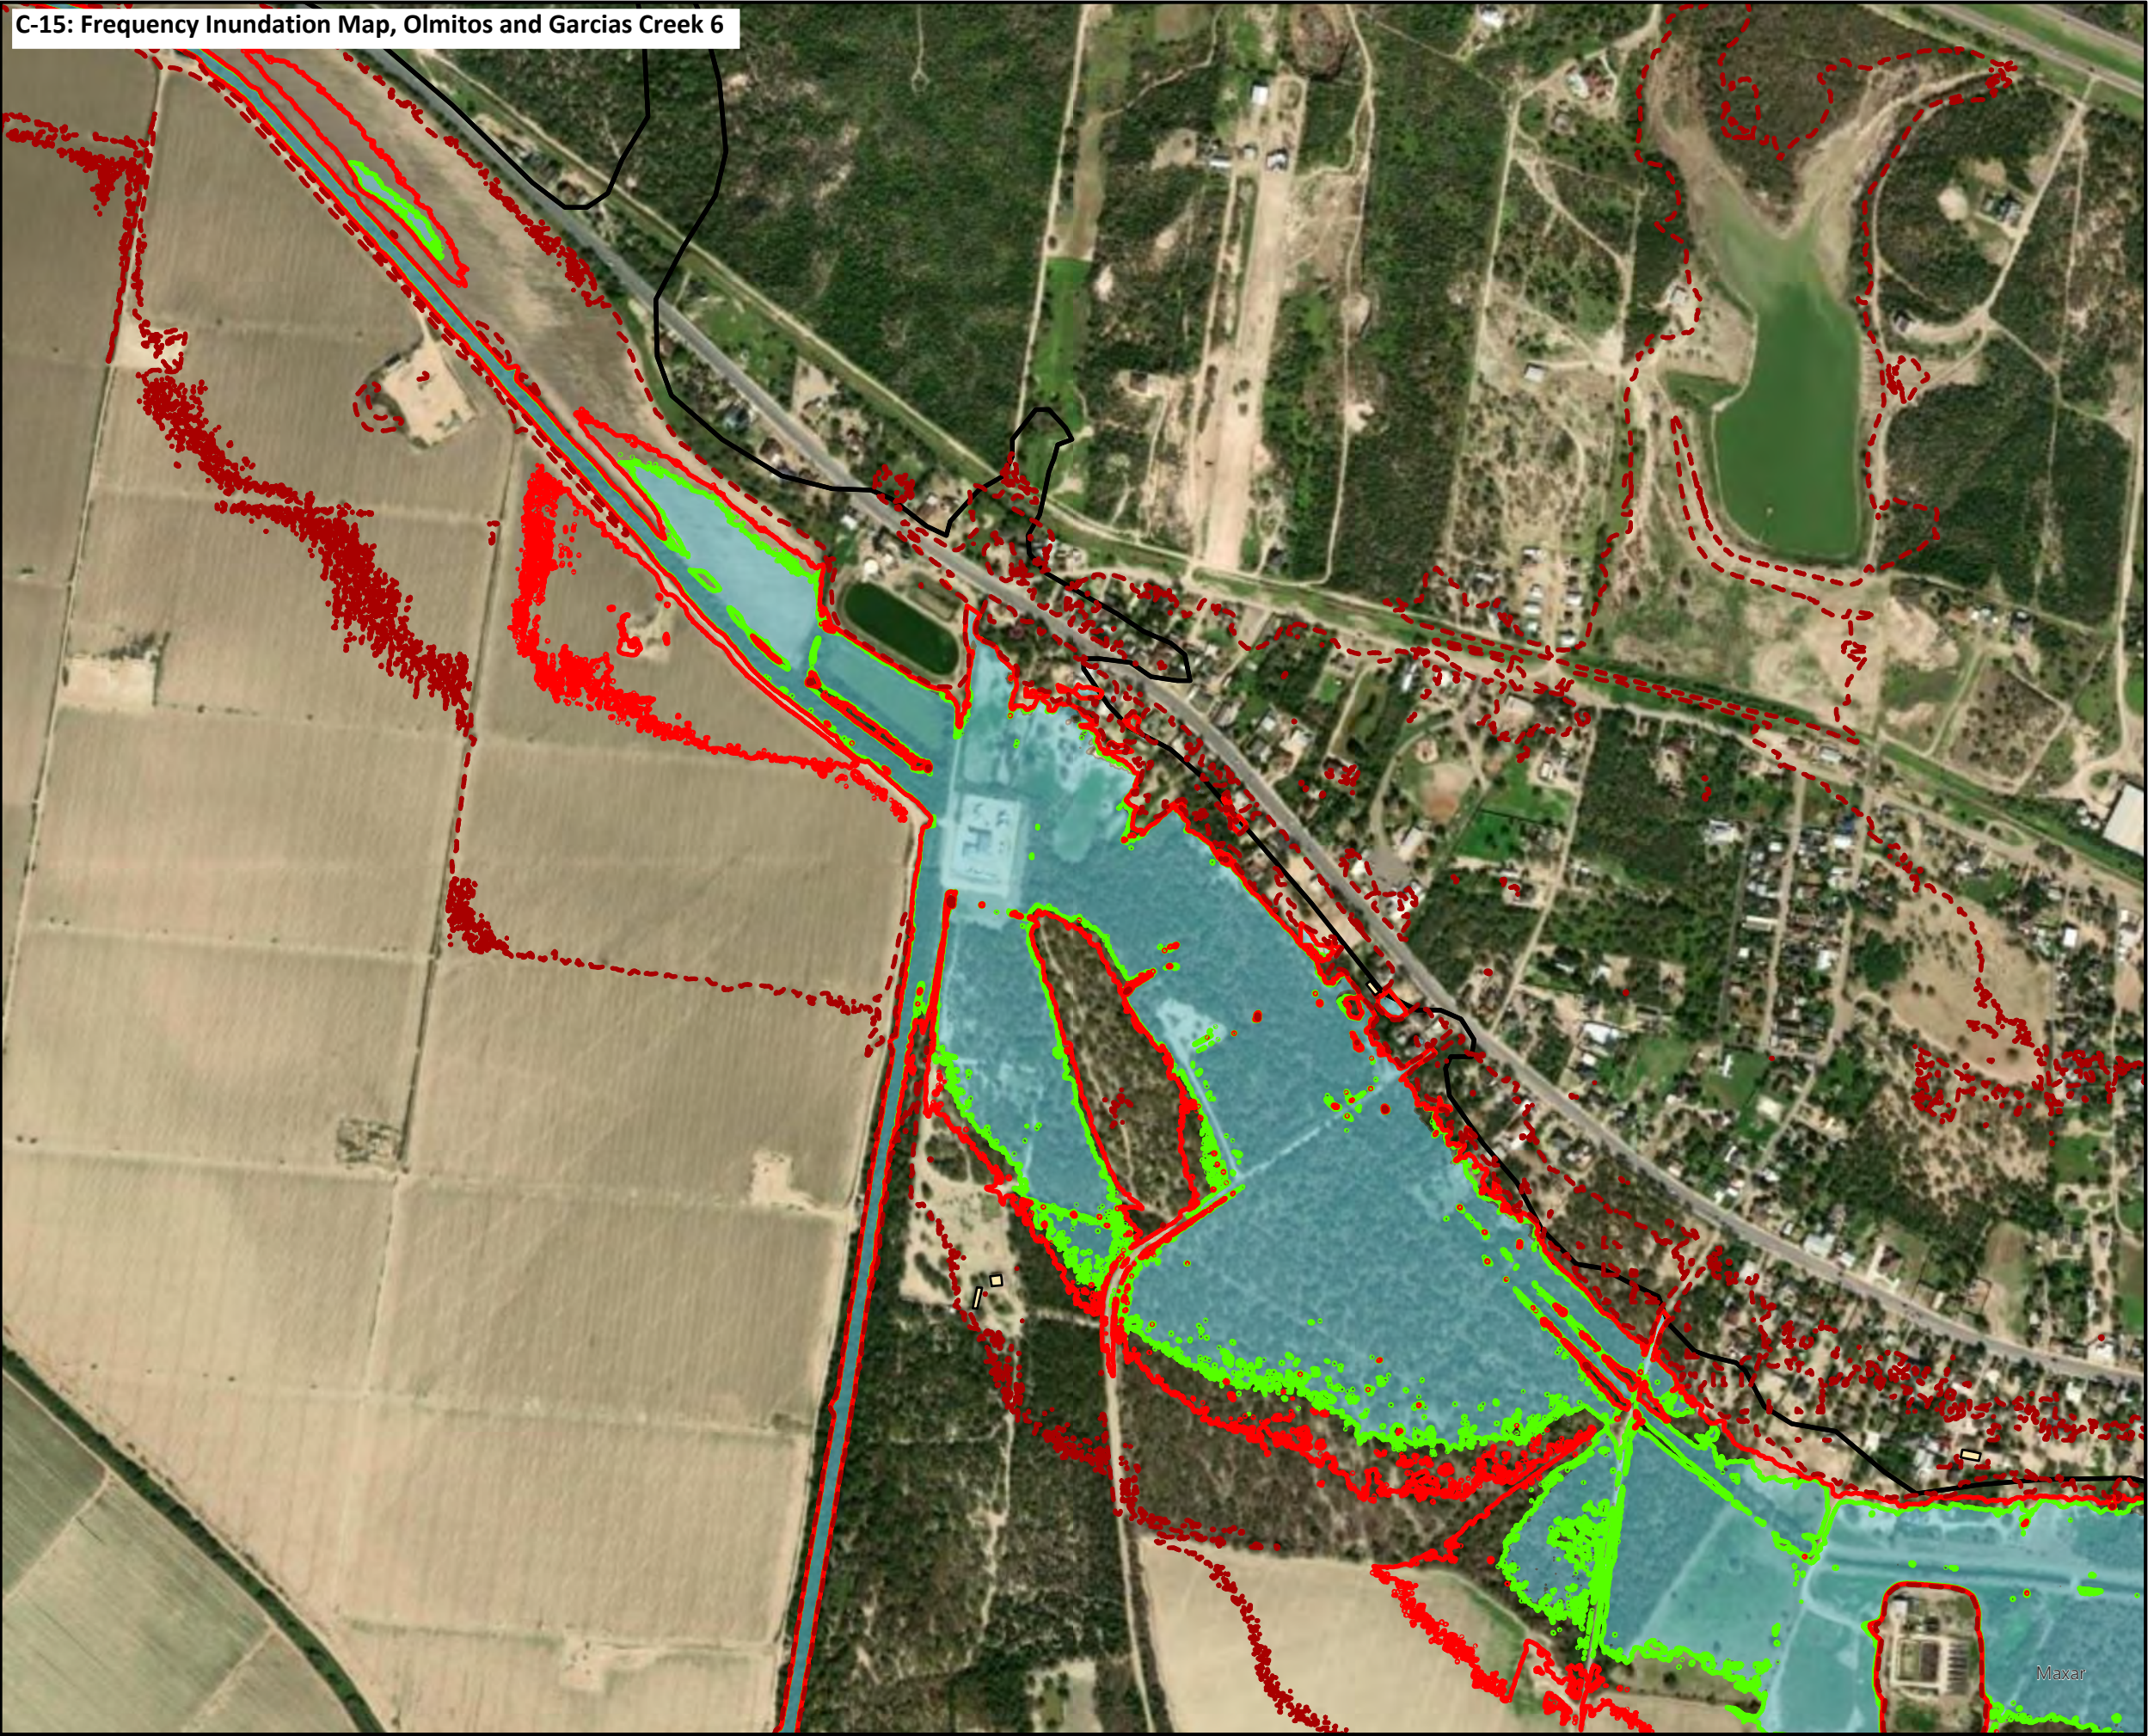
**OLMITOS & GARCIAS CREEK #6**  
**FREQUENCY EVENTS**  
**INUNDATION MAP**  
Panel 3 of 8

- Dam Centerline
- Structure Inventory
- Decom. 1000 Year Inundation
- Decom. 100 Year Inundation
- Preferred Alt. 100 Year Inundation
- Regulatory FEMA Zone A & AE
- Existing 100 yr Floodplain

*The methods used to develop inundation zones and flood wave arrival times are approximate and should only be used as guidance for establishing evacuation zones. Actual areas inundated will depend on actual failure and pre-failure hydrologic conditions and may differ significantly from information shown on maps.*

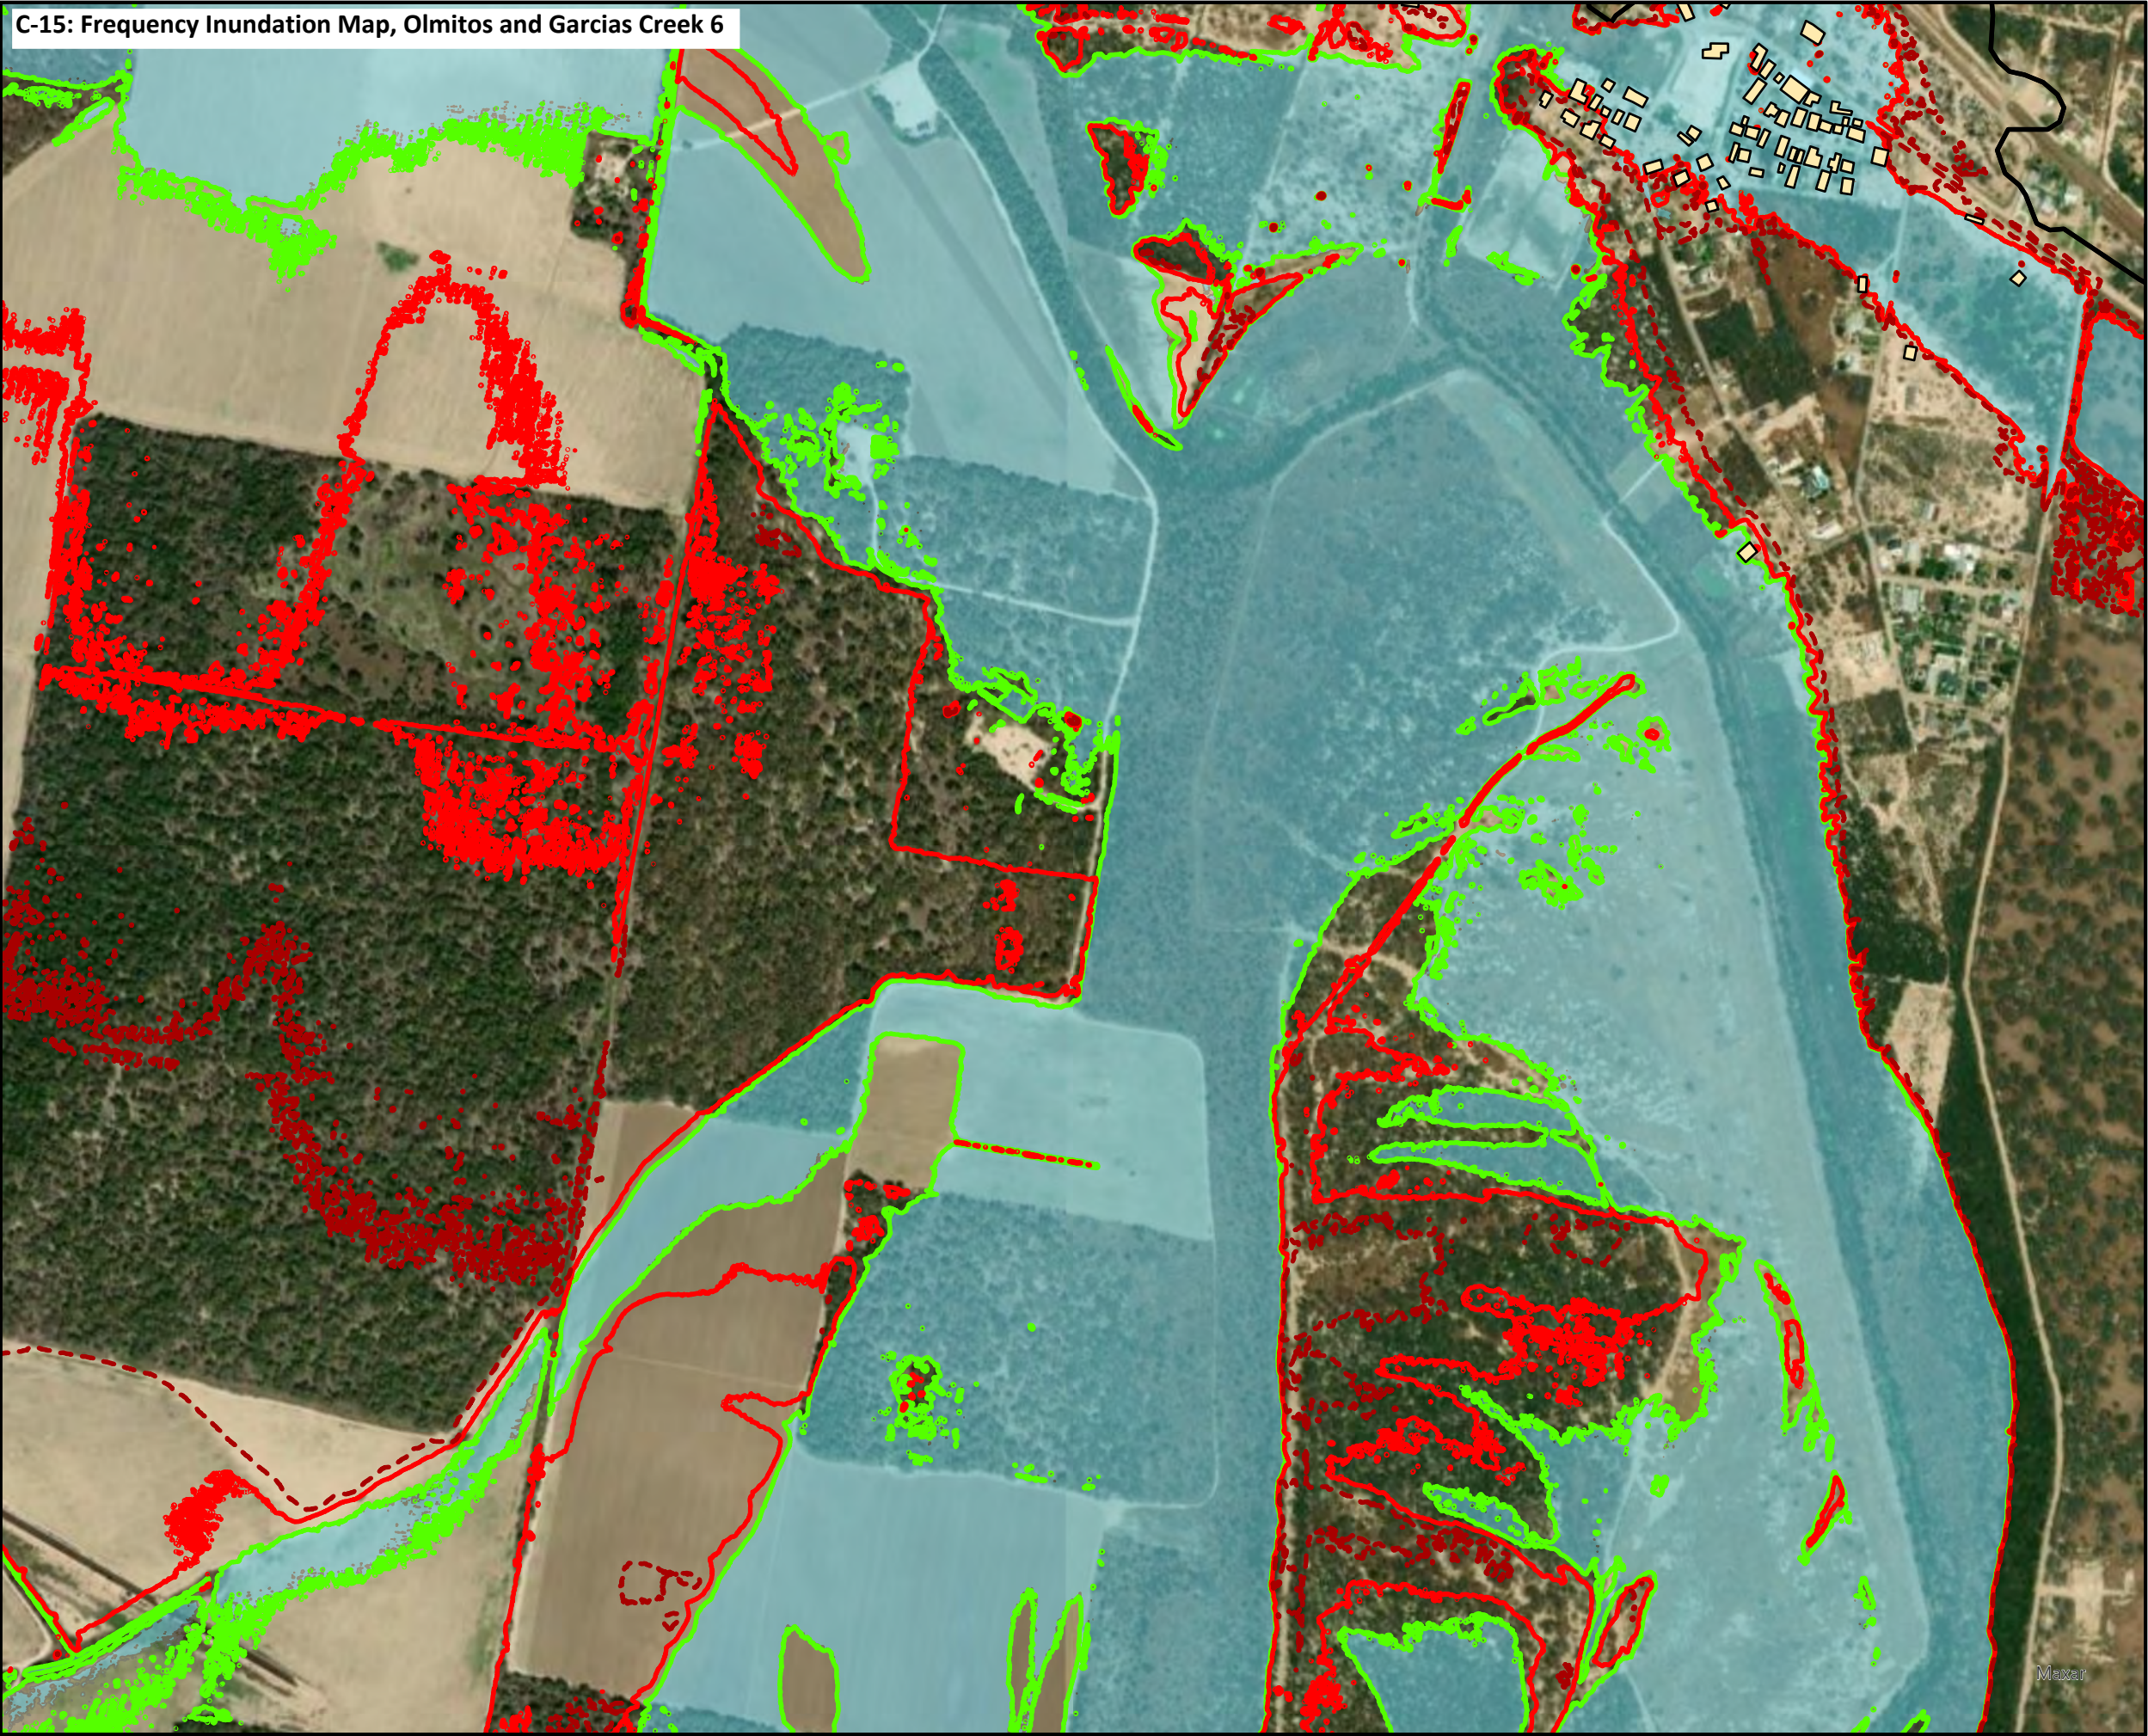
**OLMITOS & GARCIAS CREEK #6  
FREQUENCY EVENTS  
INUNDATION MAP**  
Panel 4 of 8

- Dam Centerline
- Structure Inventory
- Decom. 1000 Year Inundation
- Decom. 100 Year Inundation
- Preferred Alt. 100 Year Inundation
- Regulatory FEMA Zone A & AE
- Existing 100 yr Floodplain

*The methods used to develop inundation zones and flood wave arrival times are approximate and should only be used as guidance for establishing evacuation zones. Actual areas inundated will depend on actual failure and pre-failure hydrologic conditions and may differ significantly from information shown on maps.*

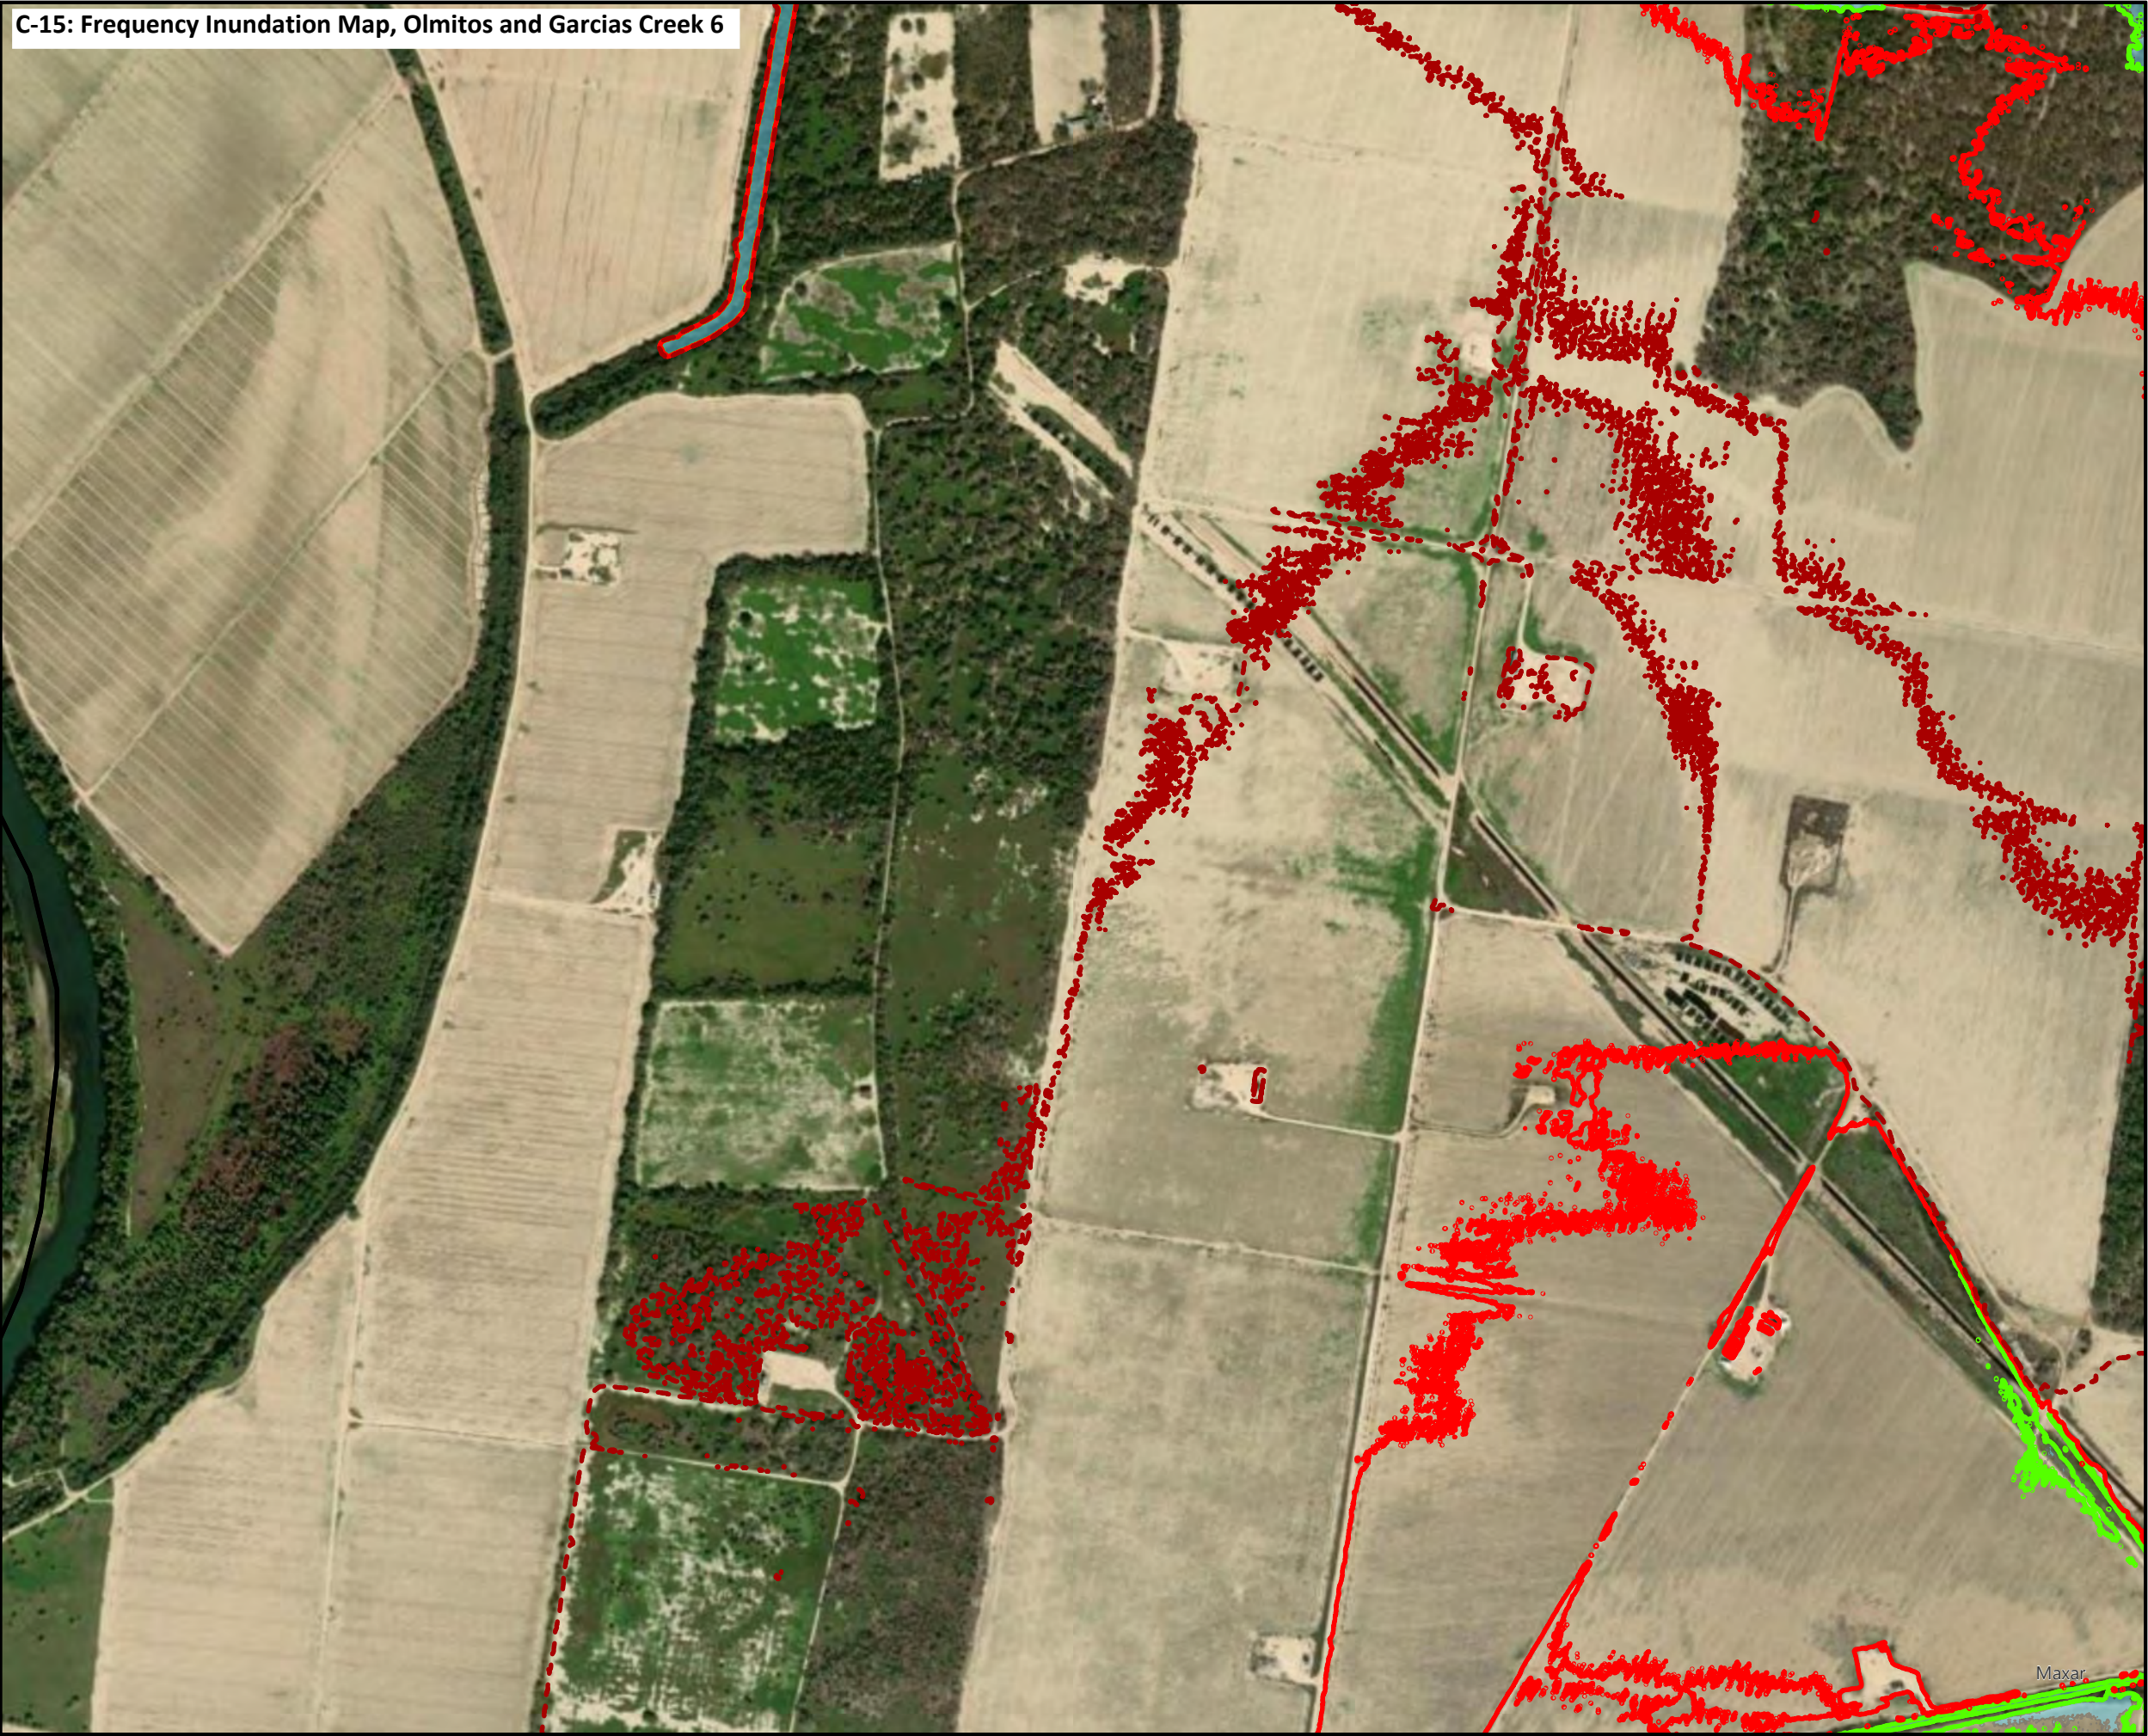
**OLMITOS & GARCIAS CREEK #6**  
**FREQUENCY EVENTS**  
**INUNDATION MAP**  
Panel 5 of 8

- Dam Centerline
- Structure Inventory
- Decom. 1000 Year Inundation
- Decom. 100 Year Inundation
- Preferred Alt. 100 Year Inundation
- Regulatory FEMA Zone A & AE
- Existing 100 yr Floodplain

*The methods used to develop inundation zones and flood wave arrival times are approximate and should only be used as guidance for establishing evacuation zones. Actual areas inundated will depend on actual failure and pre-failure hydrologic conditions and may differ significantly from information shown on maps.*
