Natural Resource Conservation Service EAXX-005-53-48-1353880190 August 2026

# Appendix F: Environmental Assessment for the Supplemental Watershed Plan No. 2 Rehabilitation of Olmitos and Garcia Watershed Dam No. 6

**Proposal Name:** Supplemental Watershed Plan No. 2 – for the Rehabilitation of Olmitos and Garcia Watershed Dam No. 6

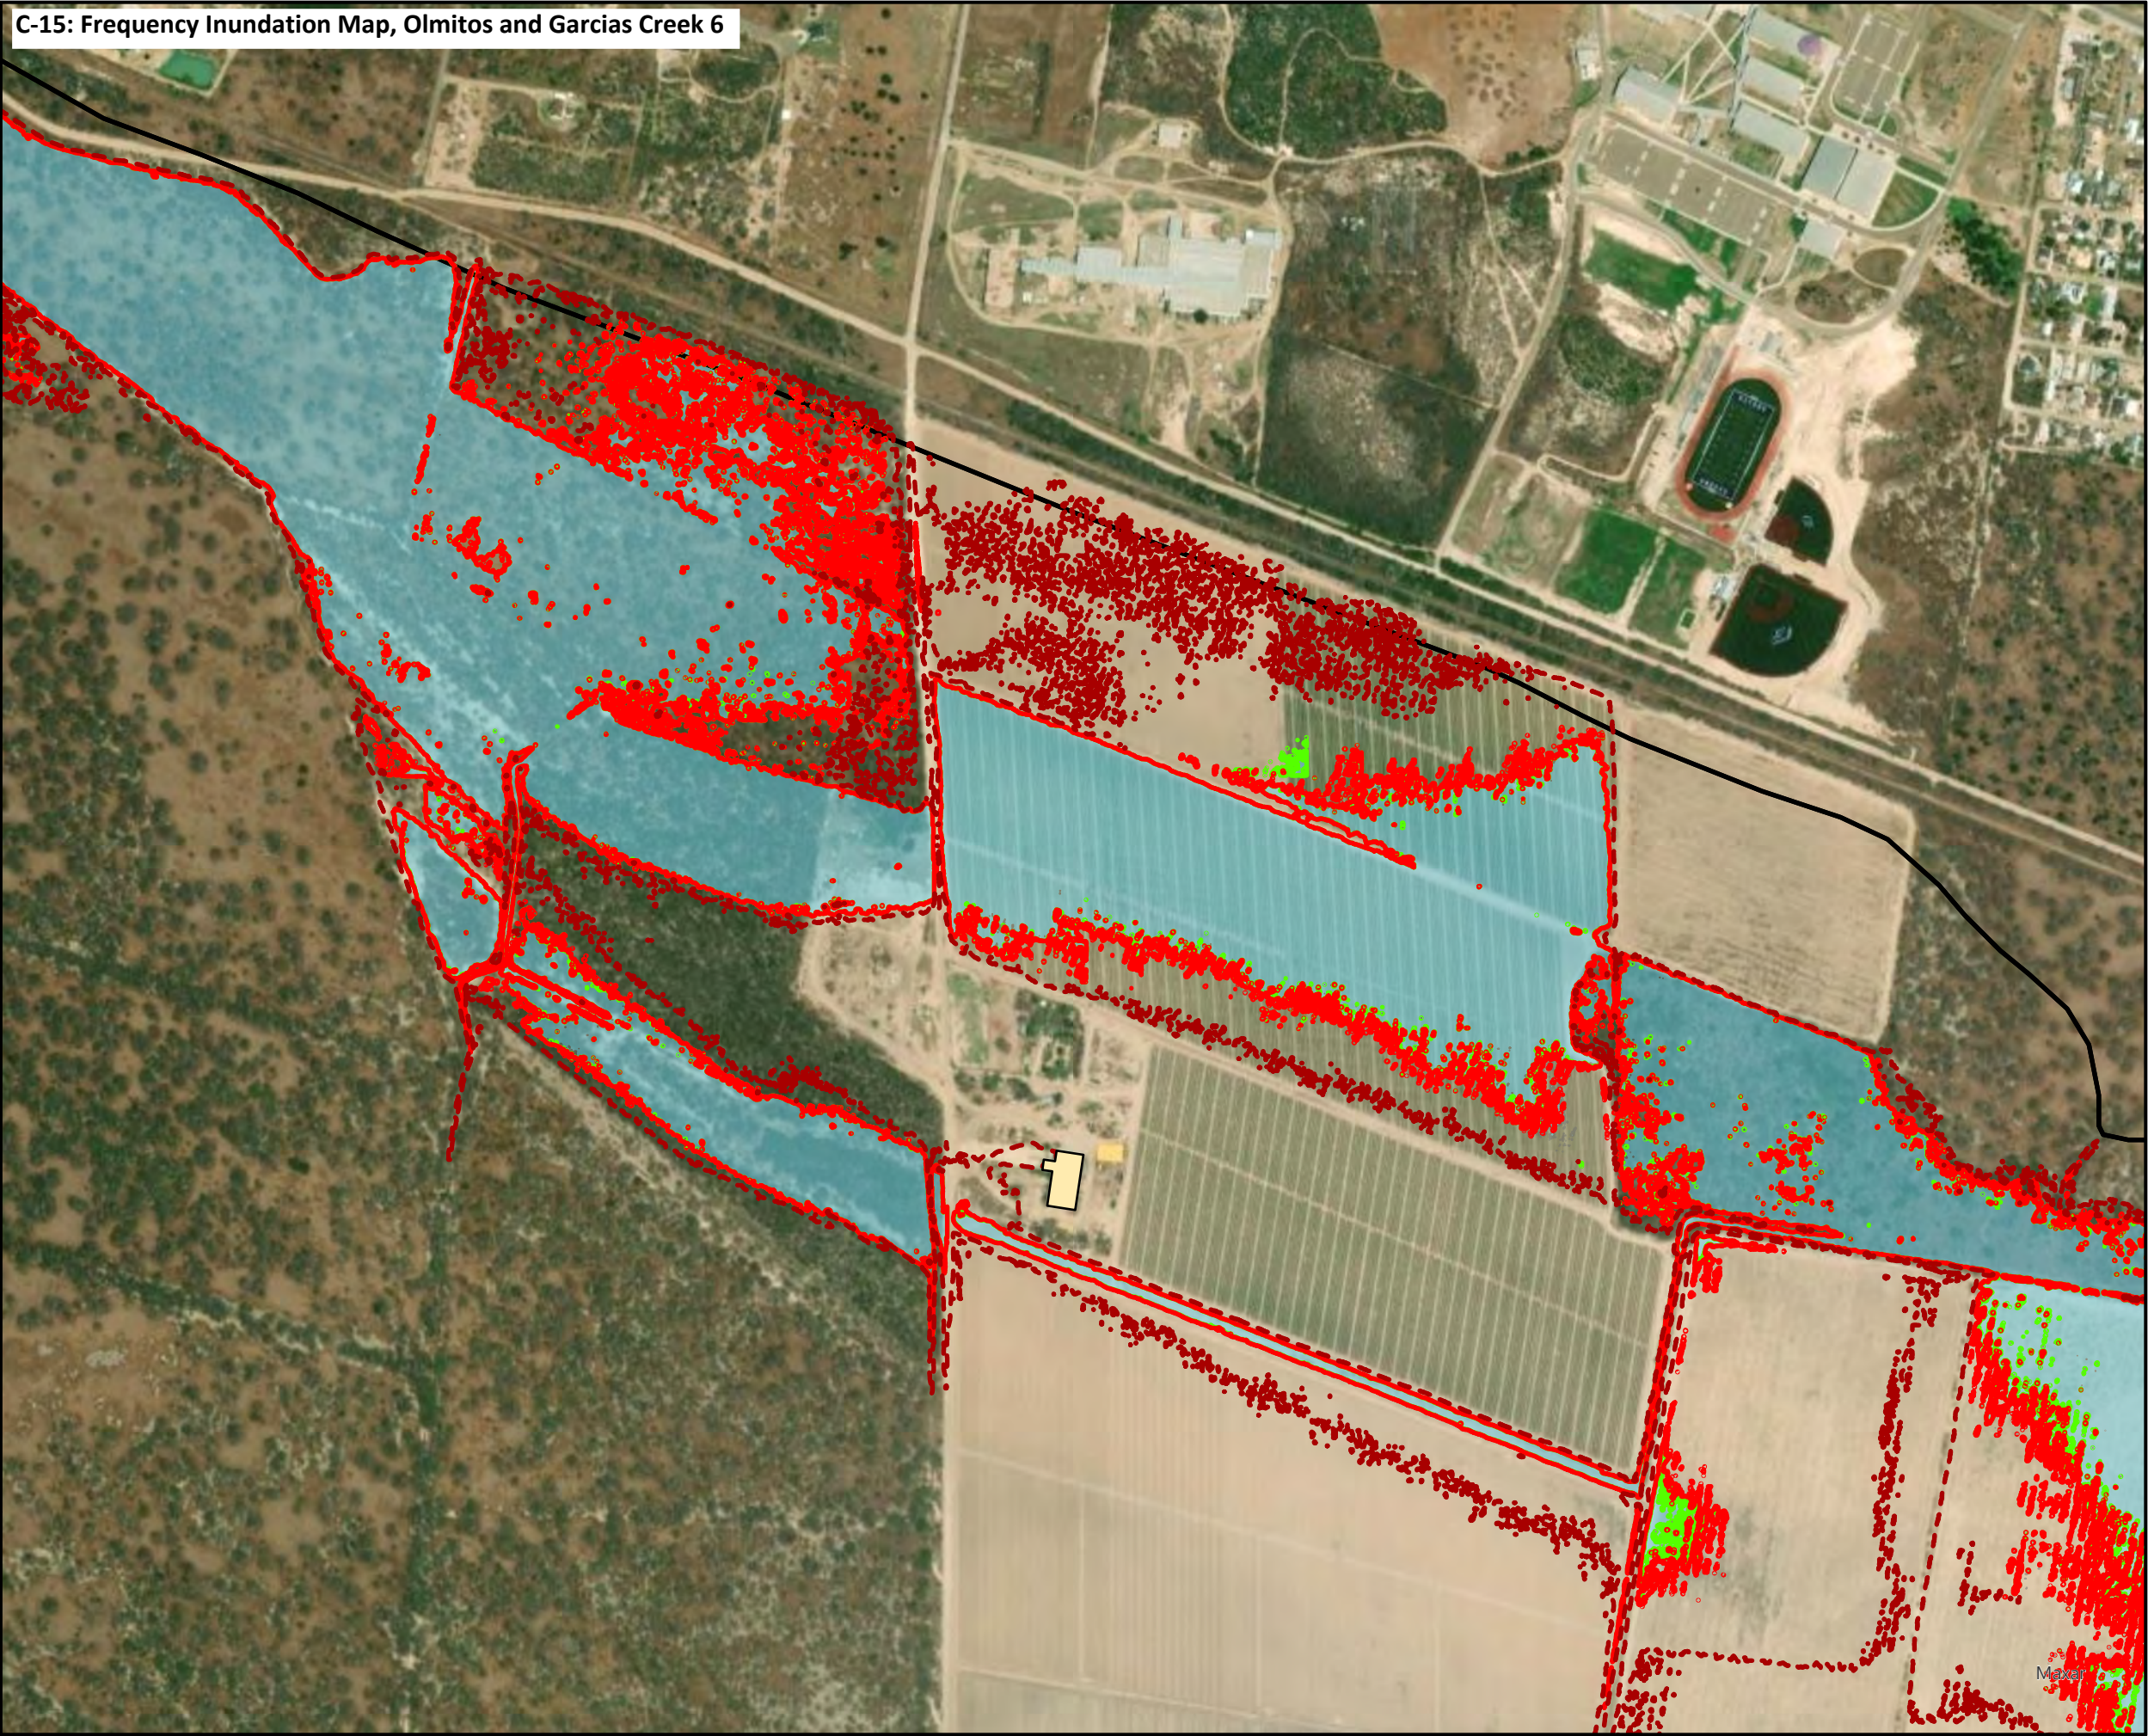
**OLMITOS & GARCIAS CREEK #6**  
**FREQUENCY EVENTS**  
**INUNDATION MAP**  
Panel 6 of 8

- Dam Centerline
- Structure Inventory
- Decom. 1000 Year Inundation
- Decom. 100 Year Inundation
- Preferred Alt. 100 Year Inundation
- Regulatory FEMA Zone A & AE
- Existing 100 yr Floodplain

*The methods used to develop inundation zones and flood wave arrival times are approximate and should only be used as guidance for establishing evacuation zones. Actual areas inundated will depend on actual failure and pre-failure hydrologic conditions and may differ significantly from information shown on maps.*

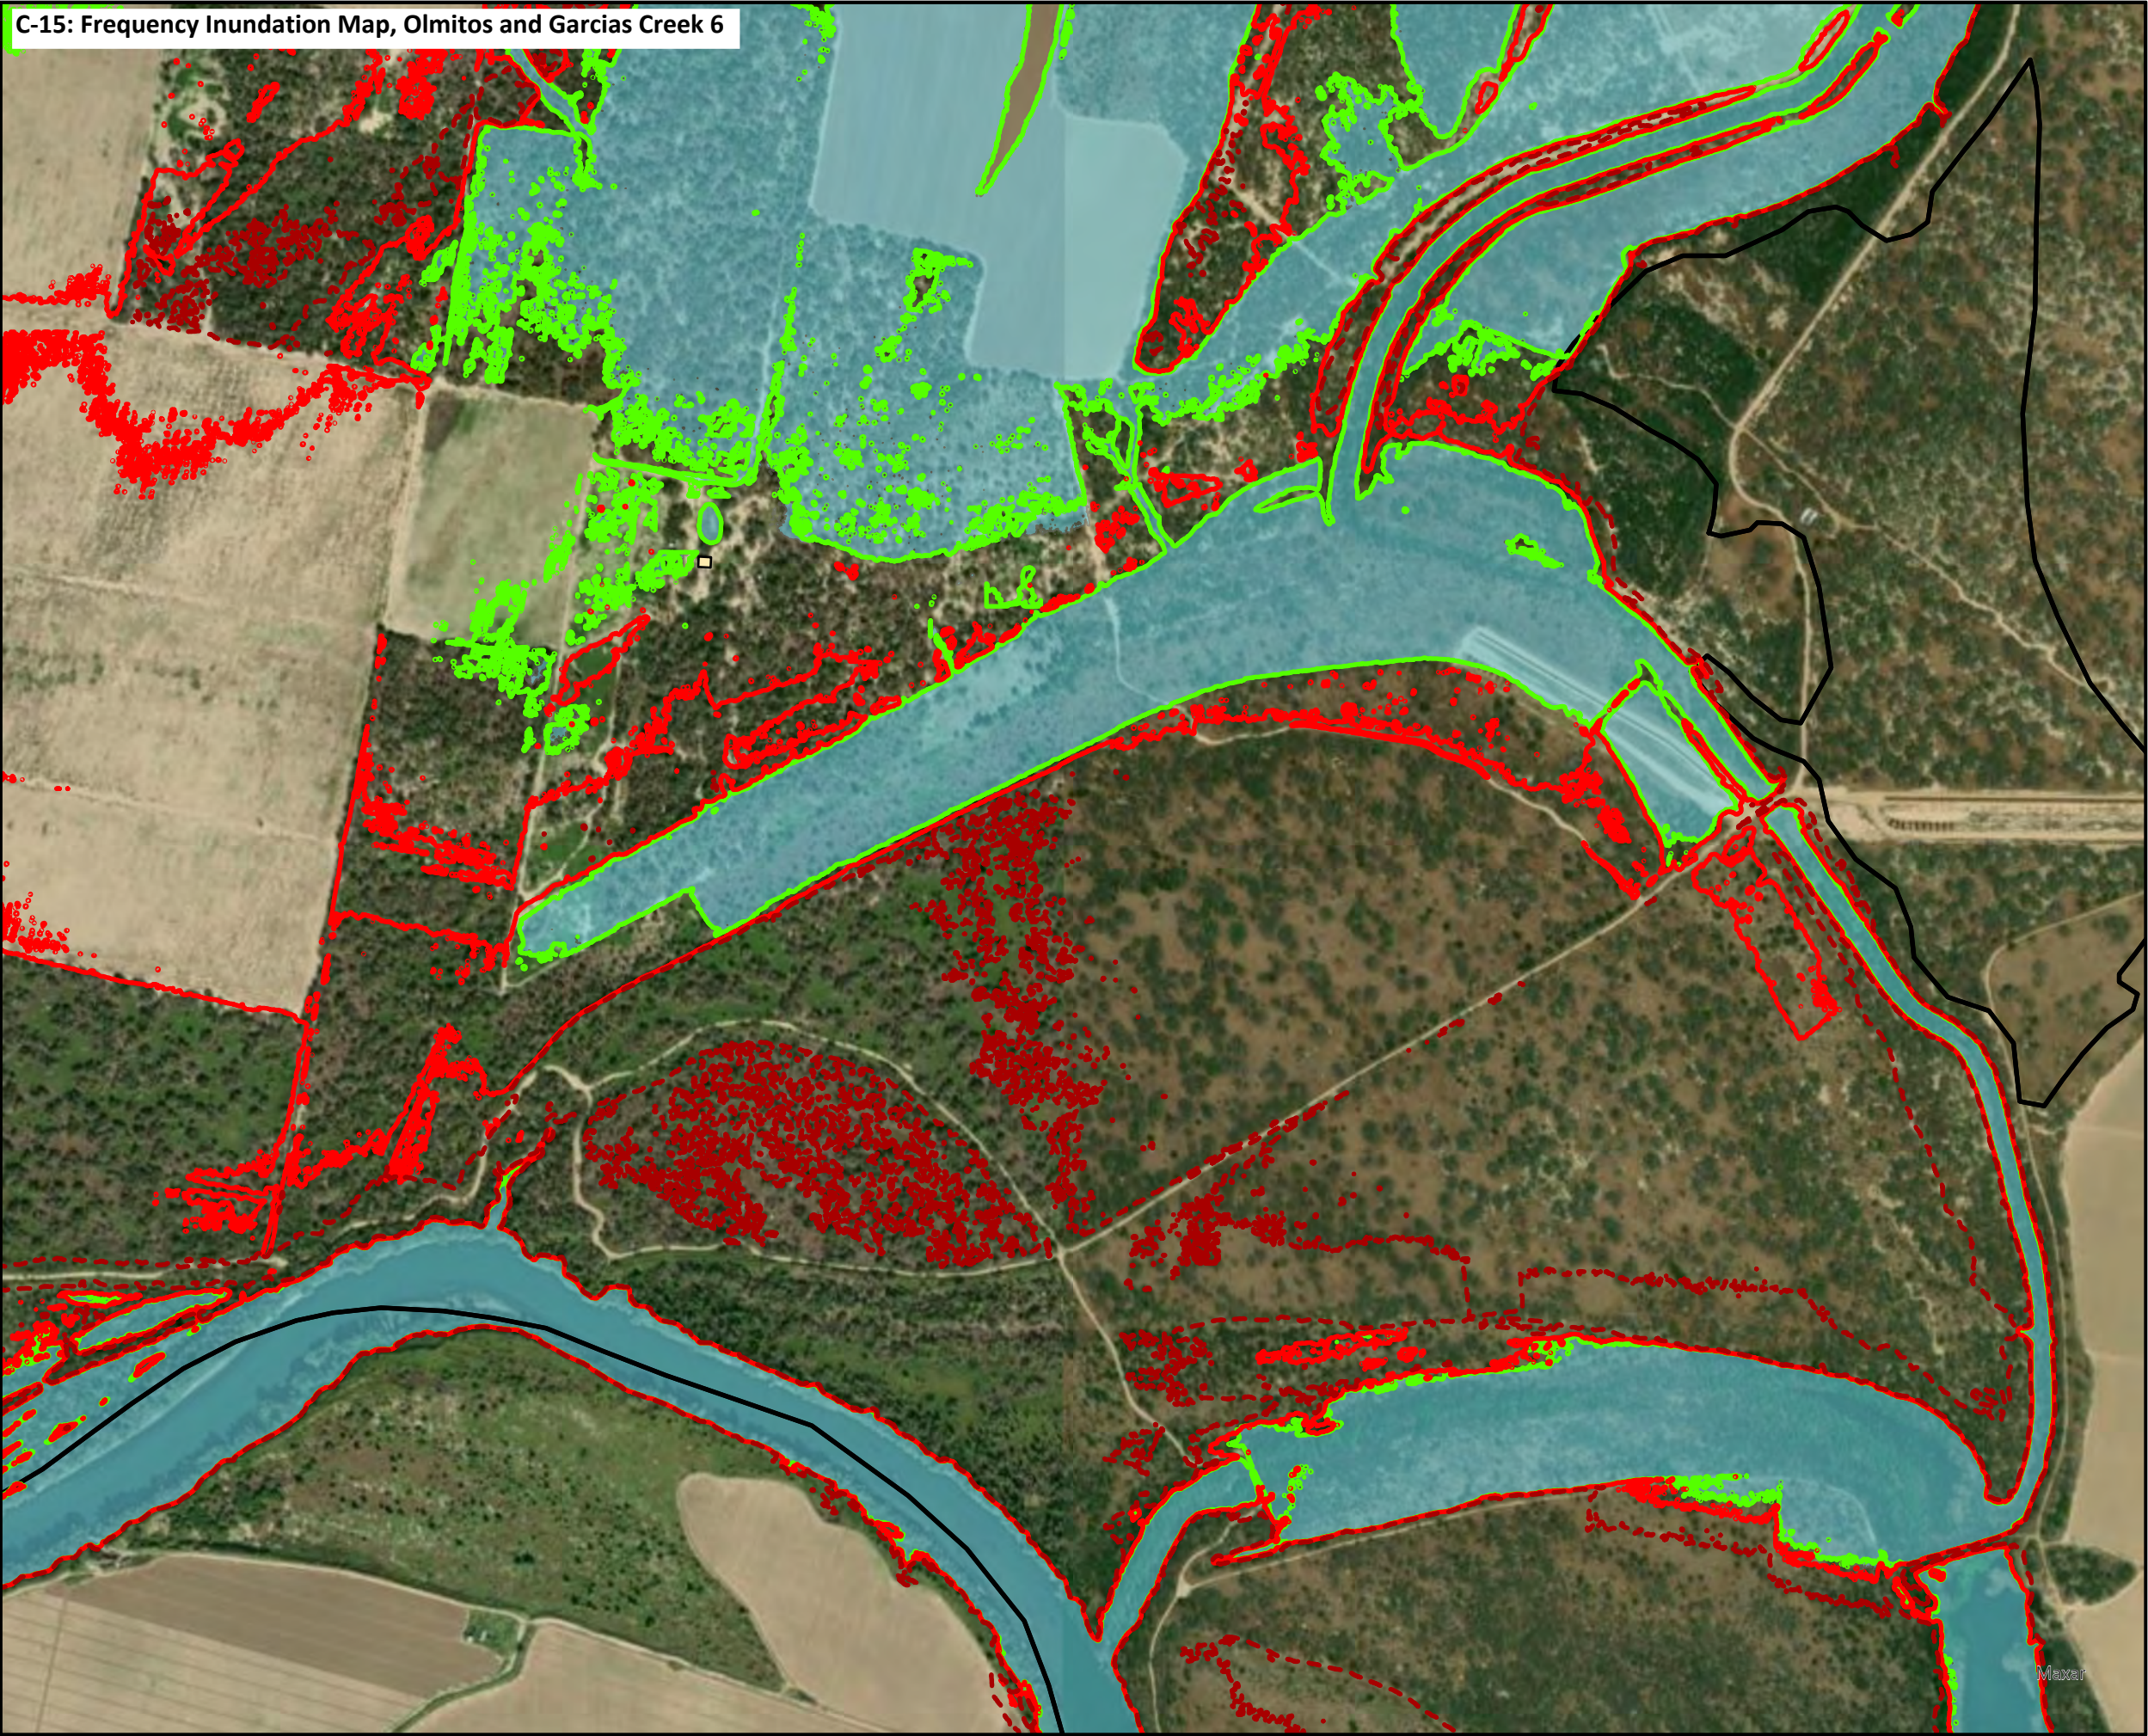
**OLMITOS & GARCIAS CREEK #6  
FREQUENCY EVENTS  
INUNDATION MAP**  
Panel 7 of 8

- Dam Centerline
- Structure Inventory
- Decom. 1000 Year Inundation
- Decom. 100 Year Inundation
- Preferred Alt. 100 Year Inundation
- Regulatory FEMA Zone A & AE
- Existing 100 yr Floodplain

*The methods used to develop inundation zones and flood wave arrival times are approximate and should only be used as guidance for establishing evacuation zones. Actual areas inundated will depend on actual failure and pre-failure hydrologic conditions and may differ significantly from information shown on maps.*

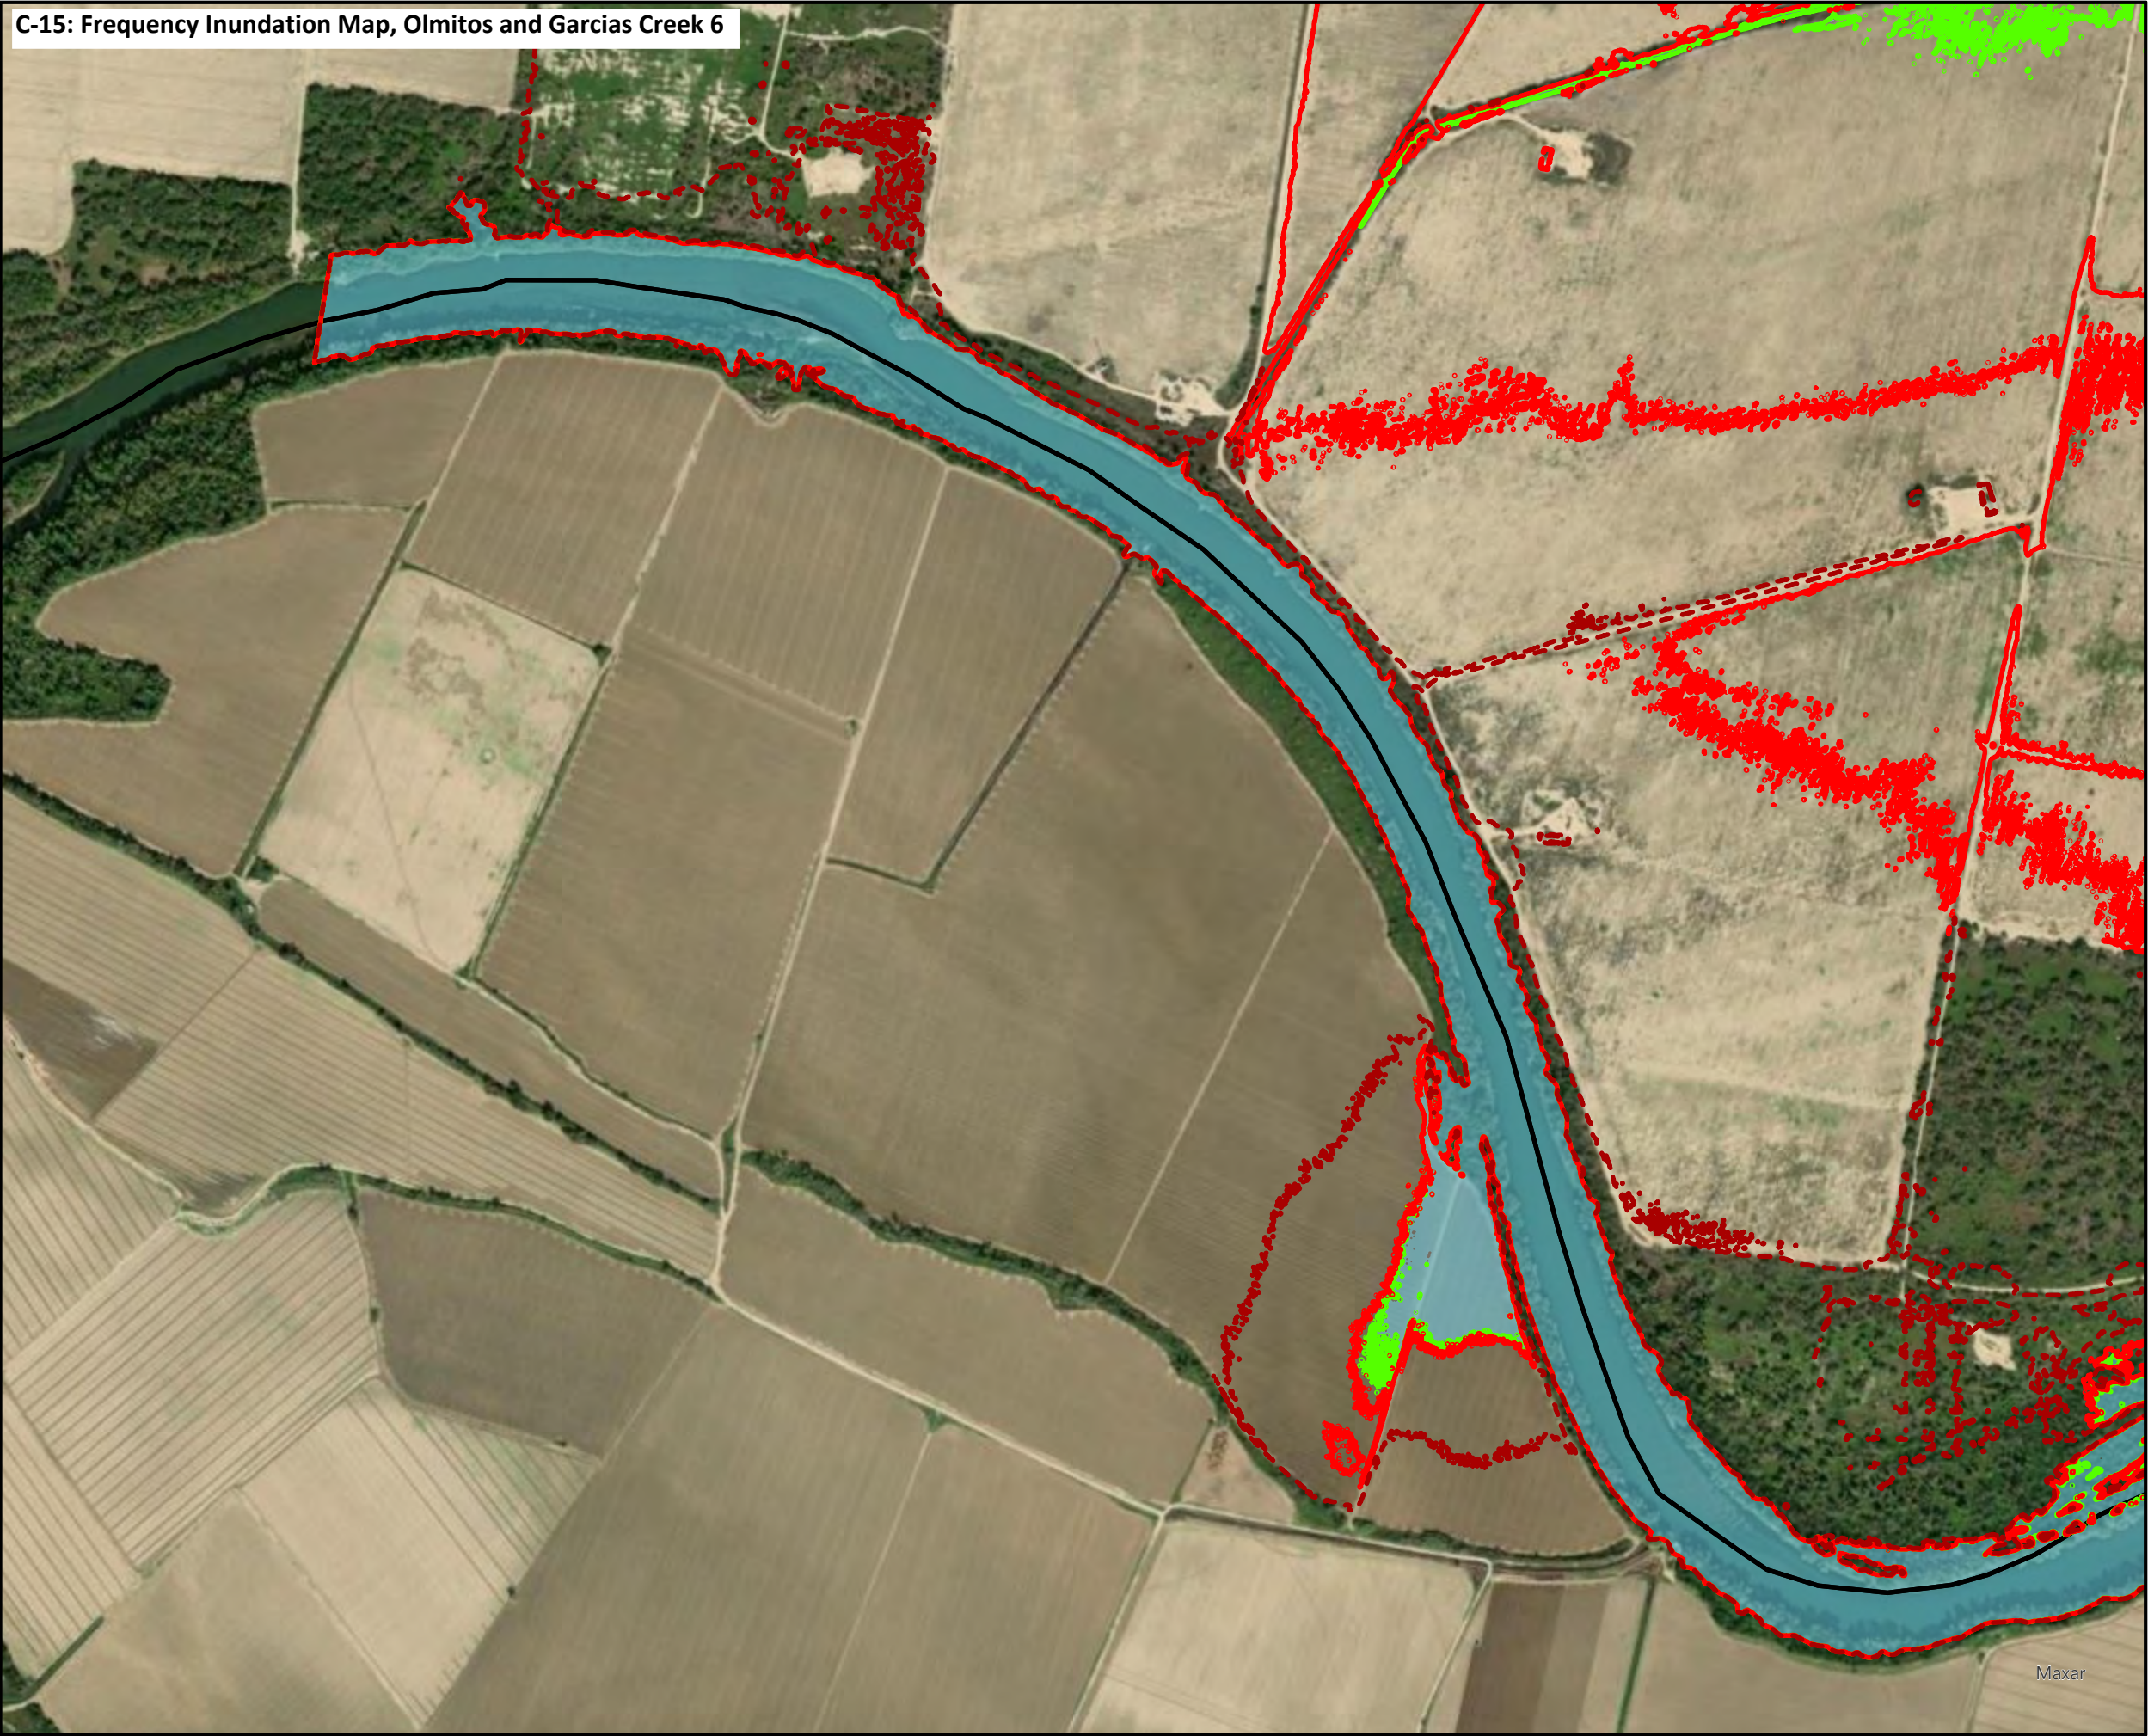
**OLMITOS & GARCIAS CREEK #6**  
**FREQUENCY EVENTS**  
**INUNDATION MAP**  
Panel 8 of 8

- Dam Centerline
- Structure Inventory
- Decom. 1000 Year Inundation
- Decom. 100 Year Inundation
- Preferred Alt. 100 Year Inundation
- Regulatory FEMA Zone A & AE
- Existing 100 yr Floodplain

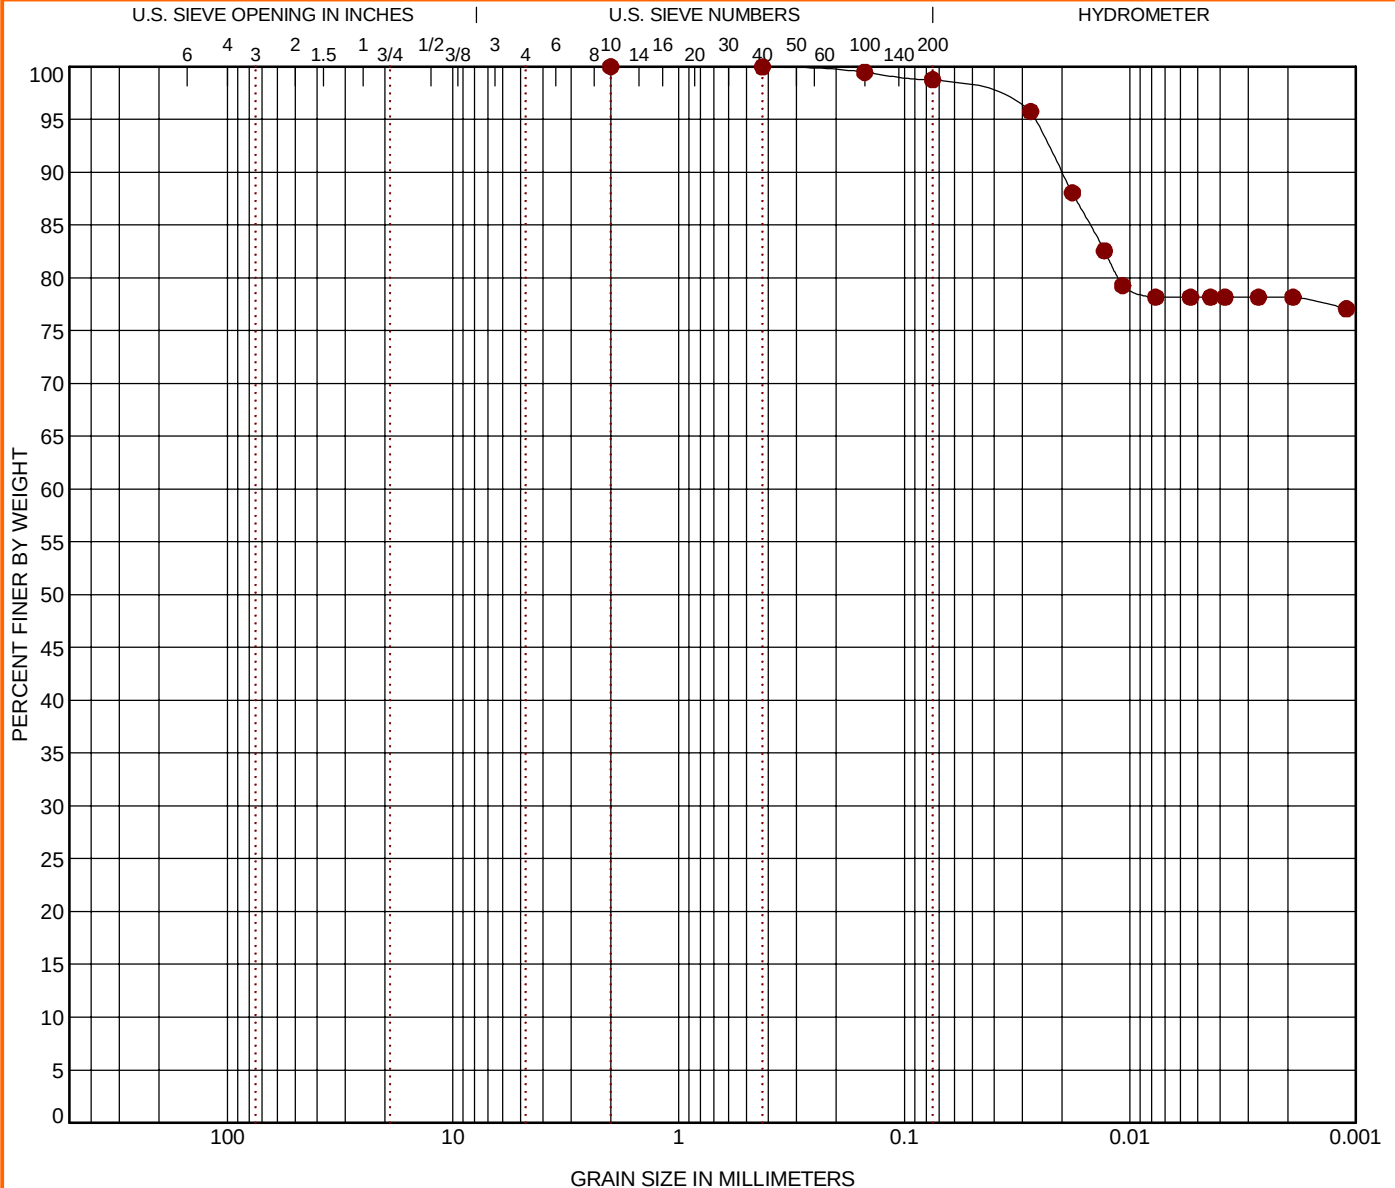
ASTM D422 / ASTM C136

| COBBLES | GRAVEL | | SAND | | | SILT OR CLAY |

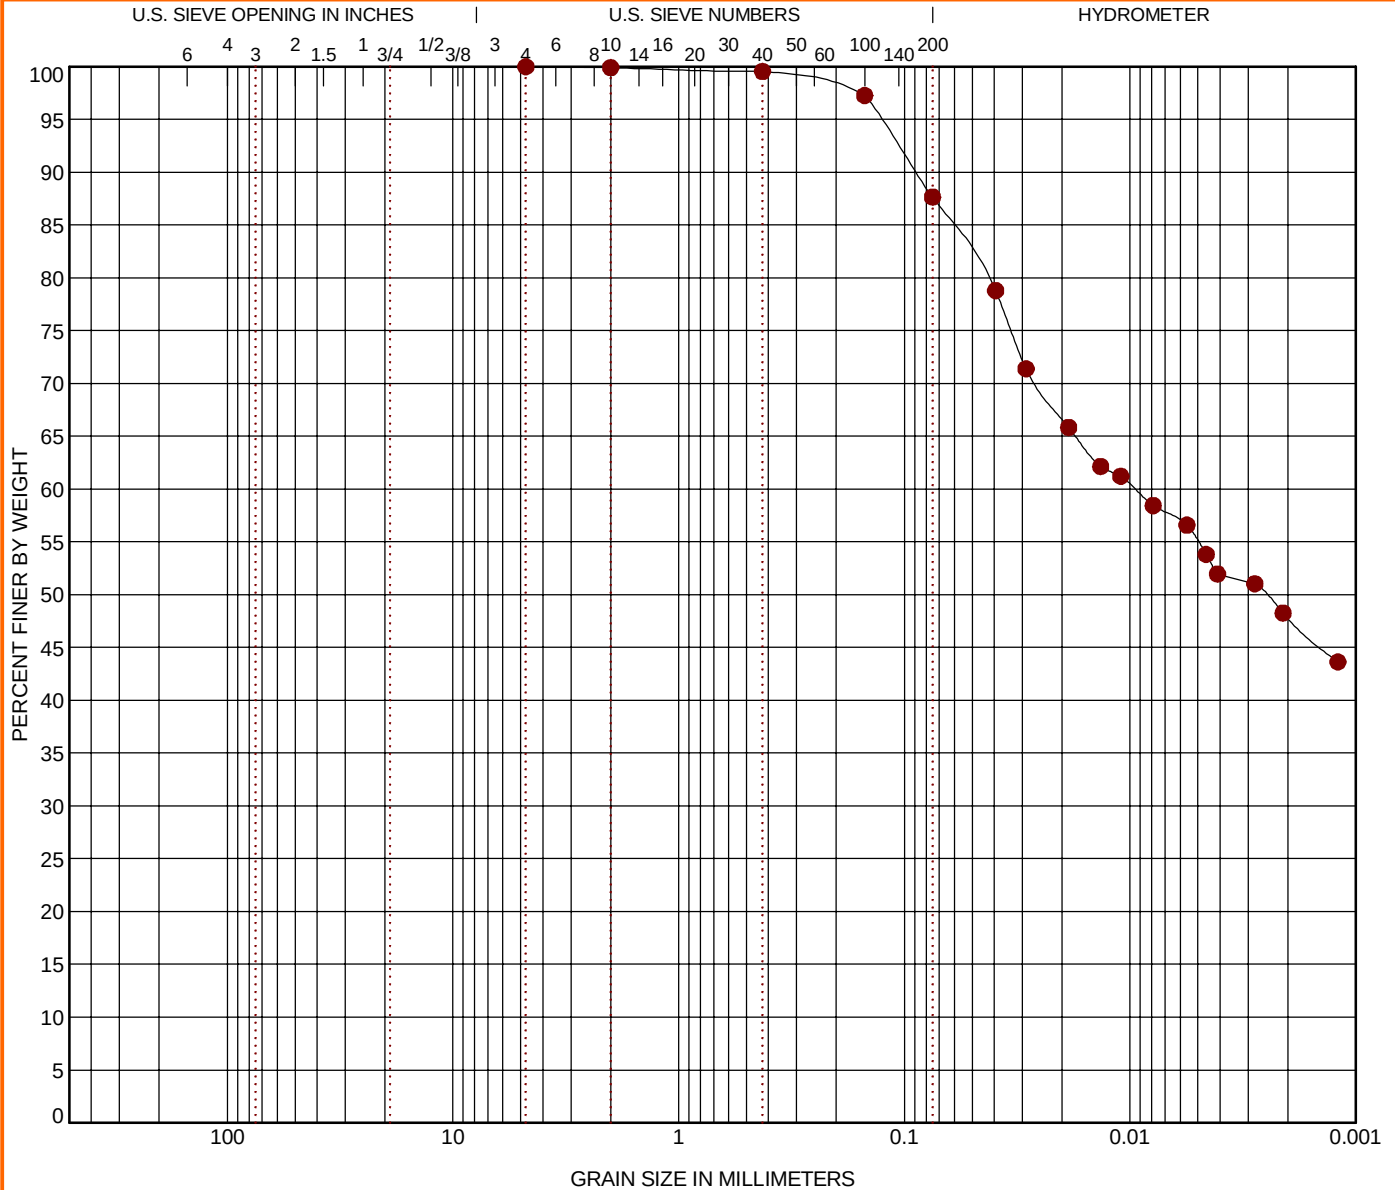
ASTM D422 / ASTM C136

| COBBLES | GRAVEL | | SAND | | | SILT OR CLAY |

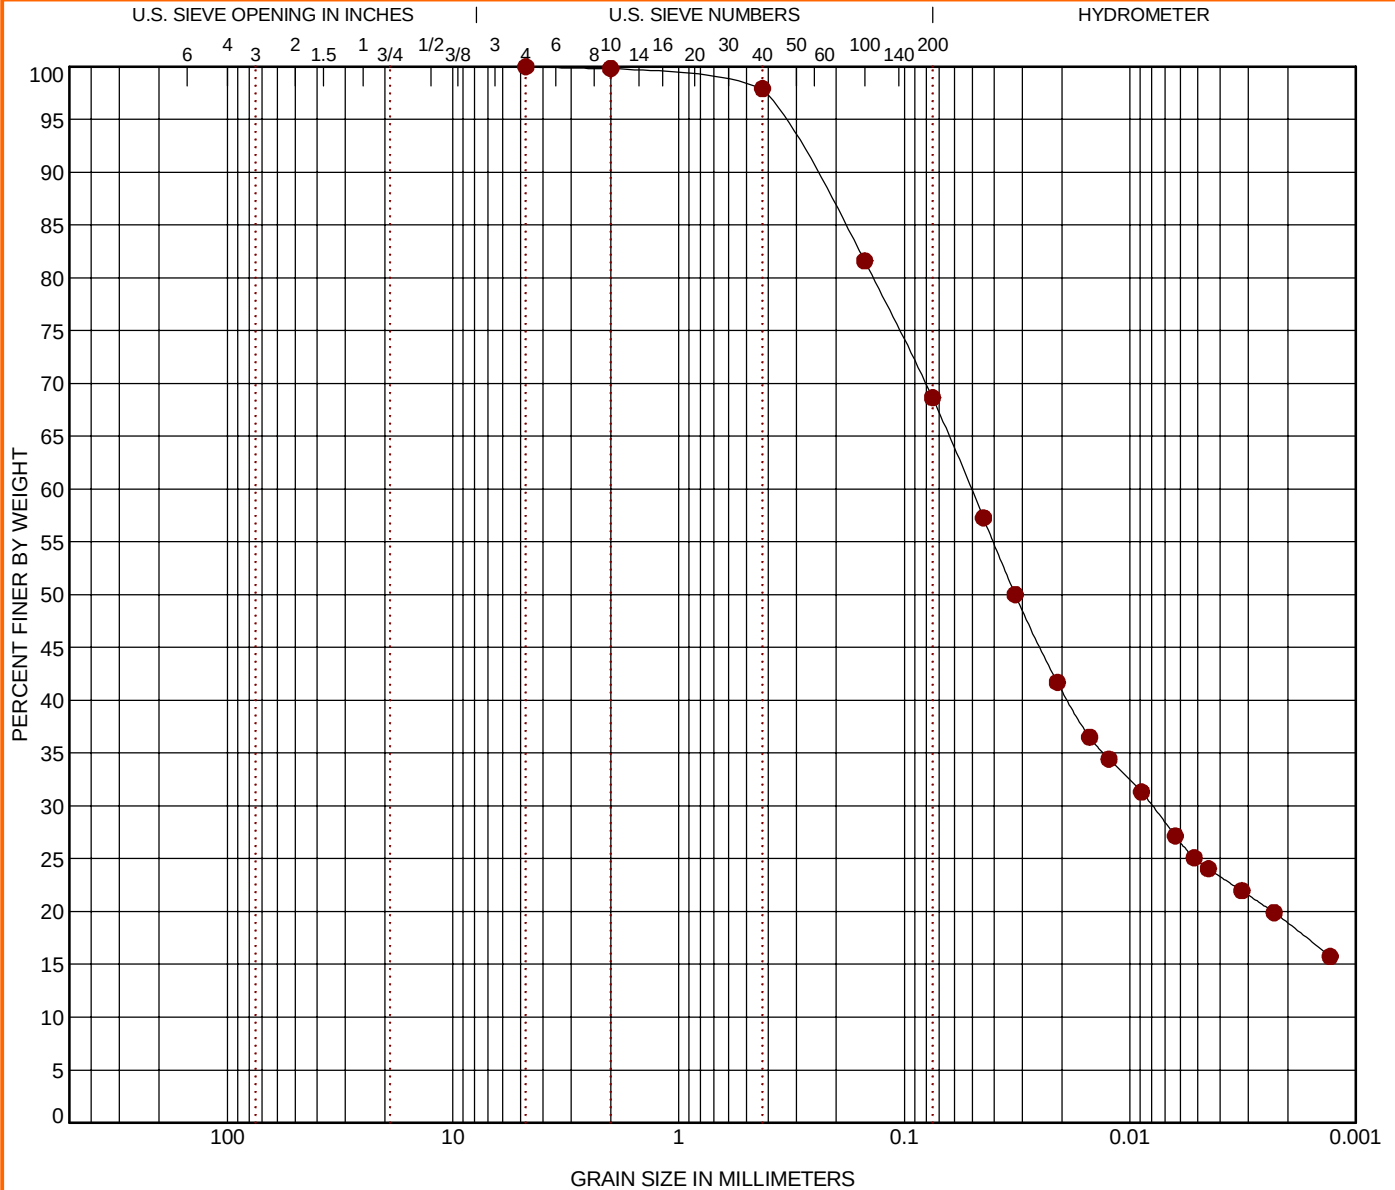
ASTM D422 / ASTM C136

| COBBLES | GRAVEL | | SAND | | | SILT OR CLAY |

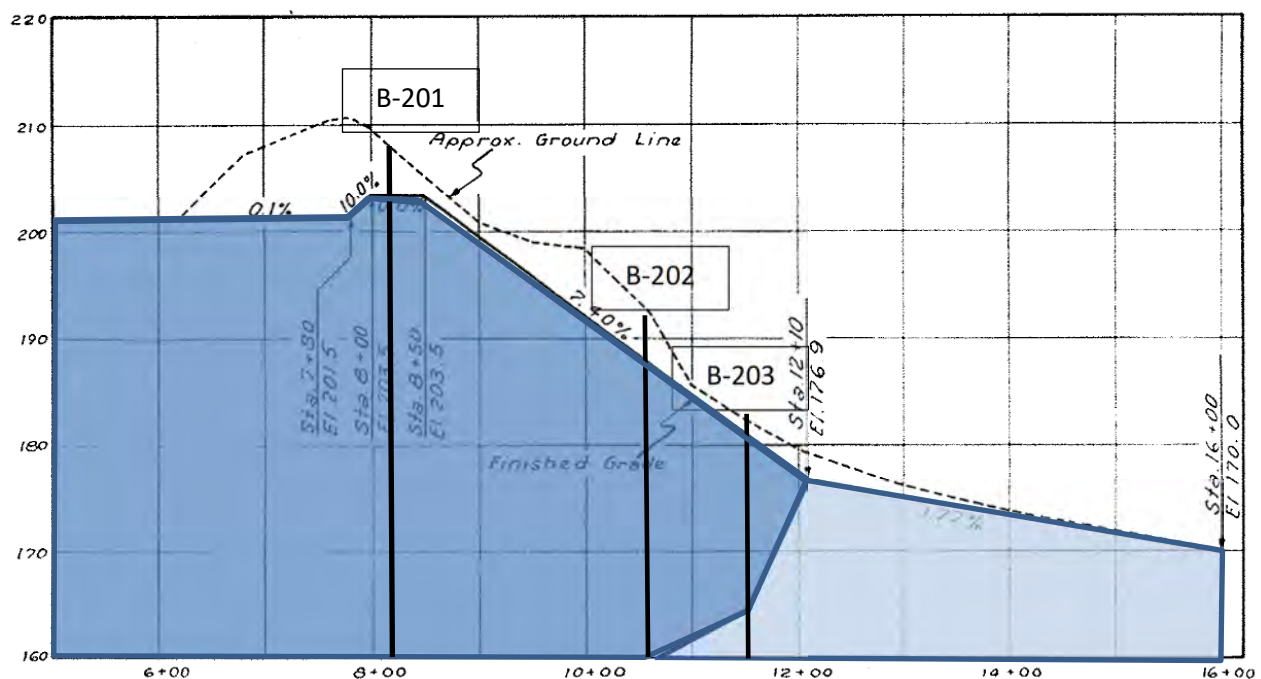
**Figure 1. Generalized Stratigraphy of Auxiliary Spillway Profile**

The proposed subsurface profile of the existing auxiliary spillway is presented in Figure 1. It is assumed that approximately the top 18.5 feet of the existing auxiliary spillway consists of the low plastic lean (CL) and silty clay (CL-ML).
